Town of Sandown Wetland Evaluation Report

Town of Sandown, NH
Conservation Commission

August 2008

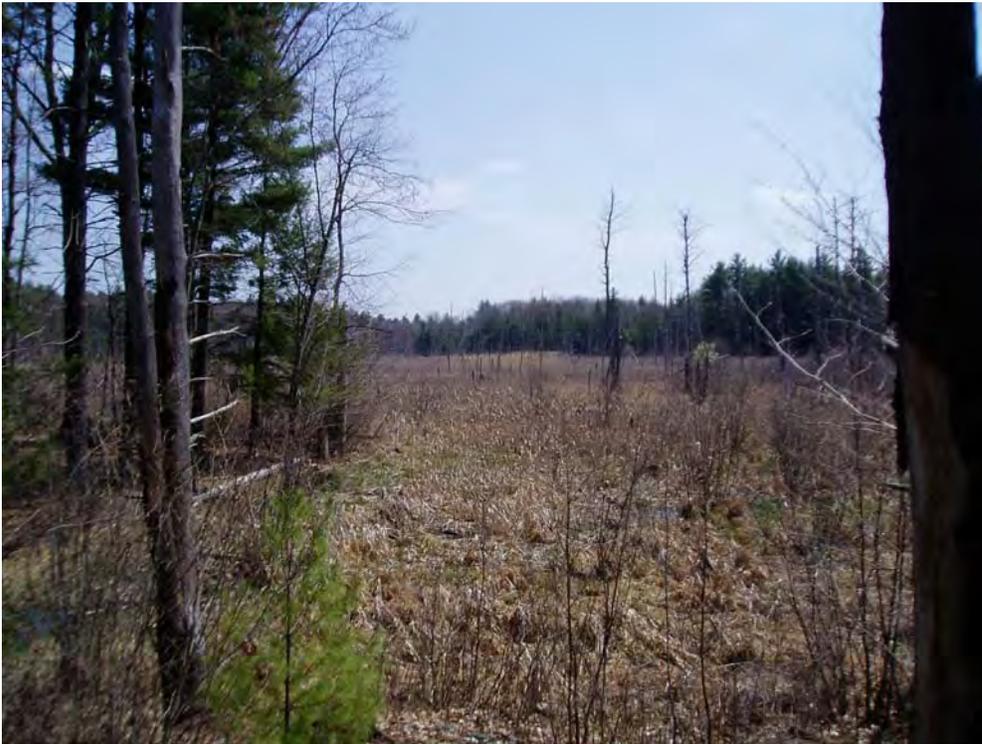
1. This photo shows Wetland #1 looking southeasterly from Mill Road. Beaver previously occupied this wetland.

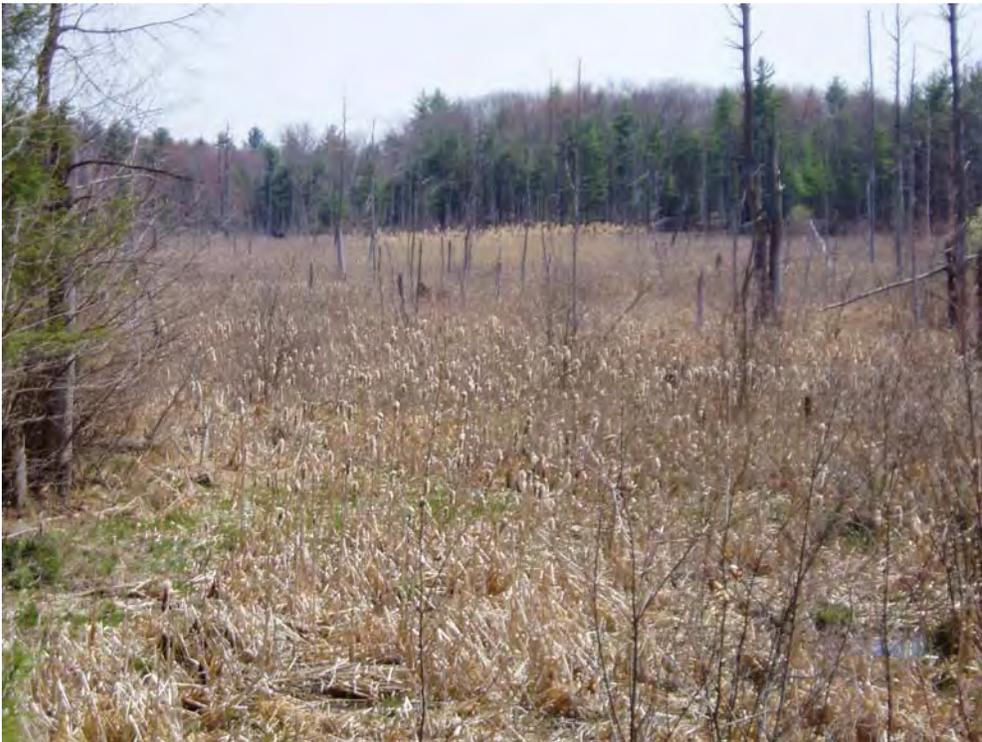
2. In this section of the wetland, an emergent plant community (PEM1Eb/PFO5Eb) is evident. The dominant plant species is broad-leaved cattails. A pocket of common reed (an invasive species) can be viewed in the back center of the photograph.

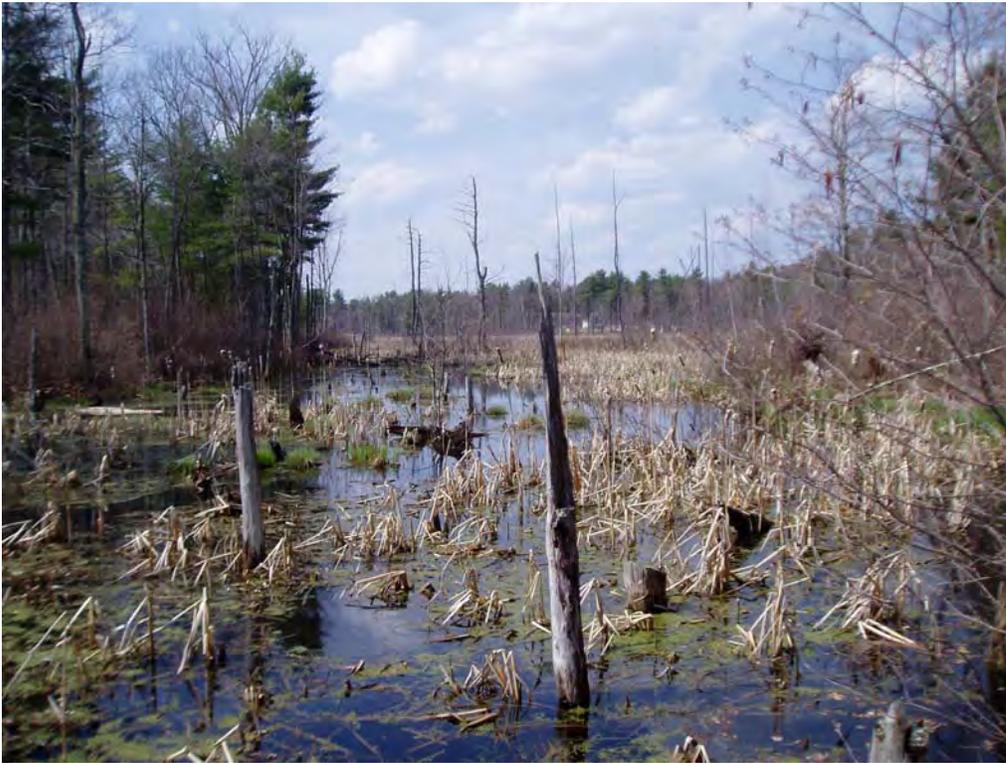
3. This photo shows the narrow section of wetland connecting the upper and most southern components. An earlier beaver dam was observed here.

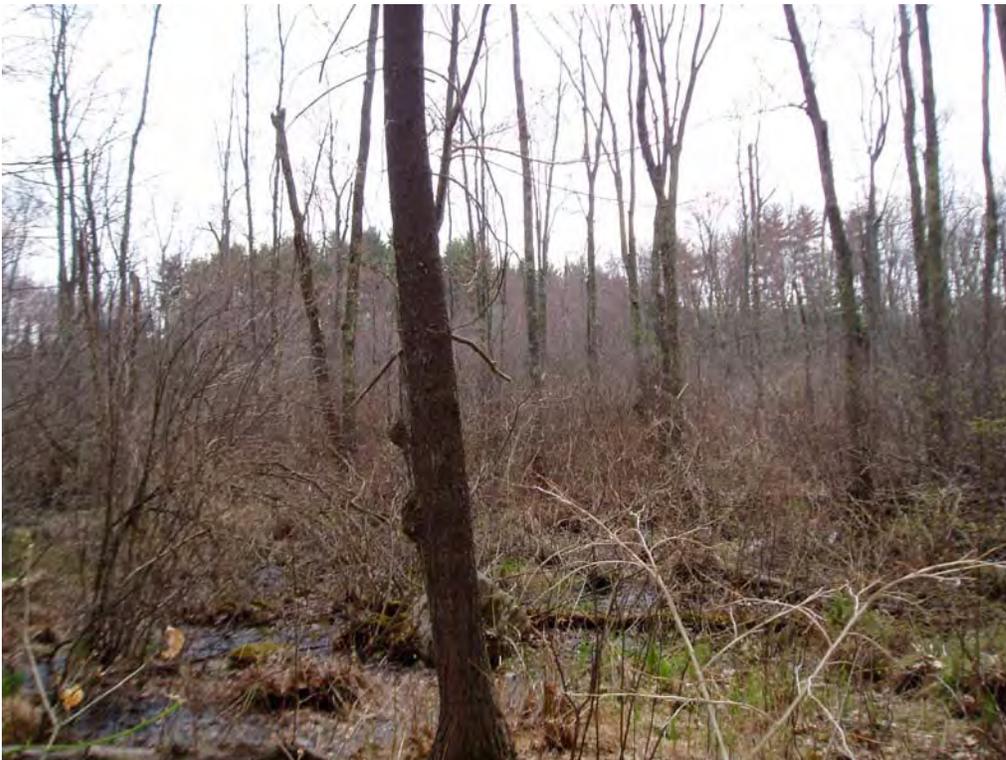
4. This photo shows the most southern wetland component (PFO1E/PSS1E). Here, a chiefly red maple tree layer overtops a thick scrub-shrub layer.

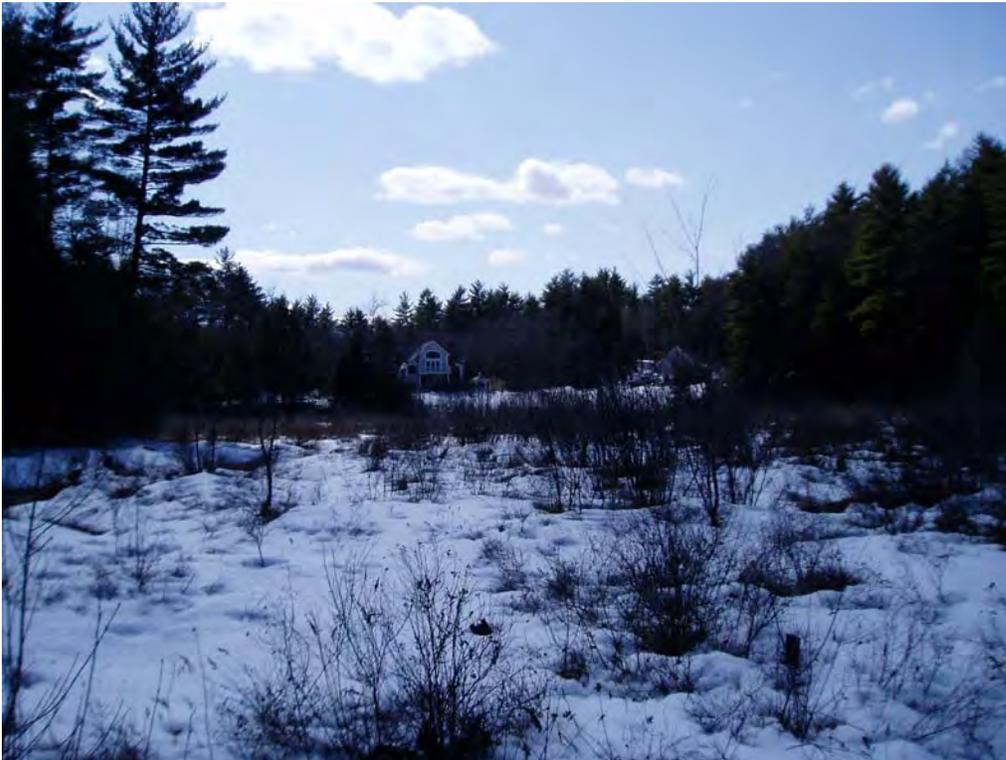
1. A large percentage of Wetland #2 is divided equally between emergent and scrub-shrub vegetation. A stream exits this wetland on its southern end and flows to the Exeter River.

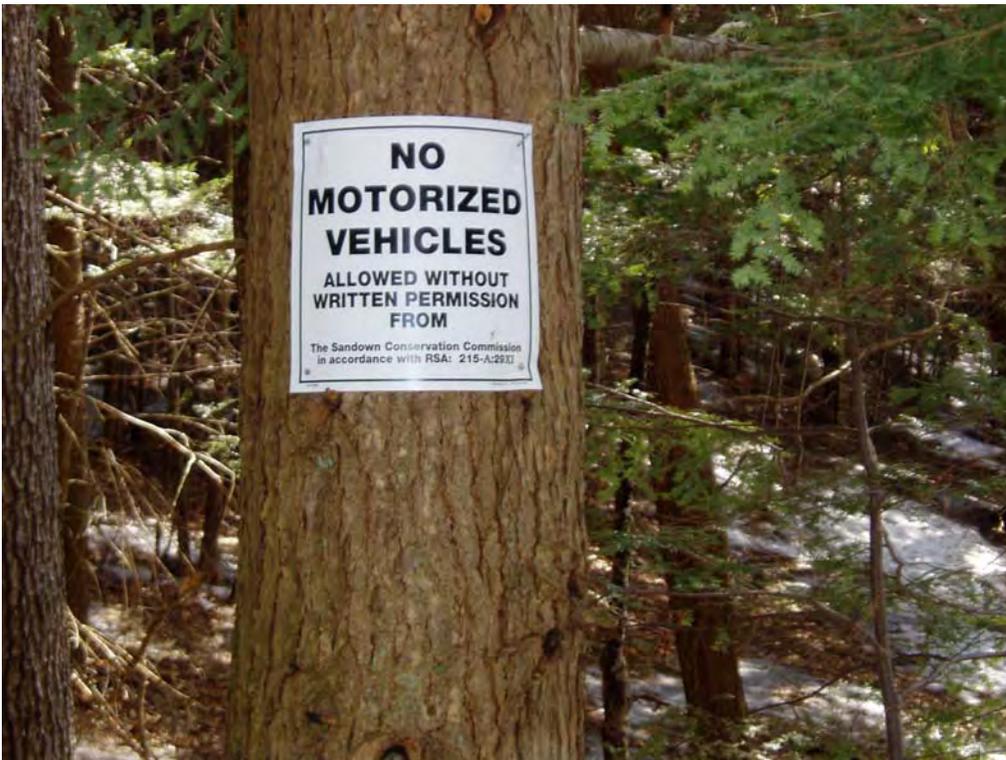
2. Wetland #2 appears contained within/adjacent the Greenwood-Hooke conservation parcel, accentuating this wetland's overall value.

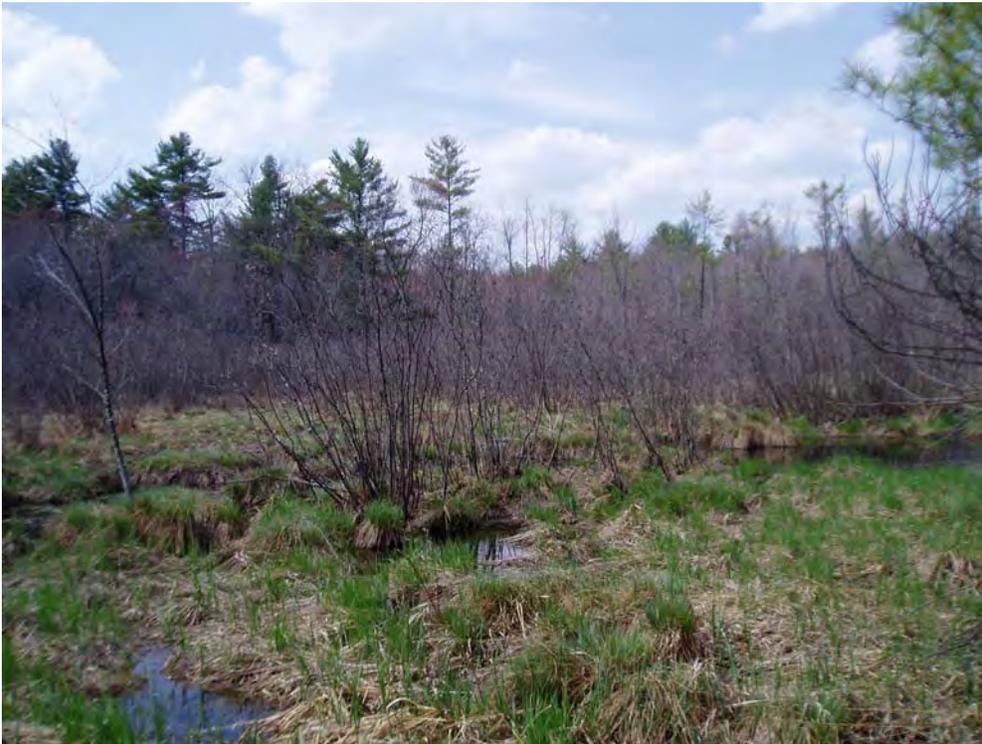
1. Wetland #4 is connected hydrologically with both Wetlands #1 & 11 via a perennial stream. This photo shows the emergent scrub-shrub wetland component adjacent Little Mill Road.

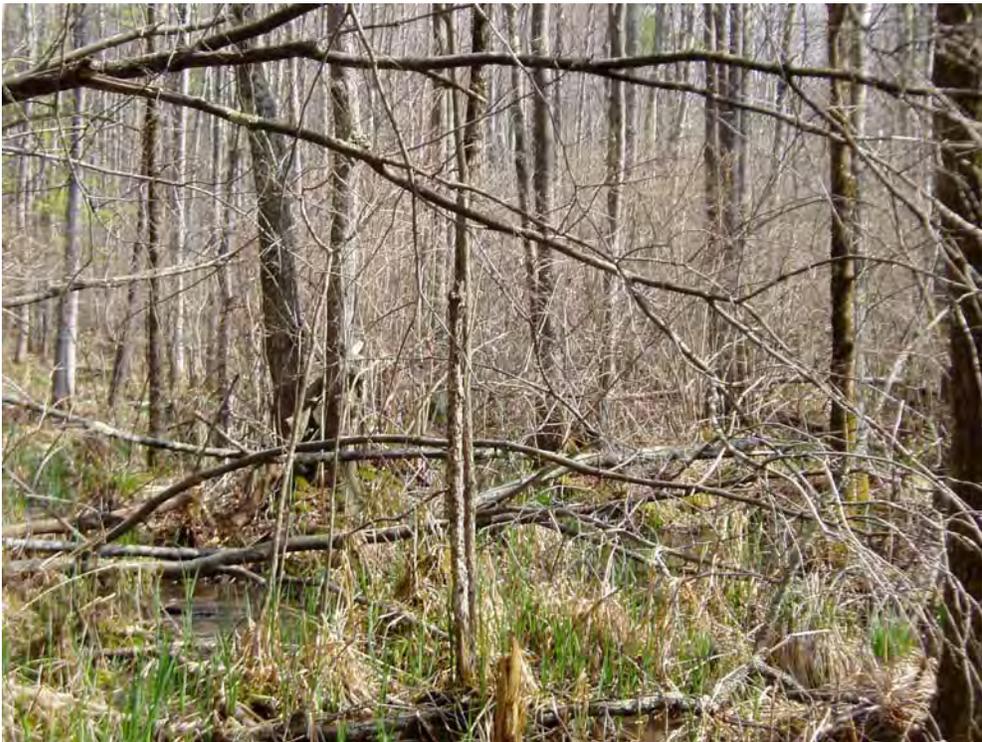
2. The northwestern component of Wetland #4 (access via Michael Circle) was forested with a thick scrub-shrub understory. The large percentage of scrub-shrub within Wetland #4 accentuates this wetland's wildlife value.

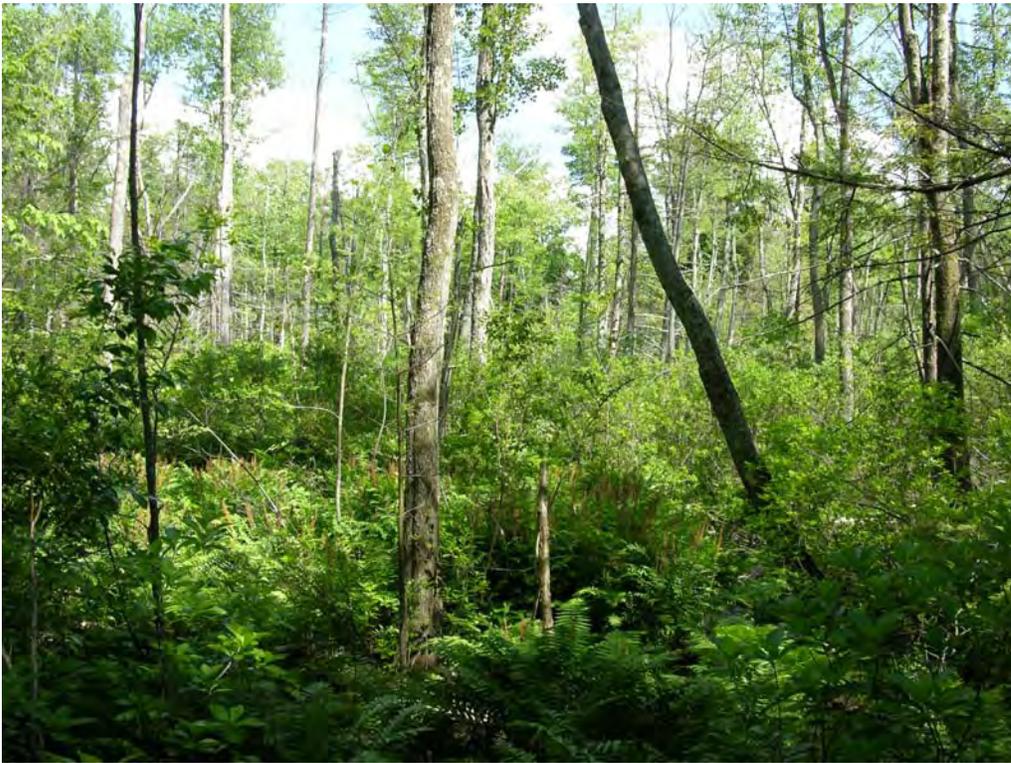
1. This is a view of the western portion of this forested/scrub-shrub swamp. The canopy is sparse, allowing for thick shrub growth.

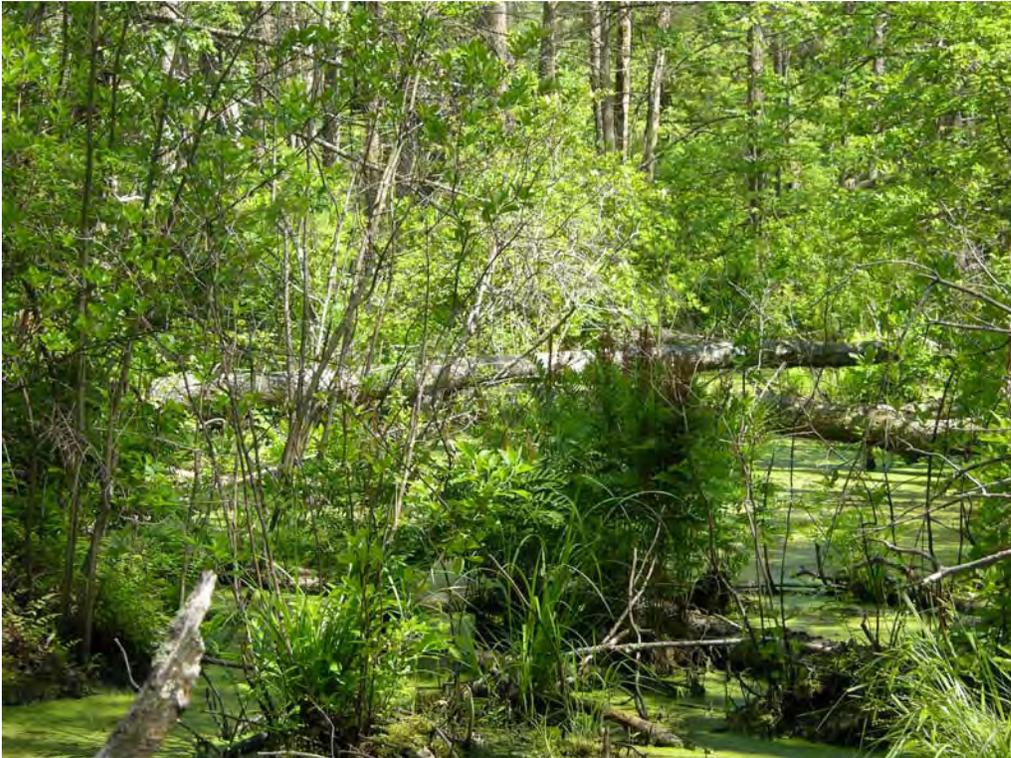
2. Pockets of open water and emergent vegetation are present in this wetland, increasing its value as aquatic habitat.

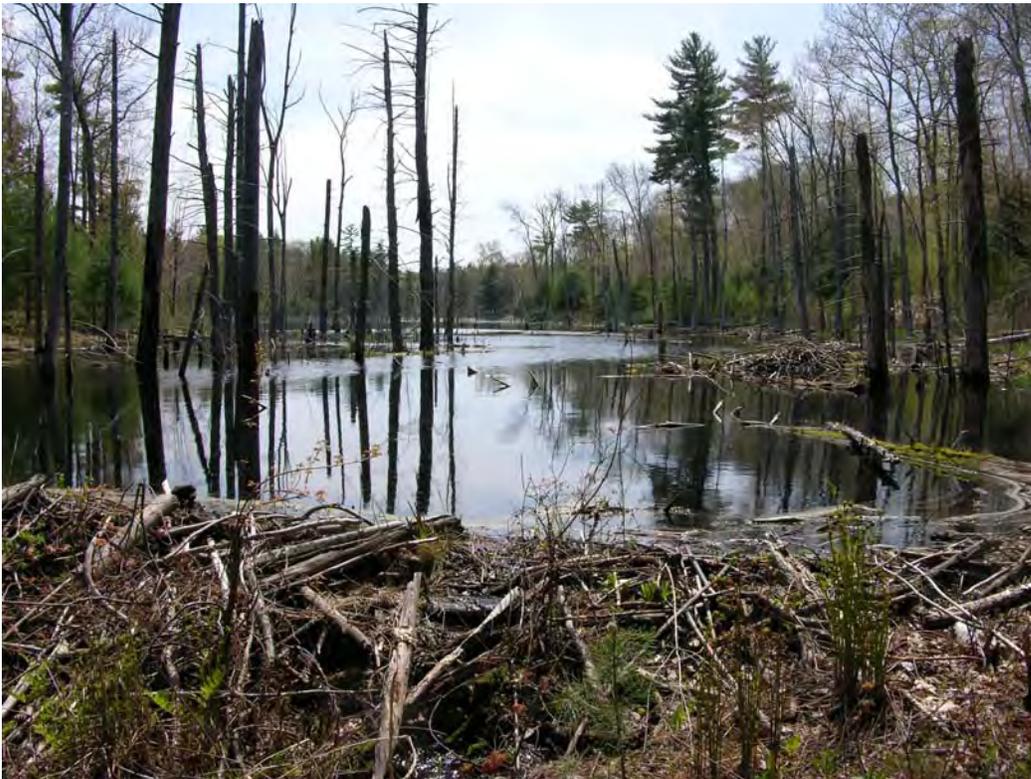
1. This is a view from the beaver dam at the northern end of Wetland #6. Dead trees and deep marsh dominated this portion of the wetland.

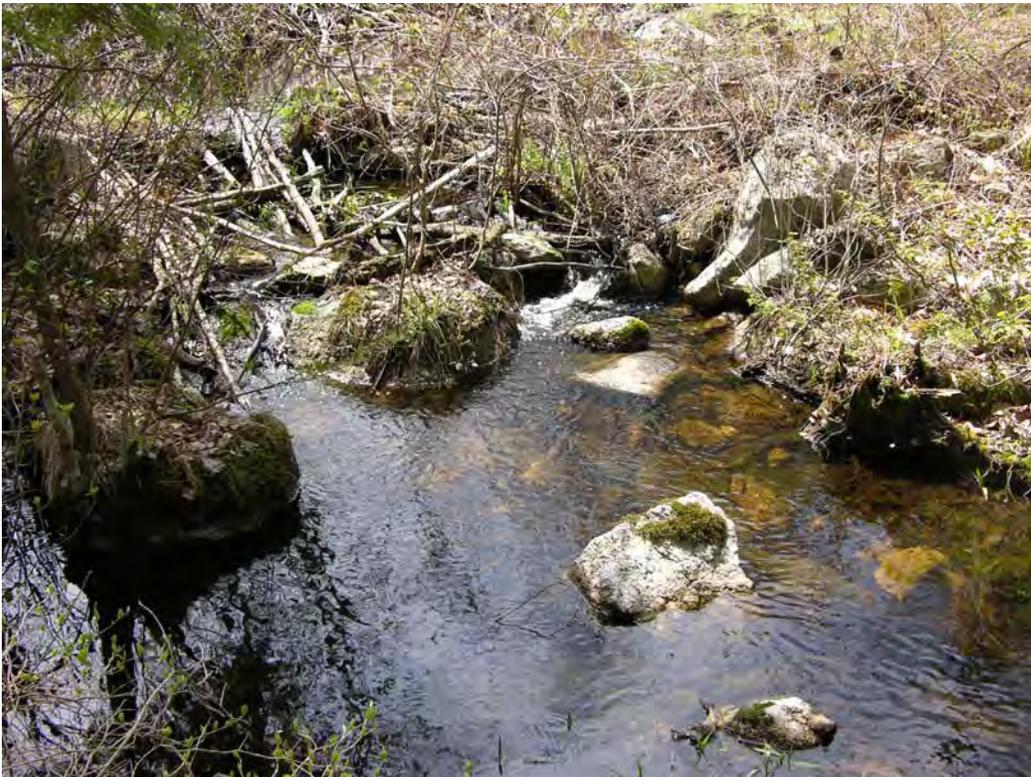
2. This is a photo of the stream that drains from Wetland #6 to Wetland #7.

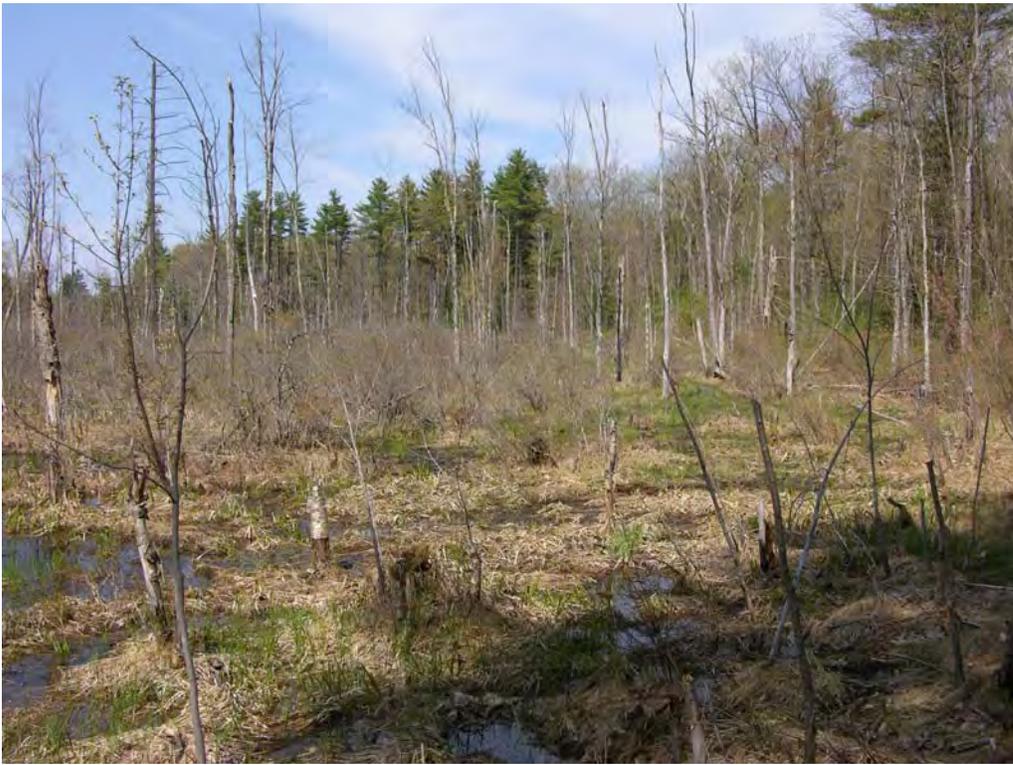
3. This is a photo of the southern portion of the wetland where a scrub-shrub/shallow marsh is present.

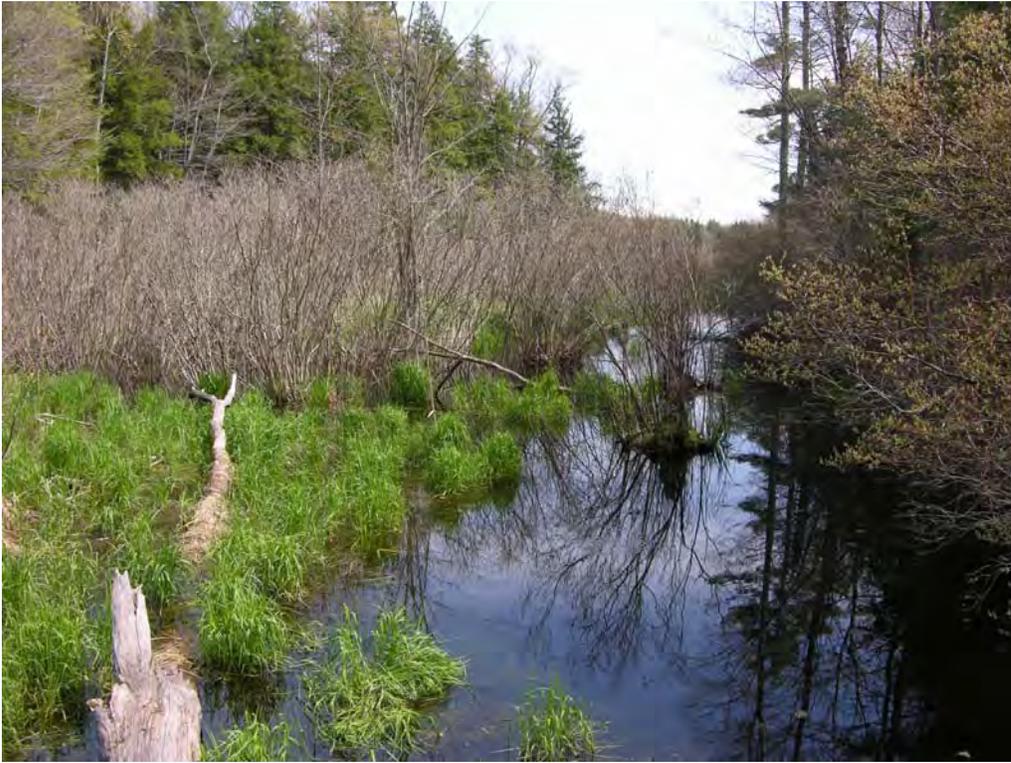
1. The northern end of Wetland #7 includes a thick scrub-shrub marsh system with pockets of open water. This is high value habitat for Blanding's turtle.

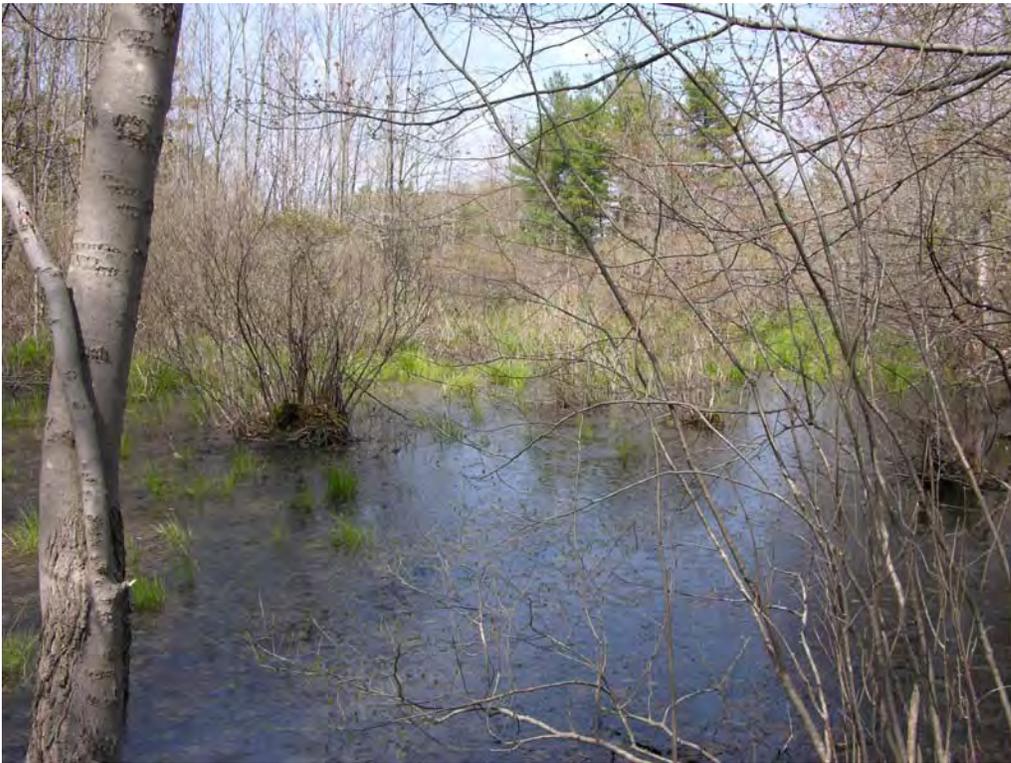
2. The southern end of this wetland includes forested components mixed with scrub-shrub marsh.

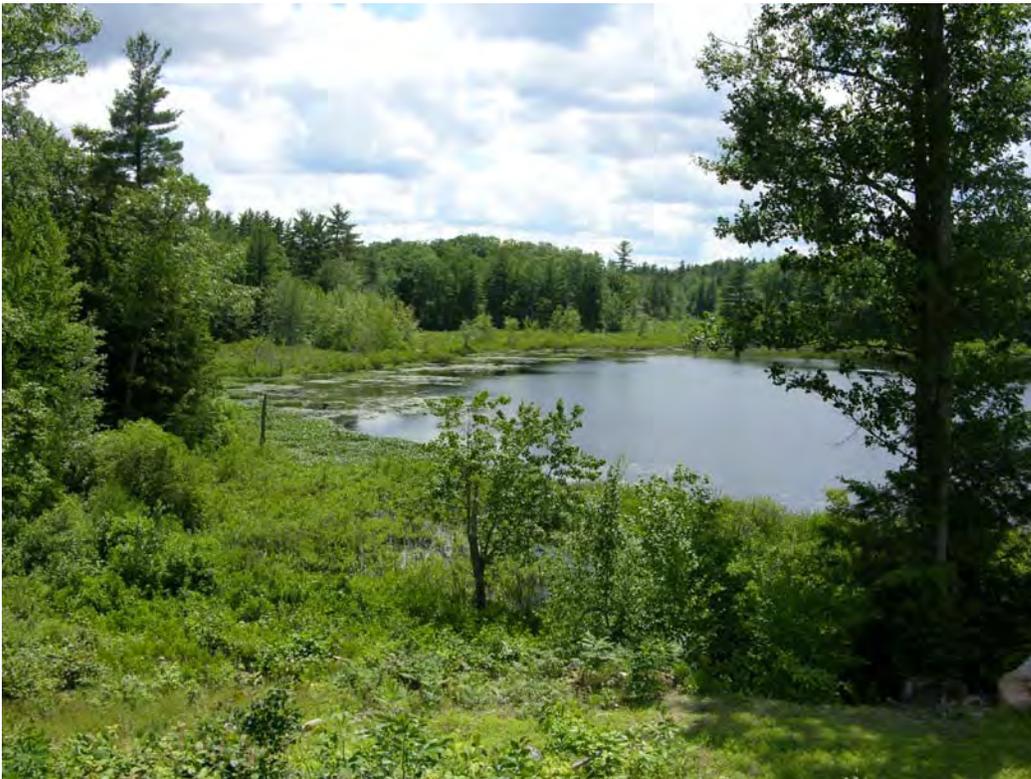
3. This is a view of Little Cub Pond looking southwest. Wetland #7 borders three sides of the pond.

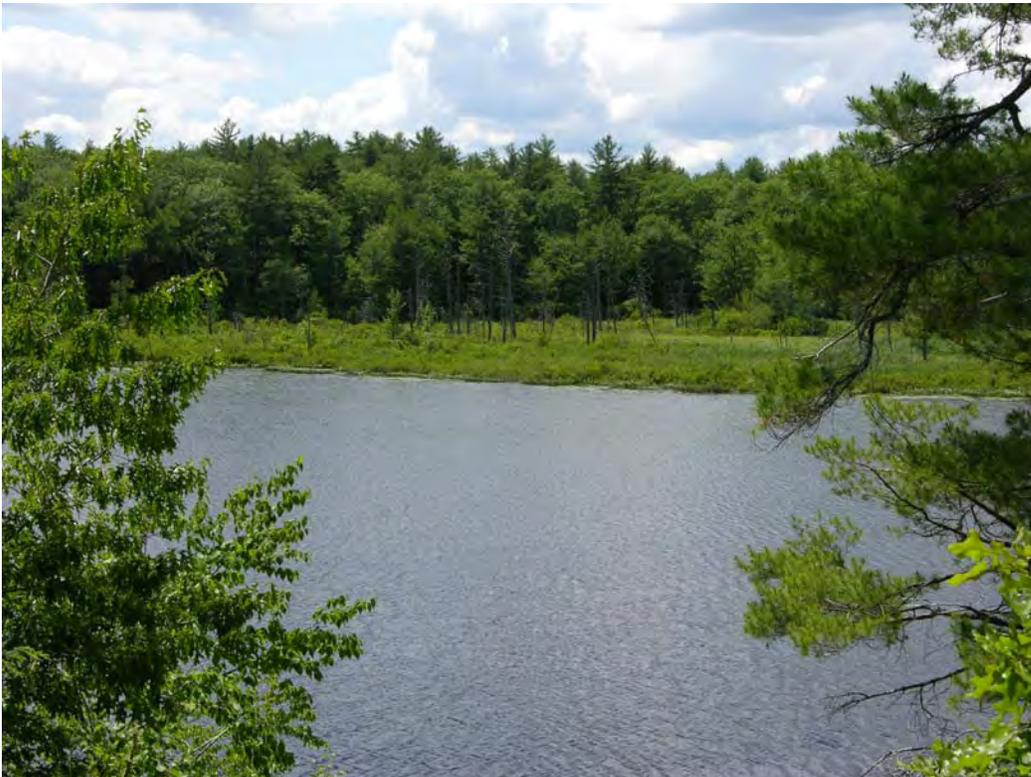
4. This is a view of the central portion of Wetland #7 from the east side of the pond.

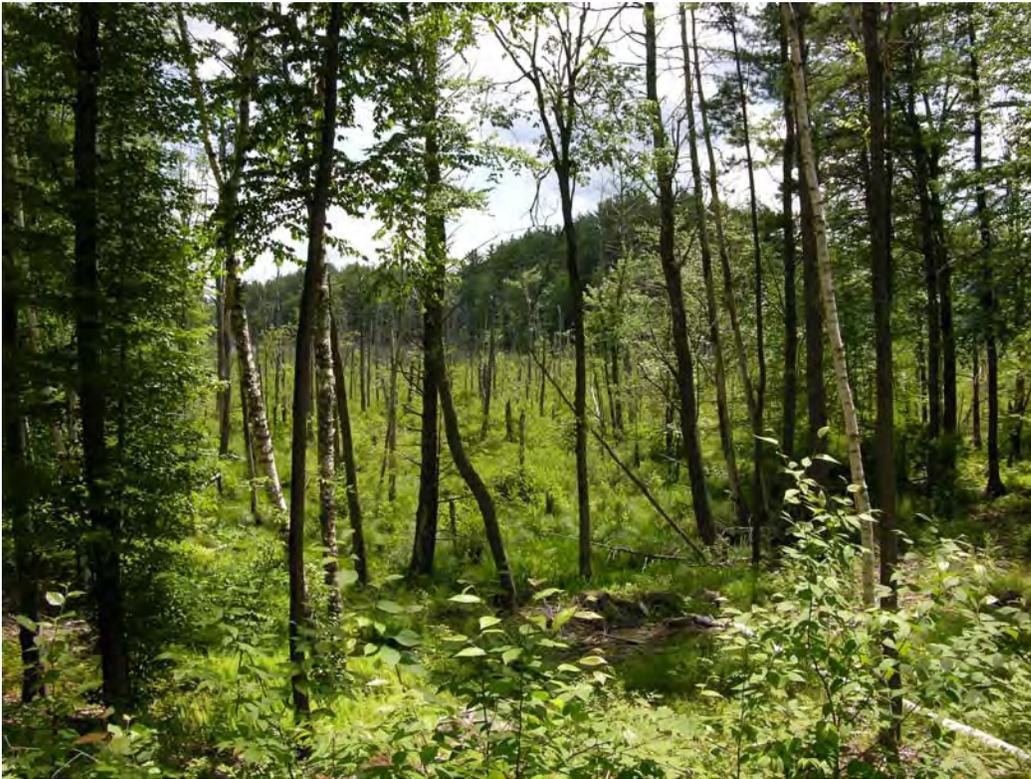
1. This is a view of the northern end of Wetland #8 looking south.

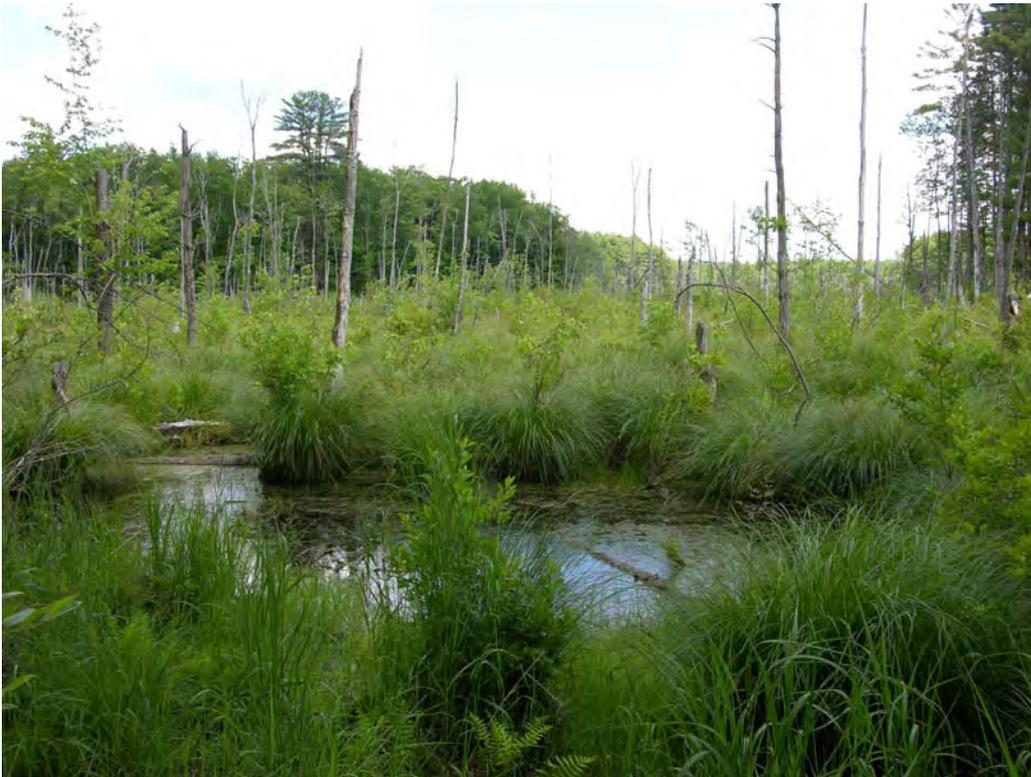
2. The central portion of this wetland includes shallow marsh and scrub-shrub habitat with numerous standing dead trees.

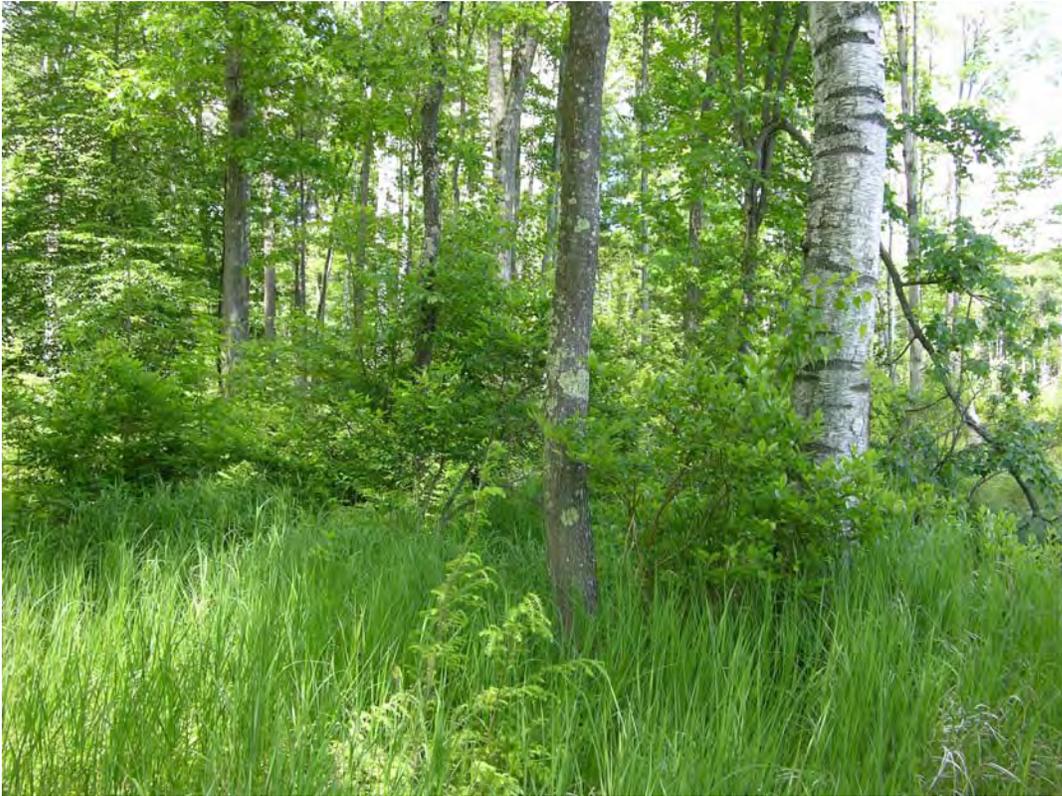
3. This wetland has a transitional forested wetland along its northern boundary.

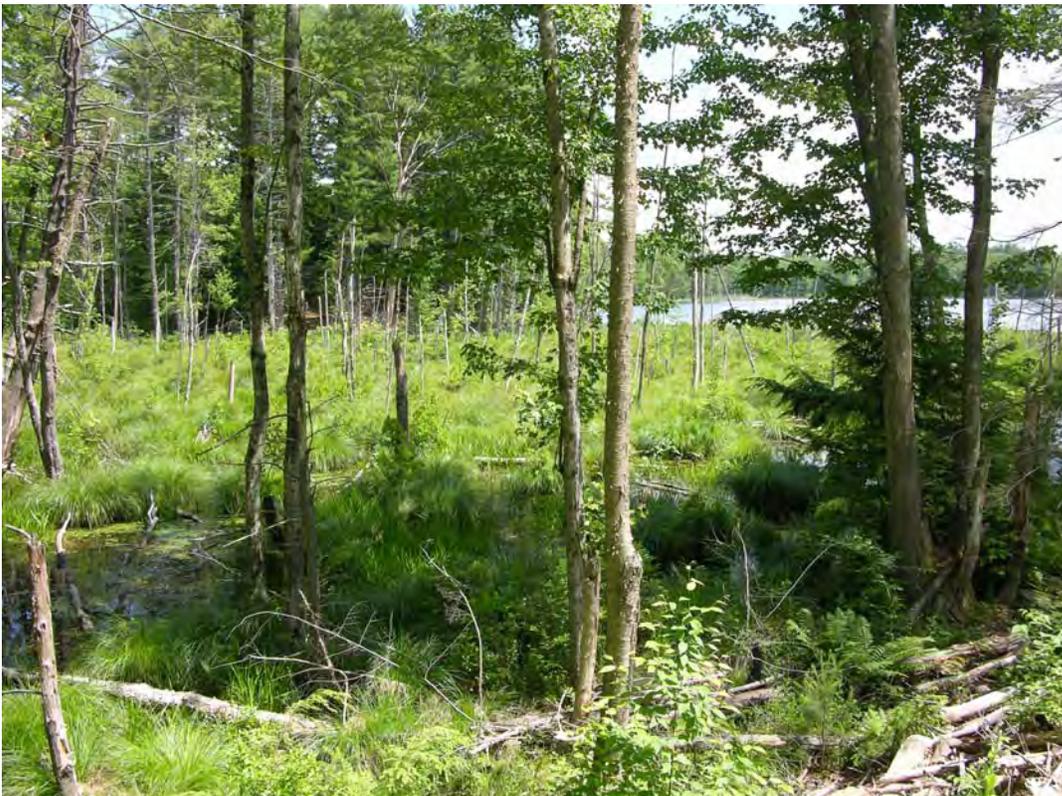
4. This is a view of the southwest portion of the wetland with Cub Pond in the background.

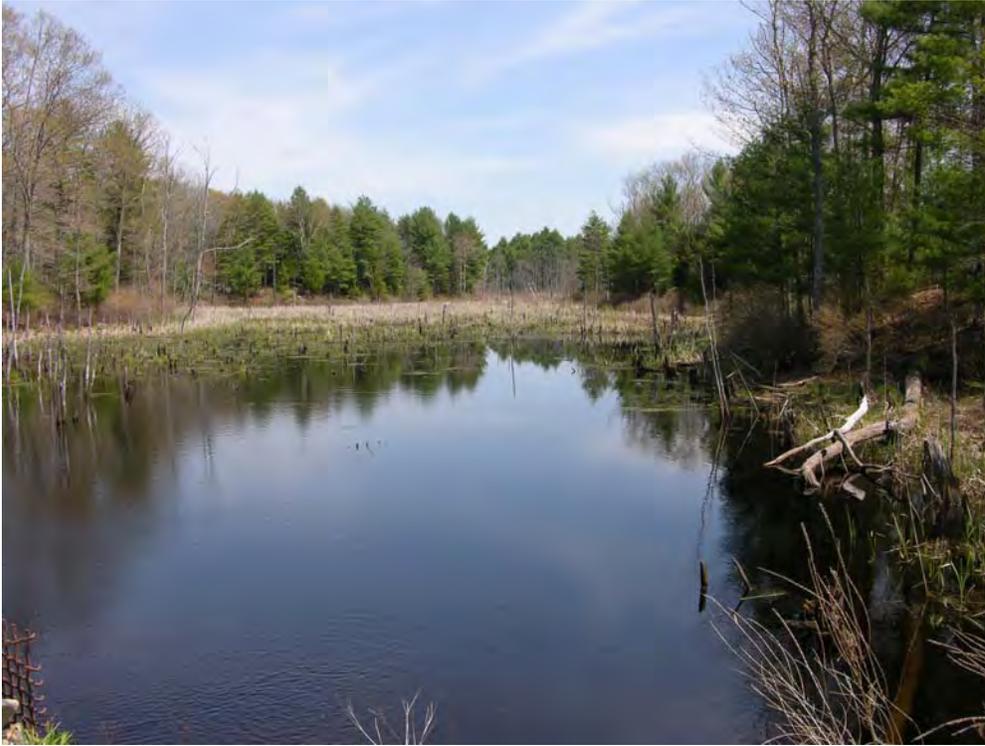
1. This is a view of Wetland #9a from Odell road looking eastwards. Open water and shallow marsh dominate this wetland.

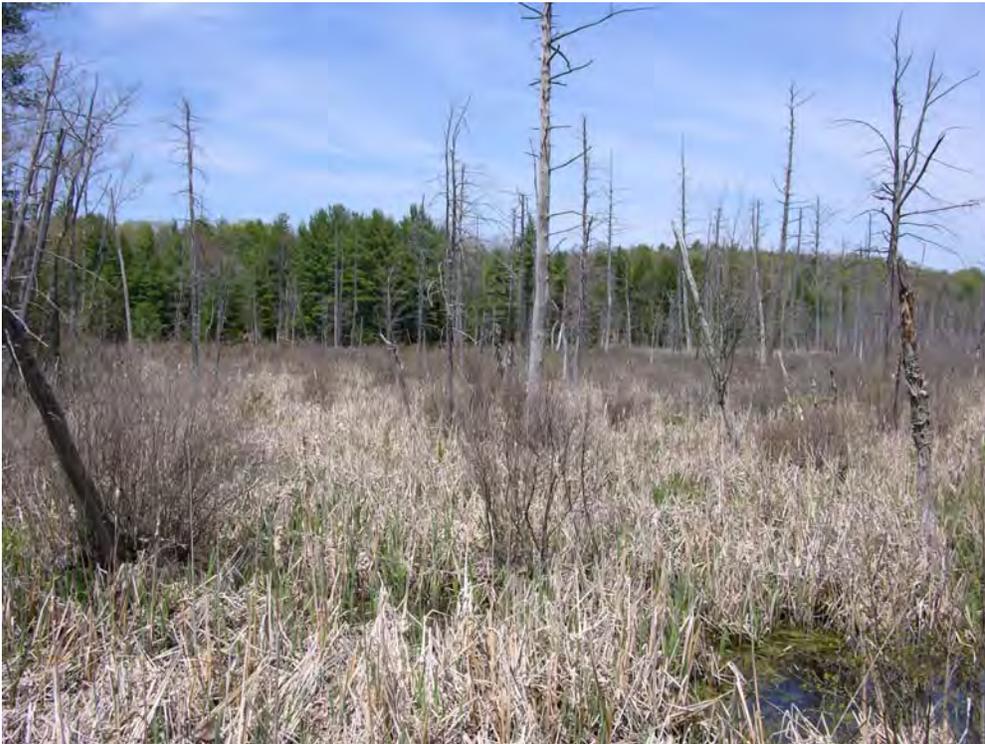
2. This is a view of the central portion of the wetland where shrubs and dead trees mix in with the marsh habitat.

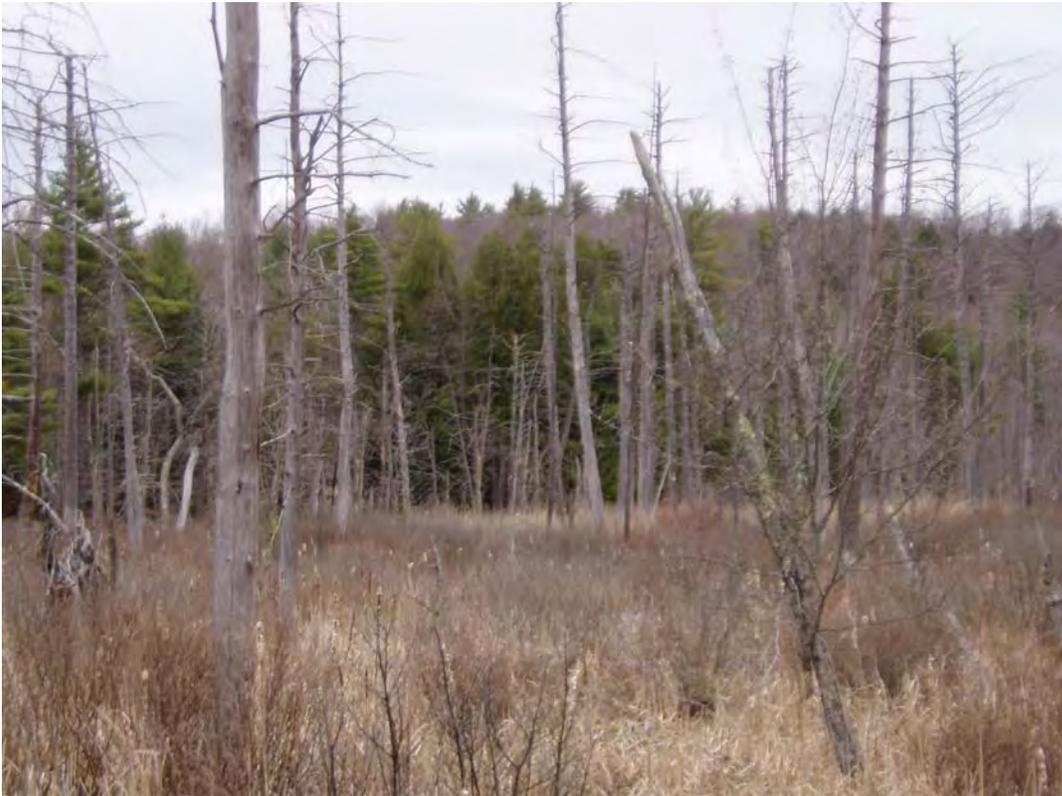
4. Snags provide a valuable habitat feature within much of Wetland #9a.

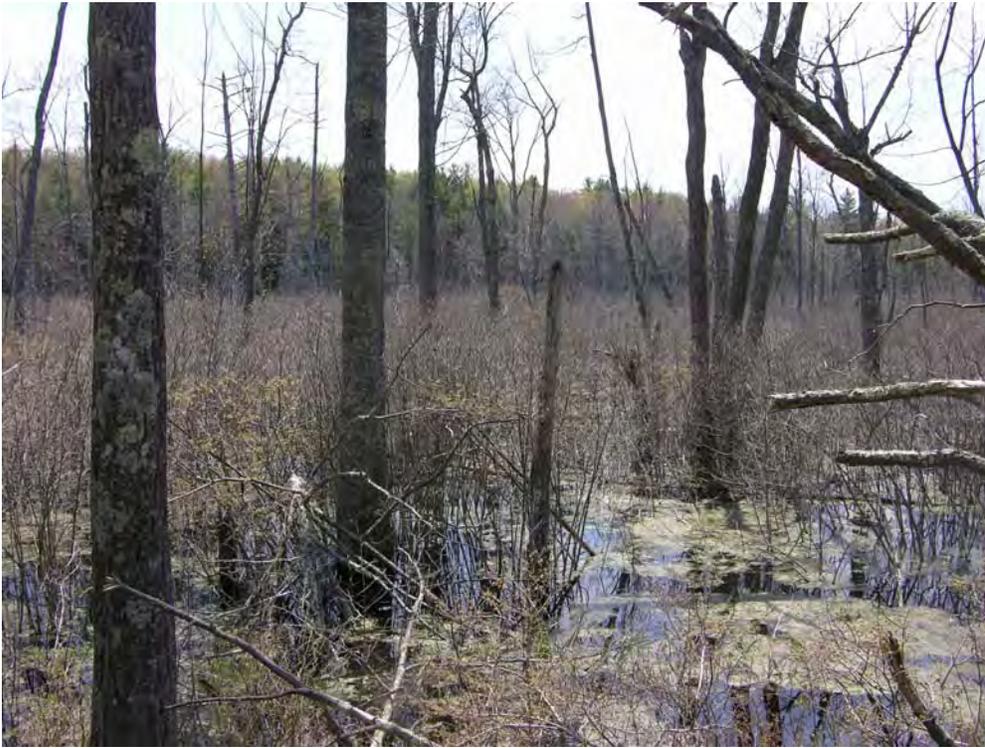
1. A residential driveway separates Wetland #9a and Wetland #9b. This photo shows the forested scrub-shrub plant community within Wetland #9b.

Wetlands #9a and 9b are separated by a residential driveway. The plant community within #9b is chiefly comprised with trees and shrubs. Beaver activity including a lodge was observed.

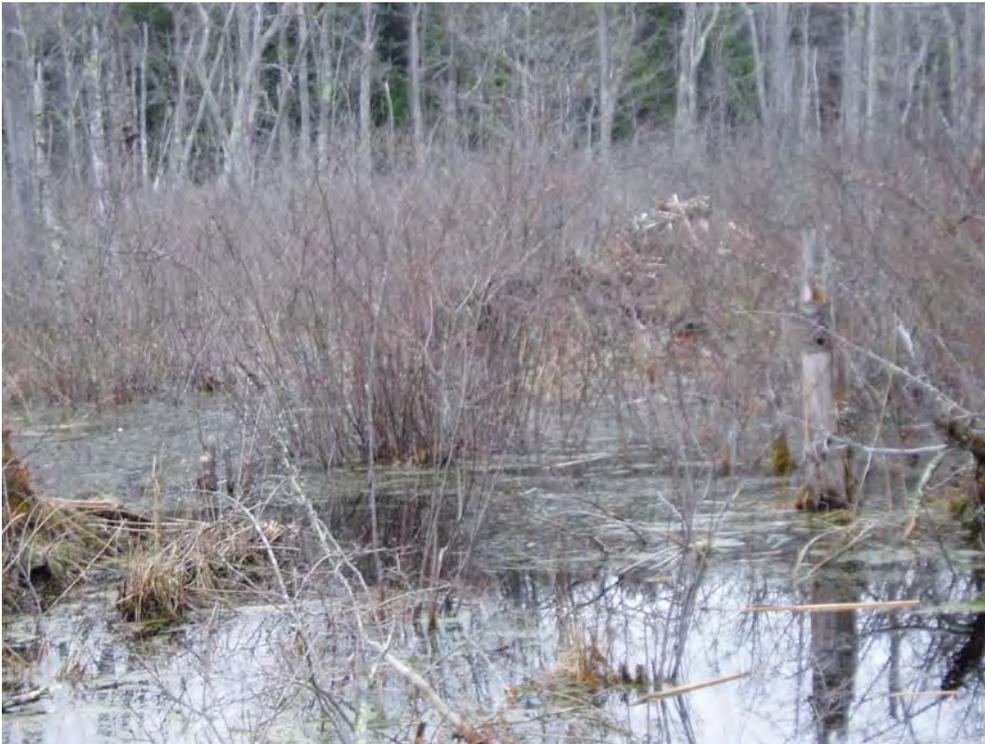
2. A beaver lodge (right, rear) was observed in the thick shrub layer in Wetland #9b. The impoundment of surface water by beaver normally attracts a multitude of other wildlife species.

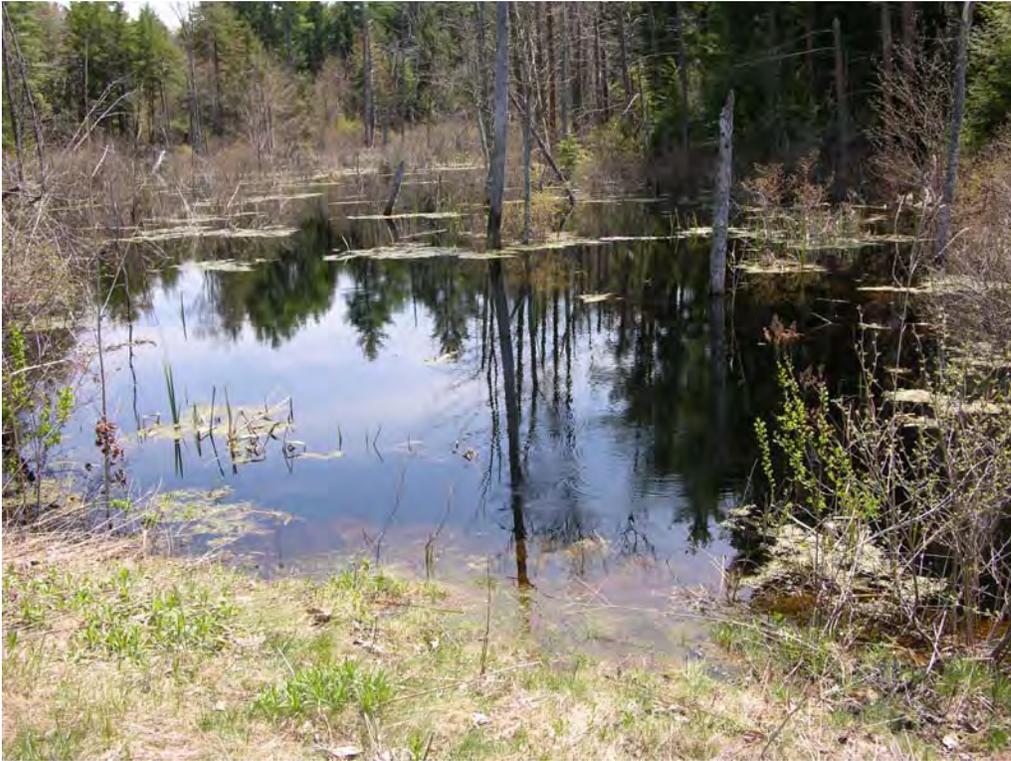
3. The southeastern finger of Wetland #9b is a shallow marsh that was flooded by beaver activity.

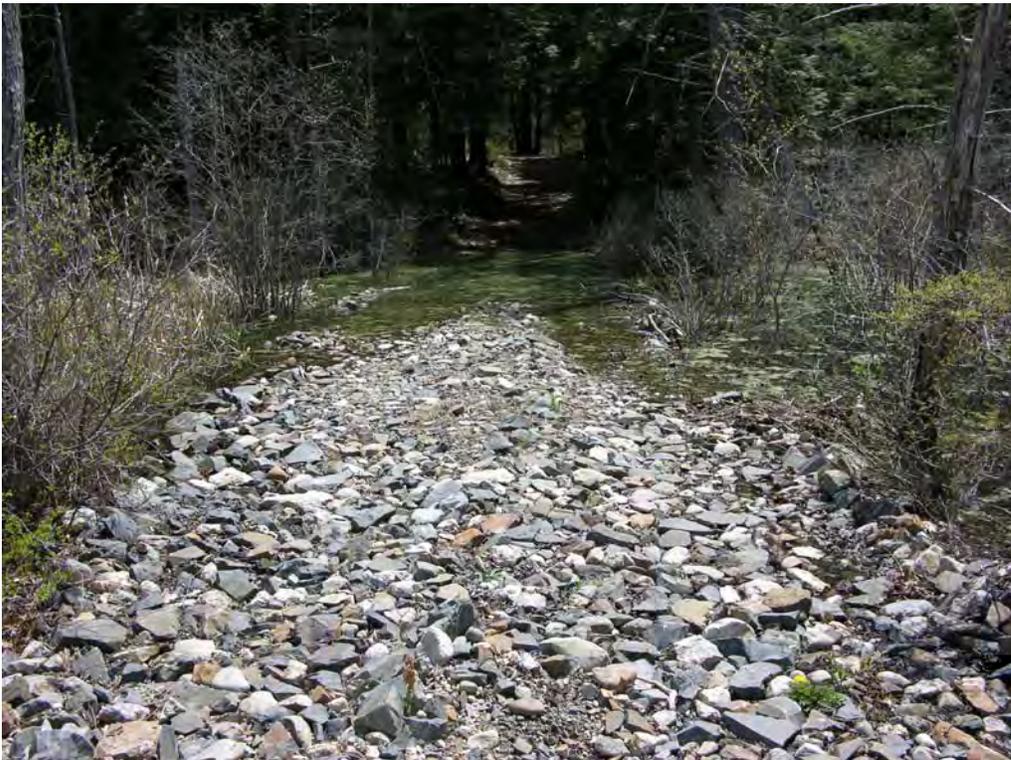
4. Wetland #9b is bisected by this stone ford which provides access into a woodlot off the main residential driveway.
