Town of Sandown Wetland Evaluation Report

Town of Sandown, NH
Conservation Commission

August 2008

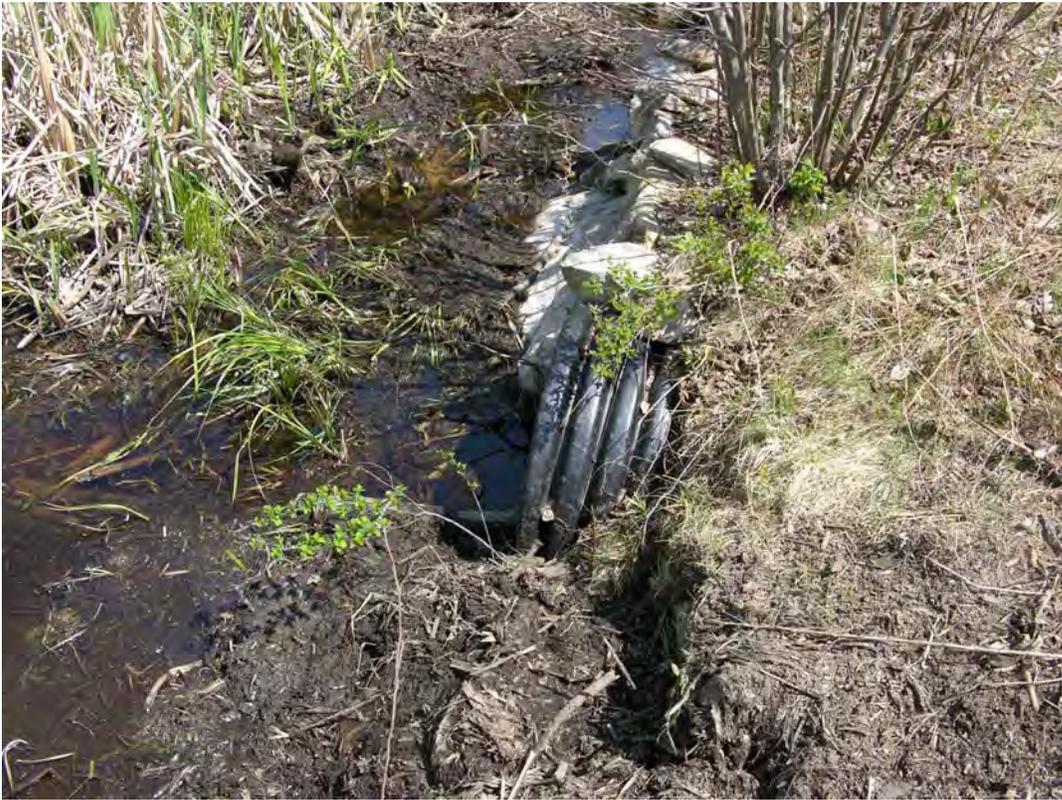
5. This is a view of one of the three 24" diameter culverts which connect Wetland #9b to #9a under the residential driveway.

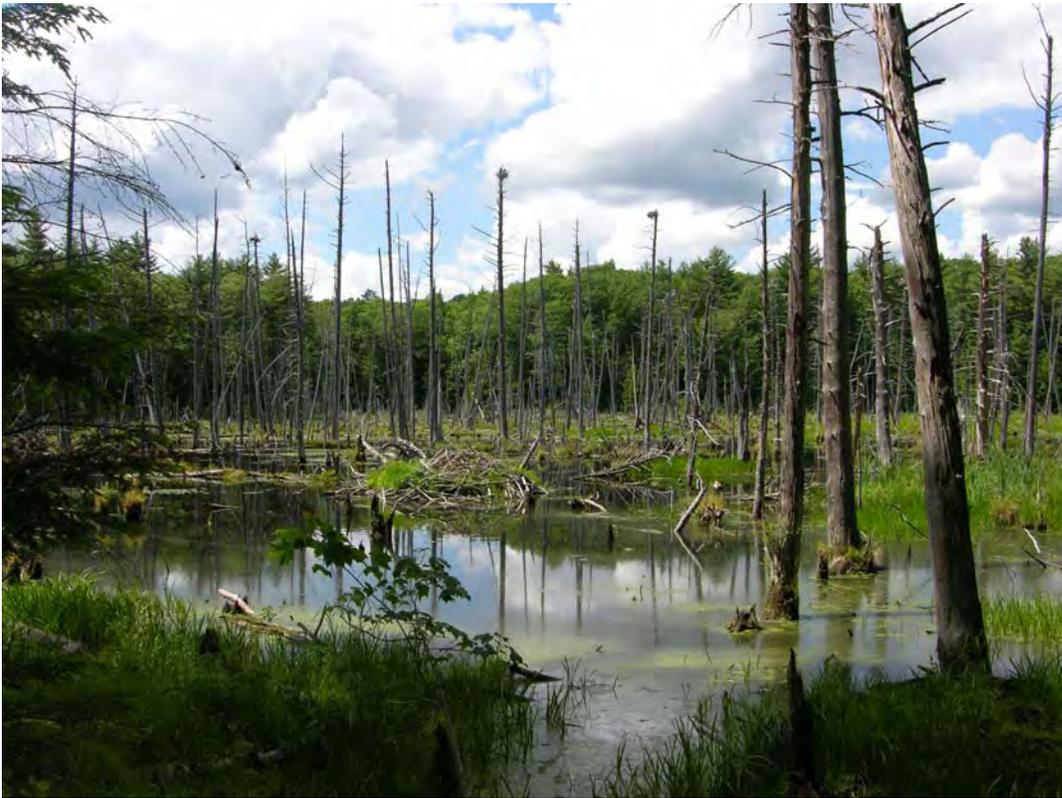
1. This isolated beaver pond includes 14 great blue heron nests and an active beaver lodge.

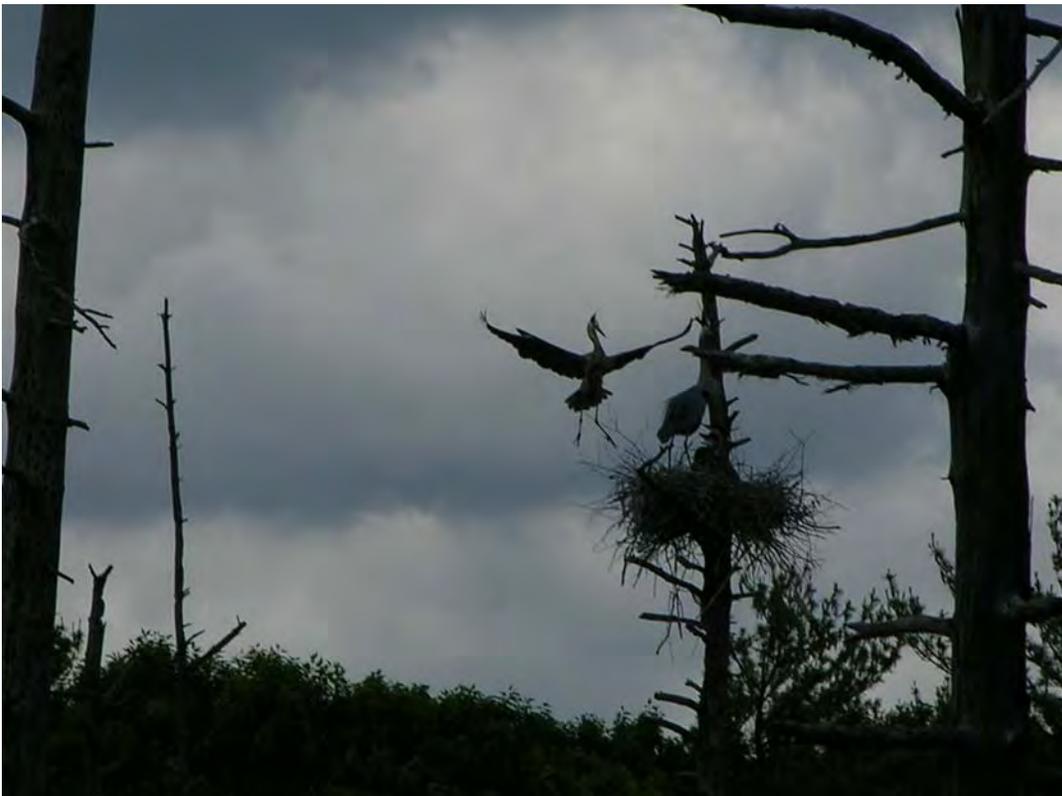
2. This is a view of a great blue heron adult returning to the nest to feed its young.

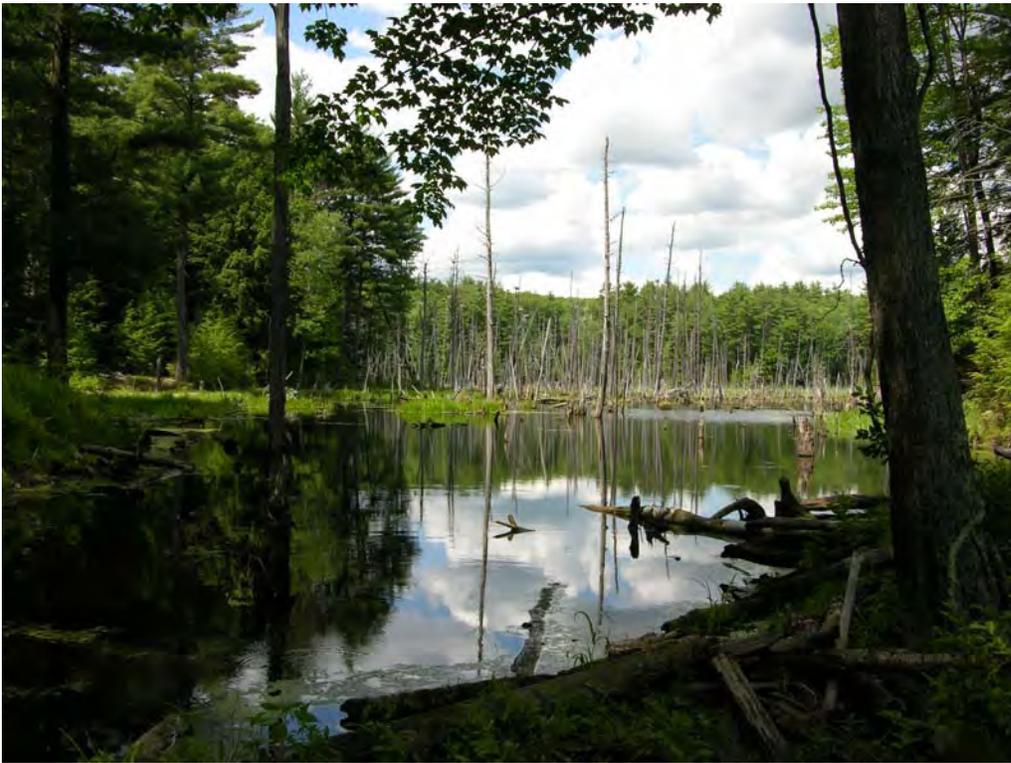
3. This photo is looking north from the southern outlet of this wetland which drains to Wetland #8 and Cub Pond.

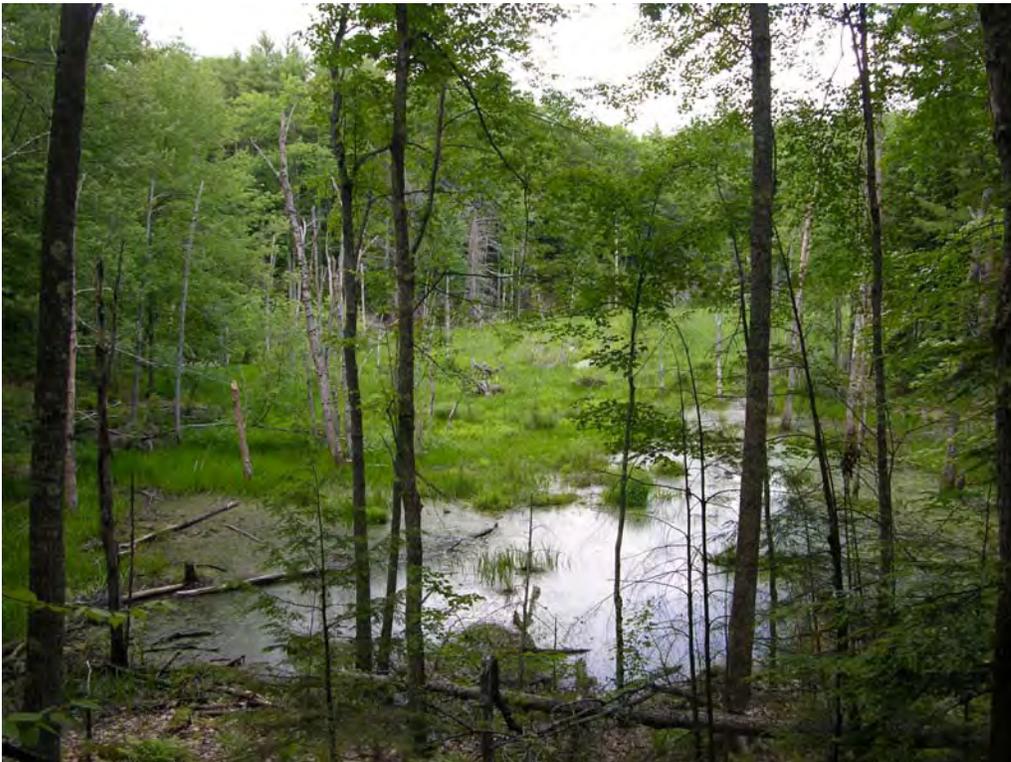
4. The southern end of the wetland includes a smaller beaver pond which has developed a thick shallow marsh plant community.

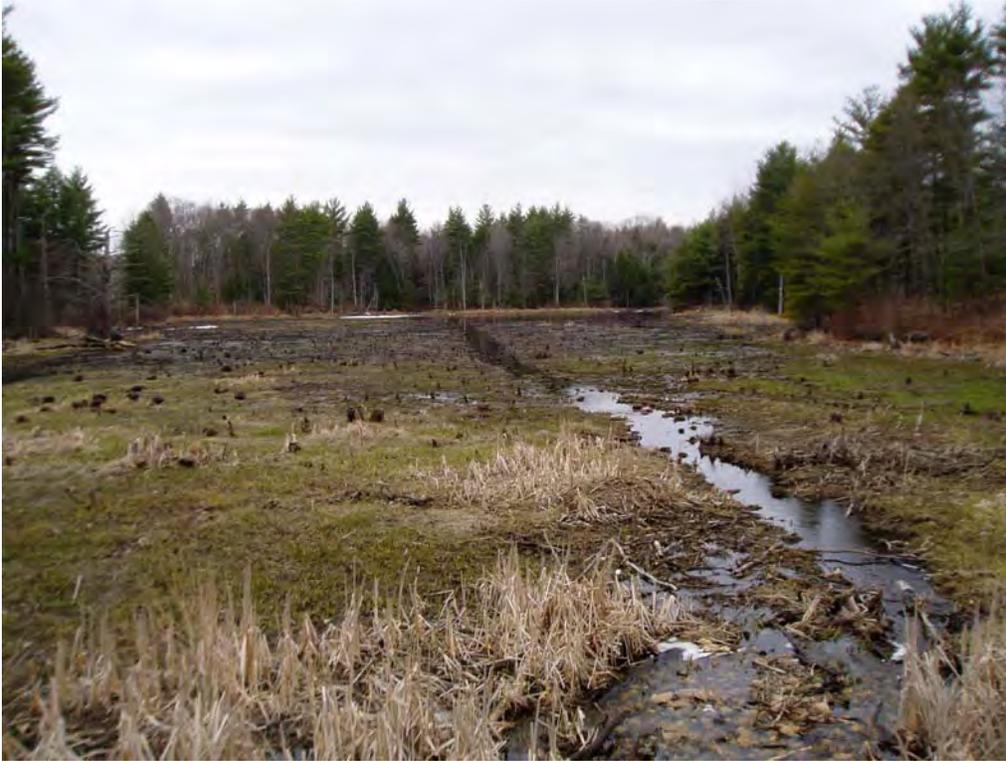
1. Wetland #10a was previously occupied by a colony of beaver. Adjacent development may have required the draining of the earlier beaver flowage and surface water.

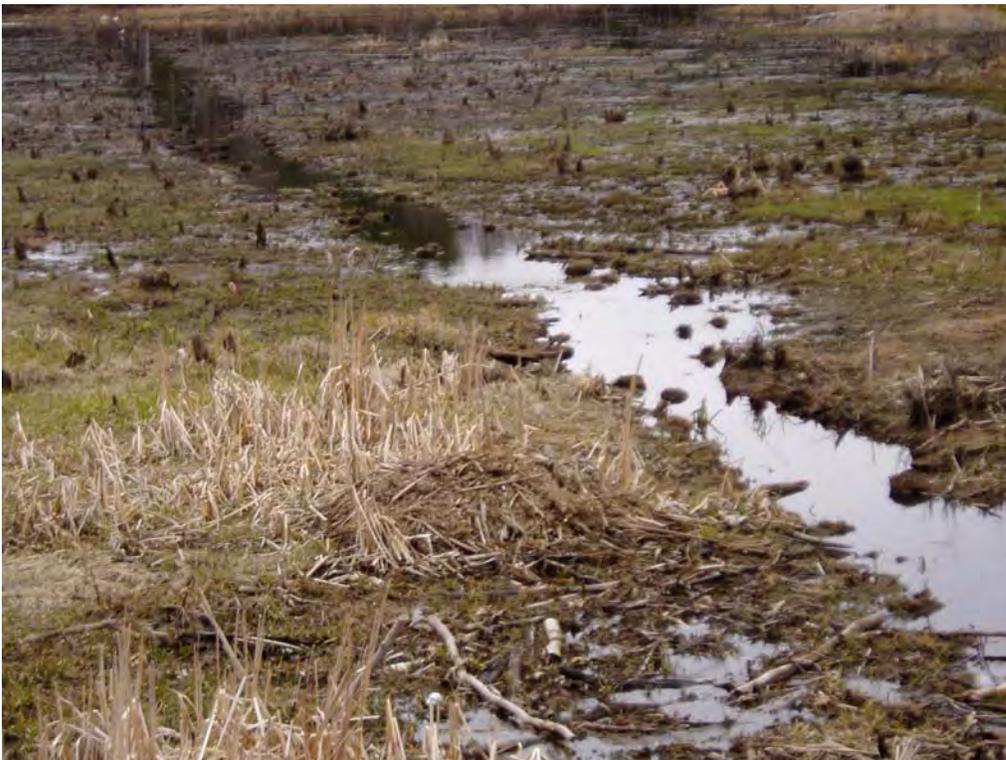
2. This photo shows a muskrat lodge (just left of existing channel). Unlike beaver that use sticks to construct their lodges, muskrat utilize herbaceous growth (mostly cattails).

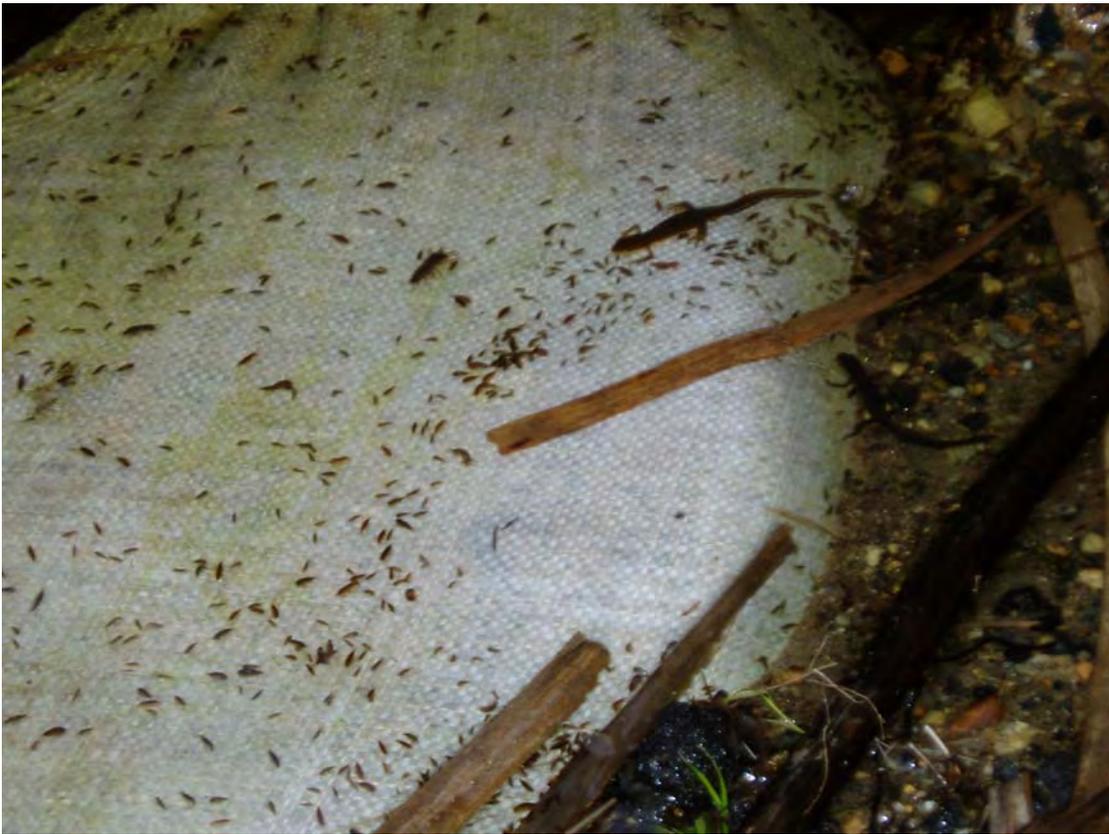
3. This photo shows the emergence of hundreds of fairy shrimp at the existing culvert. Red-spotted newts (right, top) have gathered to feed on these tiny crustaceans.

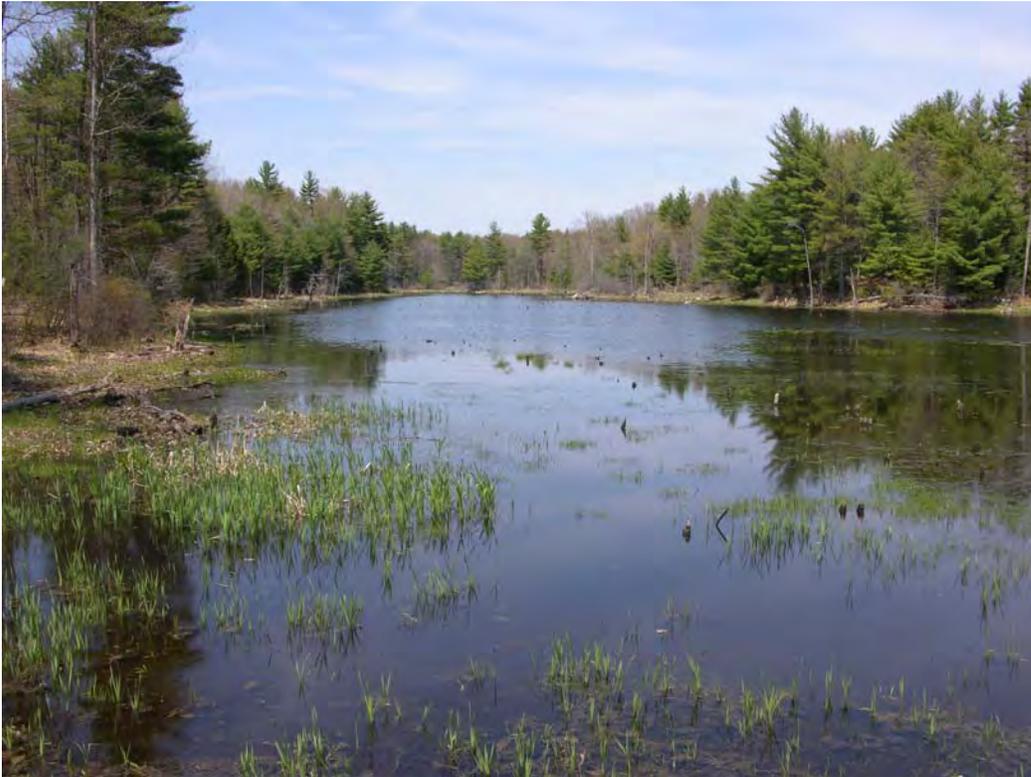
1. This photo is looking west from Odell Road into Wetland #10, a beaver pond with deep and shallow marsh habitat.

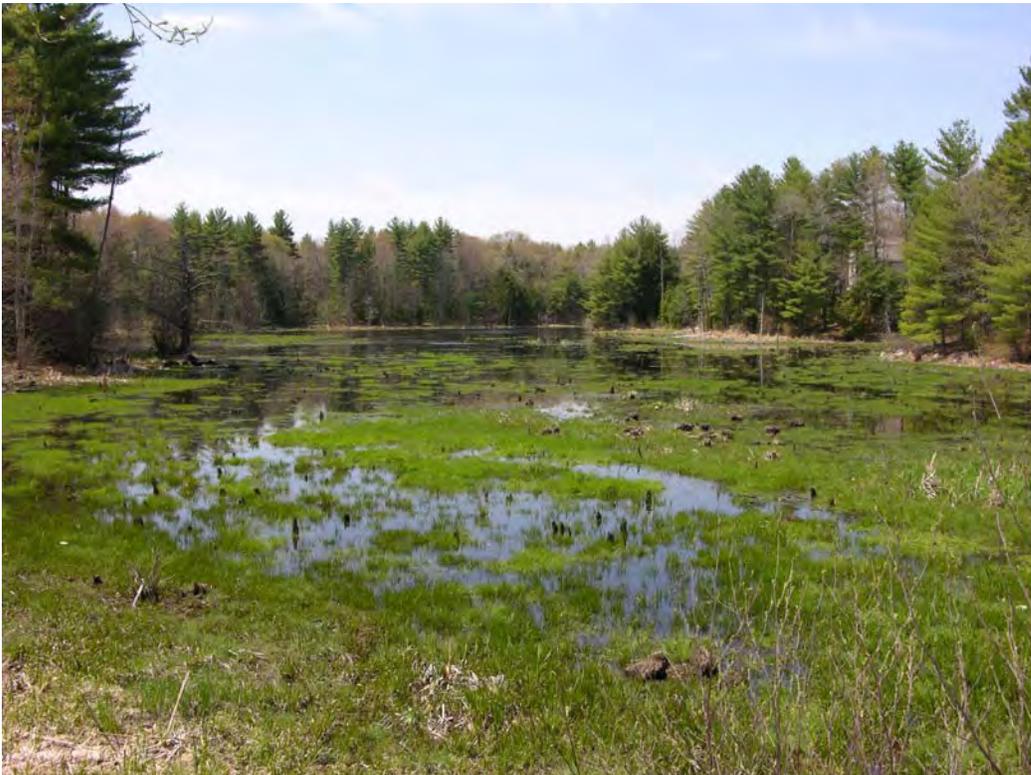
2. The central portion of this wetland has a thick emergent marsh with no shrubs or trees present.

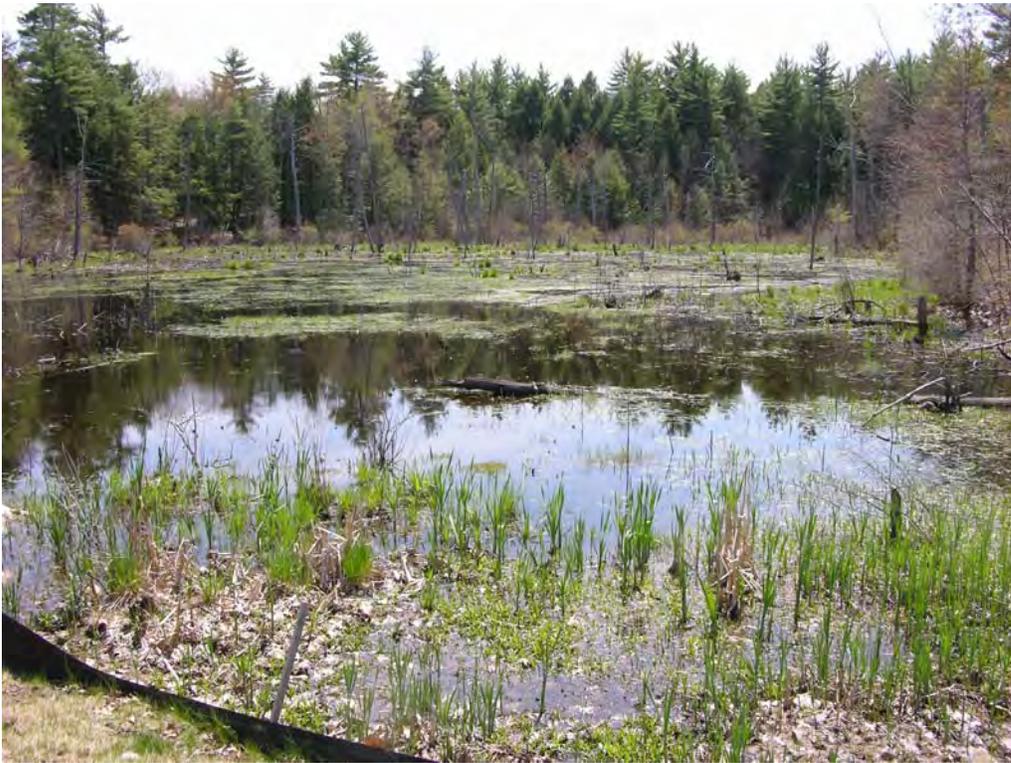
1. This photo is looking south from Meadowbrook Crossing at this small beaver pond. Scrub-shrub, shallow marsh habitat, and deep marsh habitat are present in this wetland.

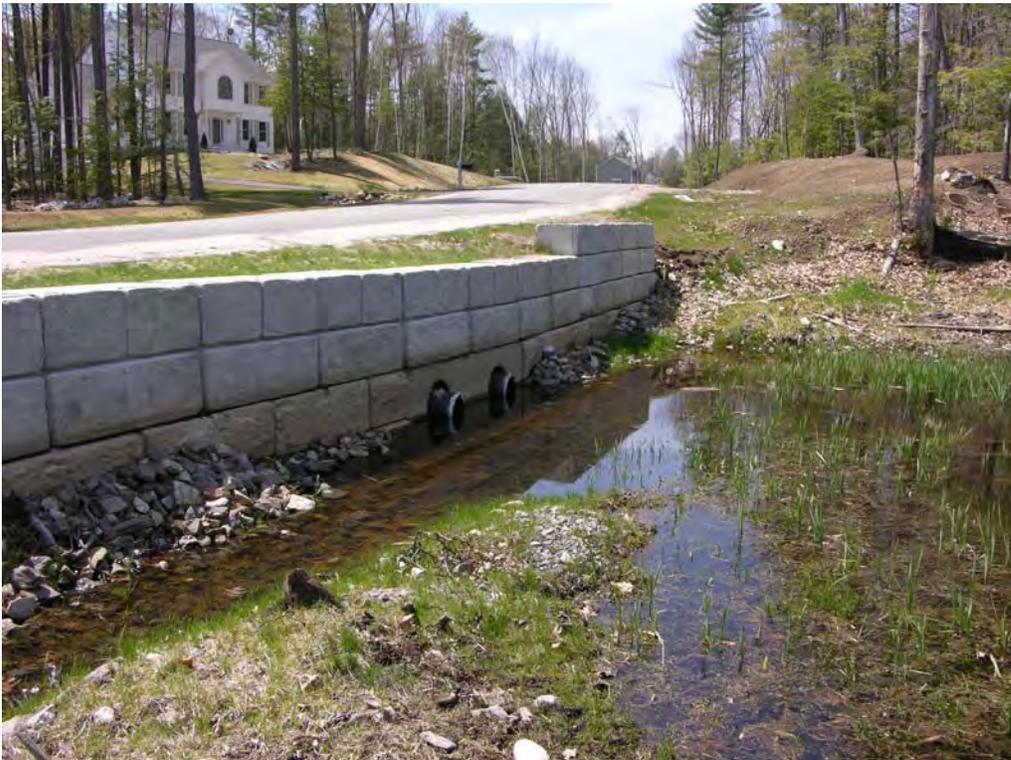
2. This is a view of the road crossing that separates Wetland 10b from 10a limiting the connectivity between these two wetlands.

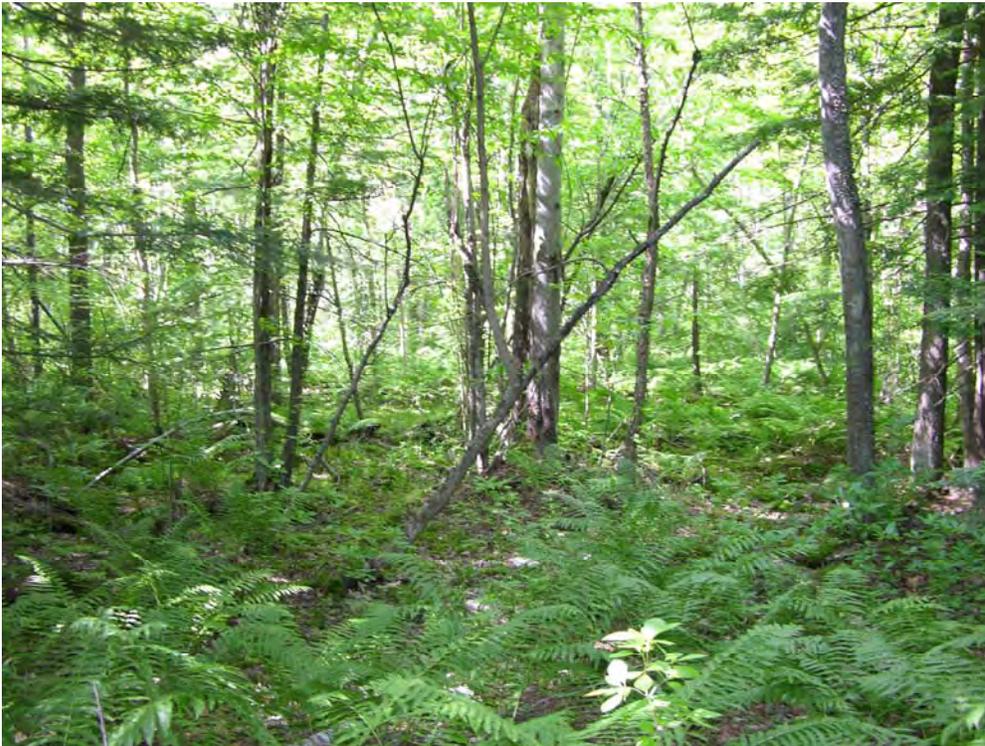
1. This is a view of the central portion of this red maple basin swamp which has pit and mound topography.

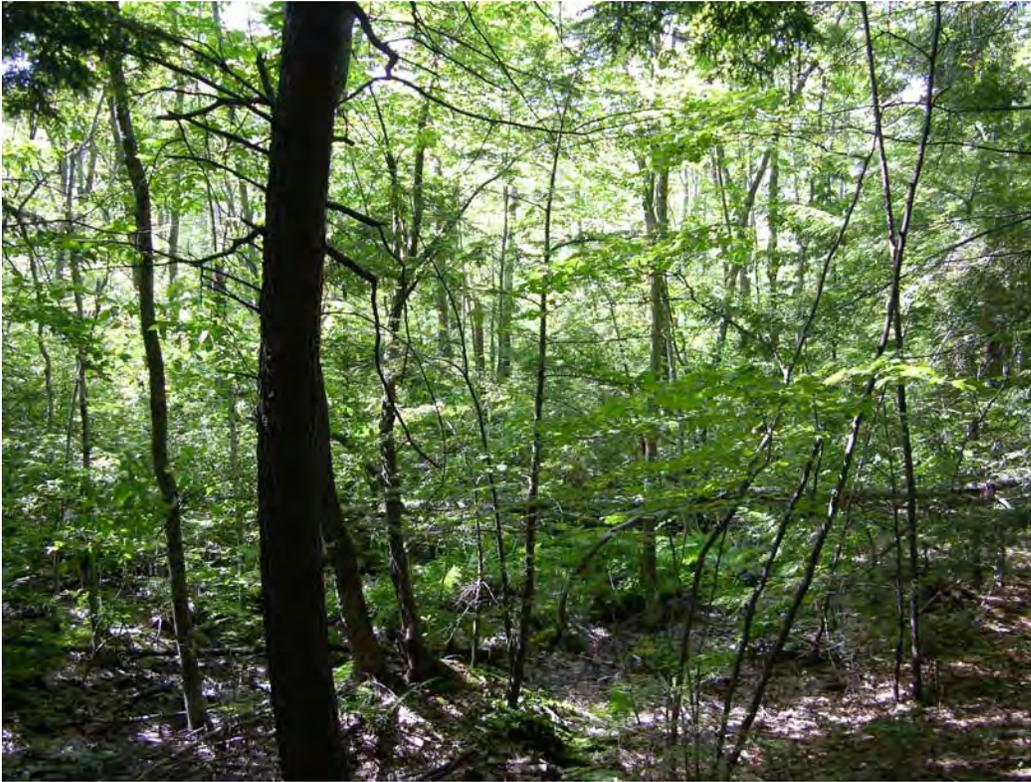
1. This is a view of the eastern portion of Wetland #12 which is bordered by an eastern hemlock forest.

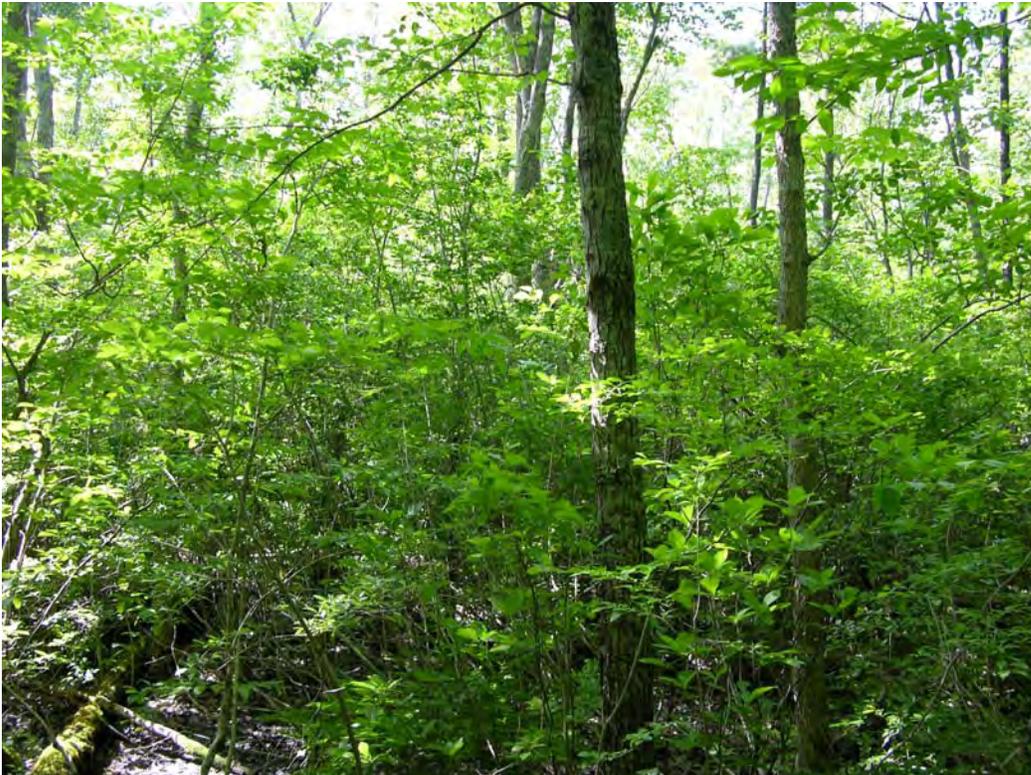
2. This wetland has a thick shrub layer which includes sweet pepperbush.

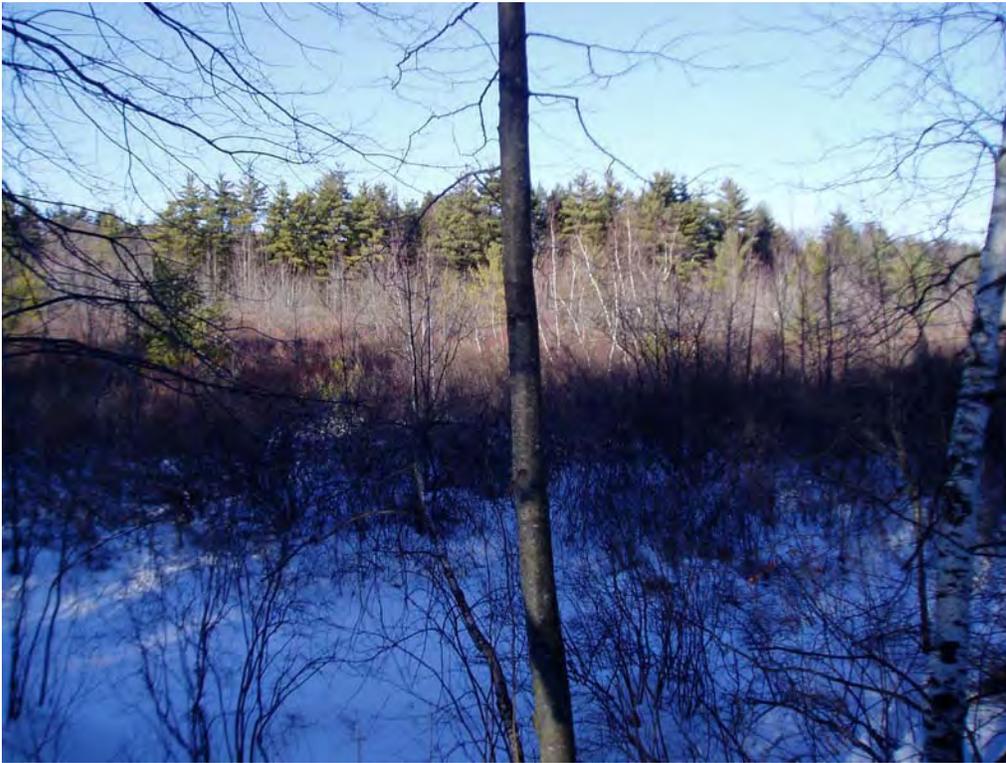
1. This is a view of Wetland #13 looking north from Tamworth Road. This is a scrub-shrub wetland with a thin to moderate interspersed sapling layer.

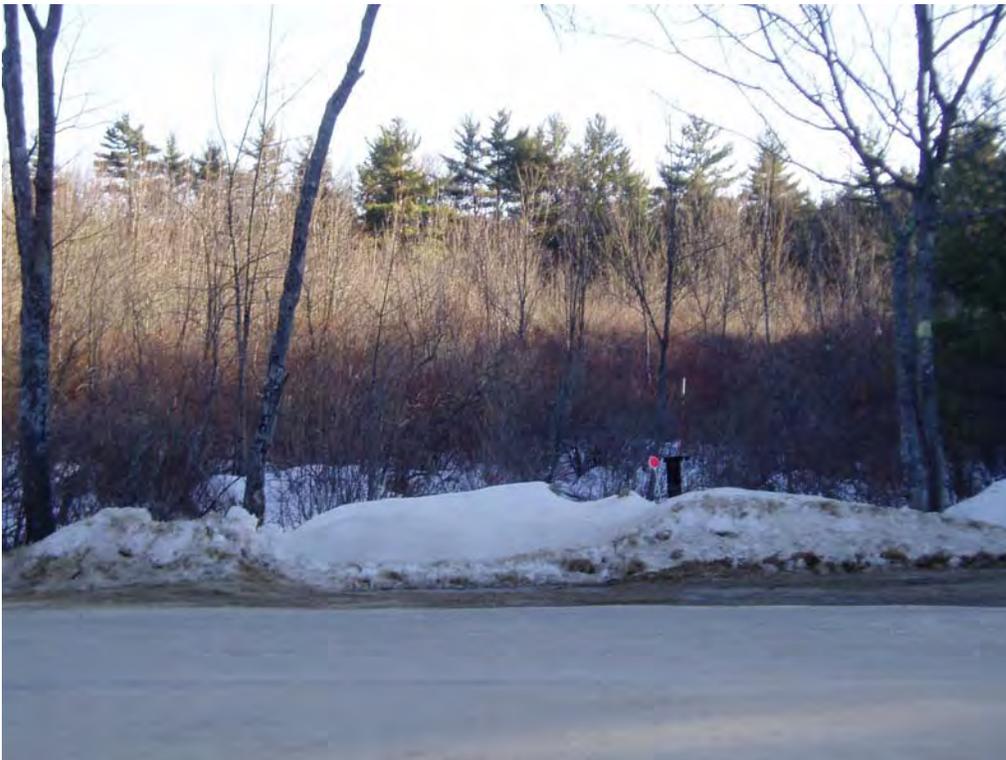
2. This is another view of Wetland #13 looking south from the town's highway shed. Areas within this wetland with standing water may provide important vernal pool habitat.

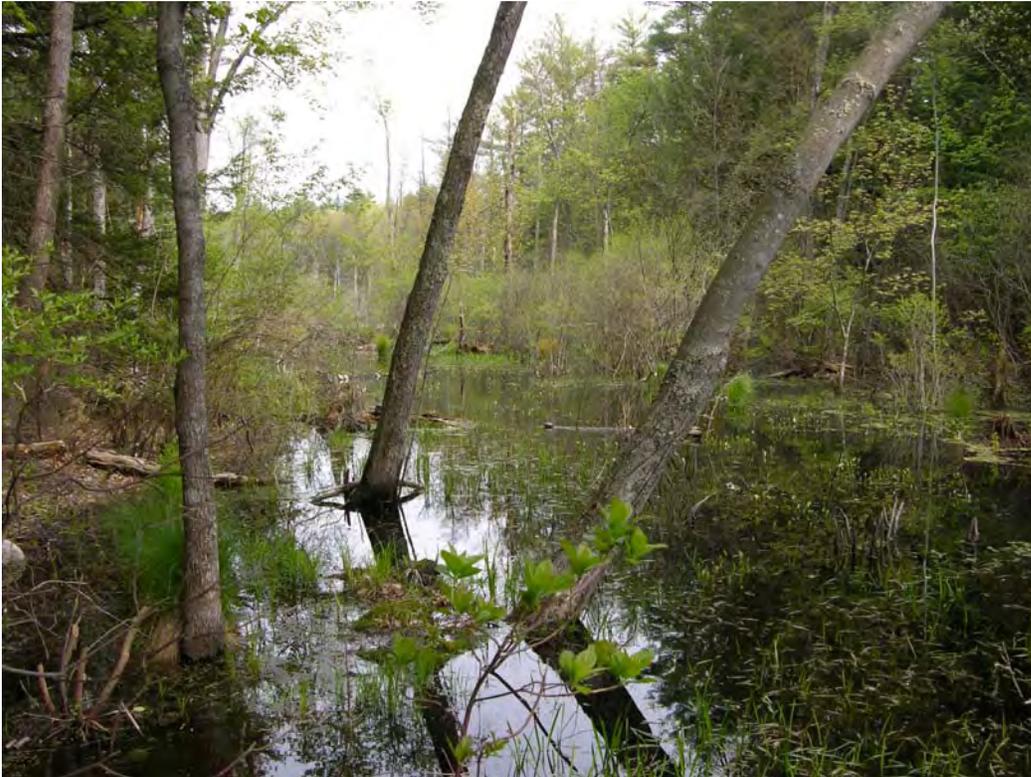
1. This is a view of the eastern finger of the wetland which is a forested/scrub-shrub beaver flowage.

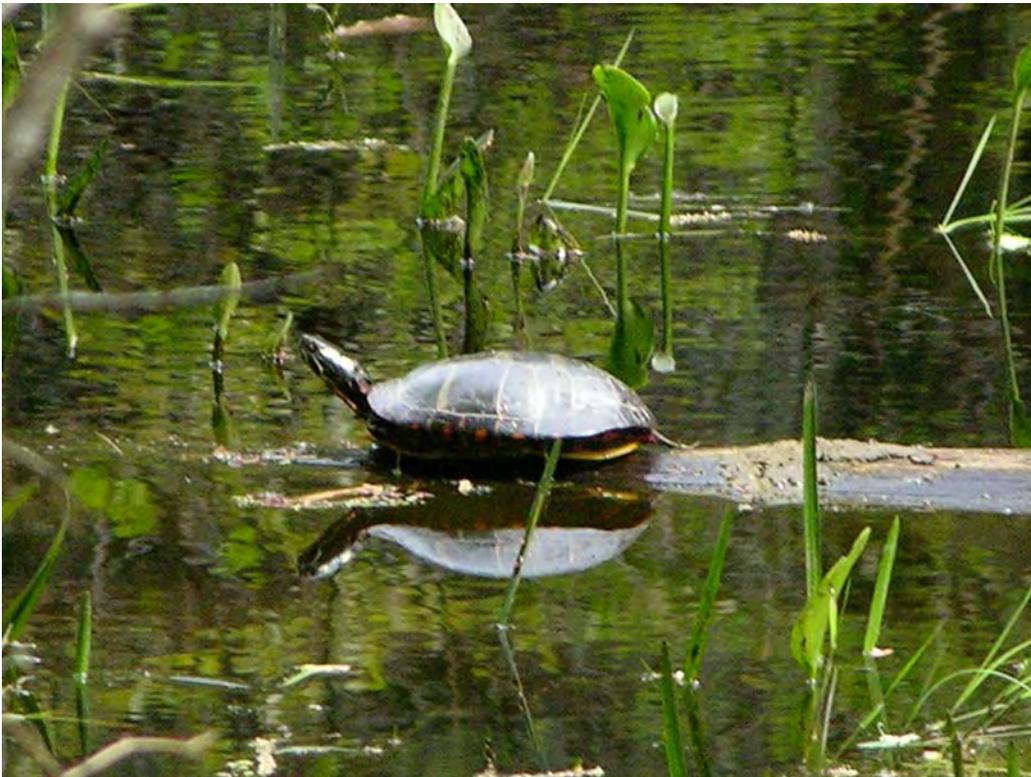
2. A painted turtle was utilizing a log to sun itself in this wetland.

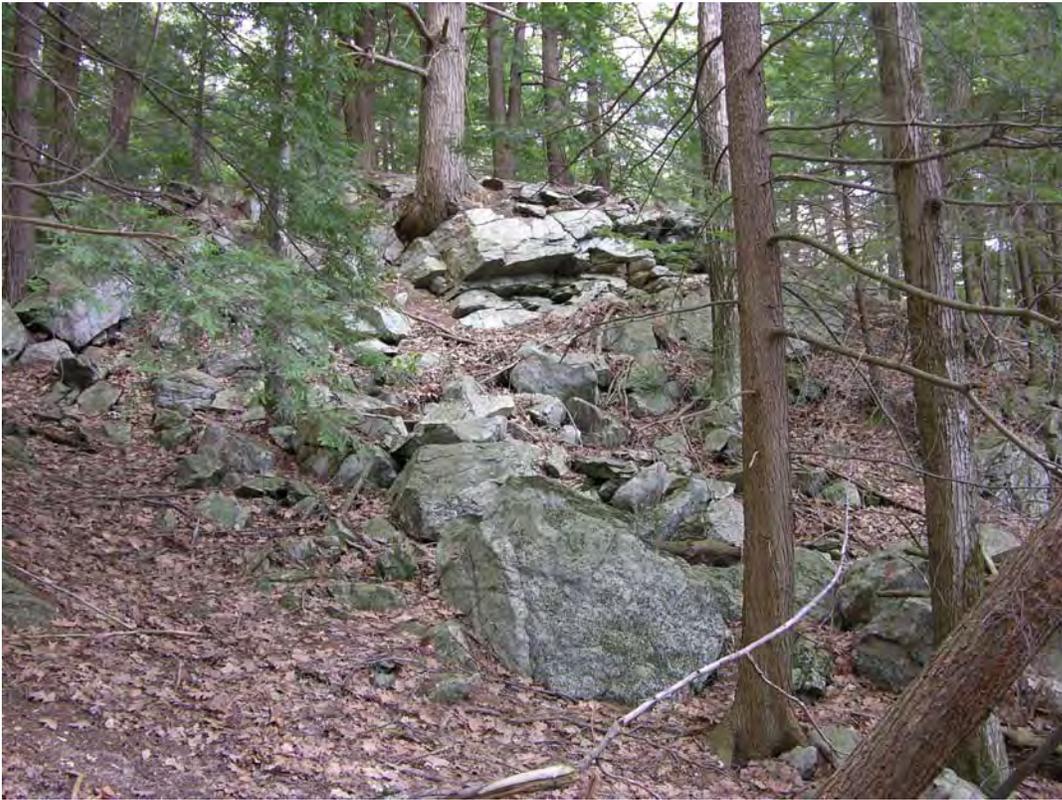
3. Upland bordering this portion of the wetland includes rock outcrops and surface boulders.

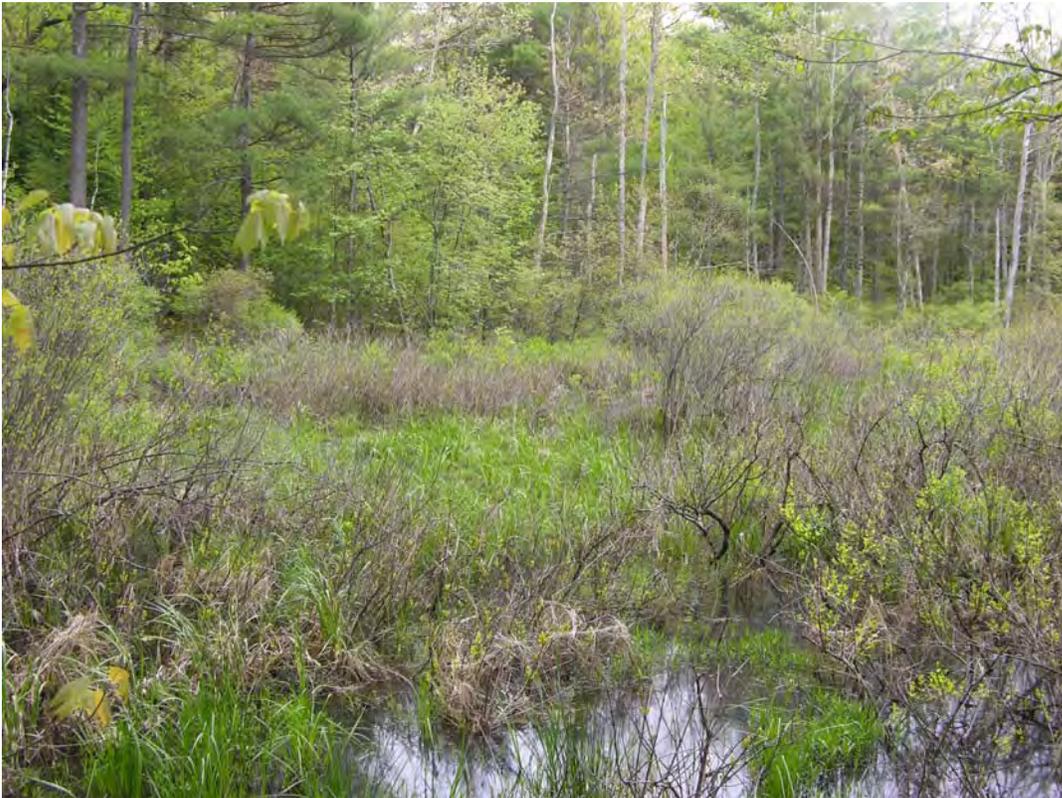
4. This is a view of the northern portion of the wetland which includes a scrub-shrub marsh.

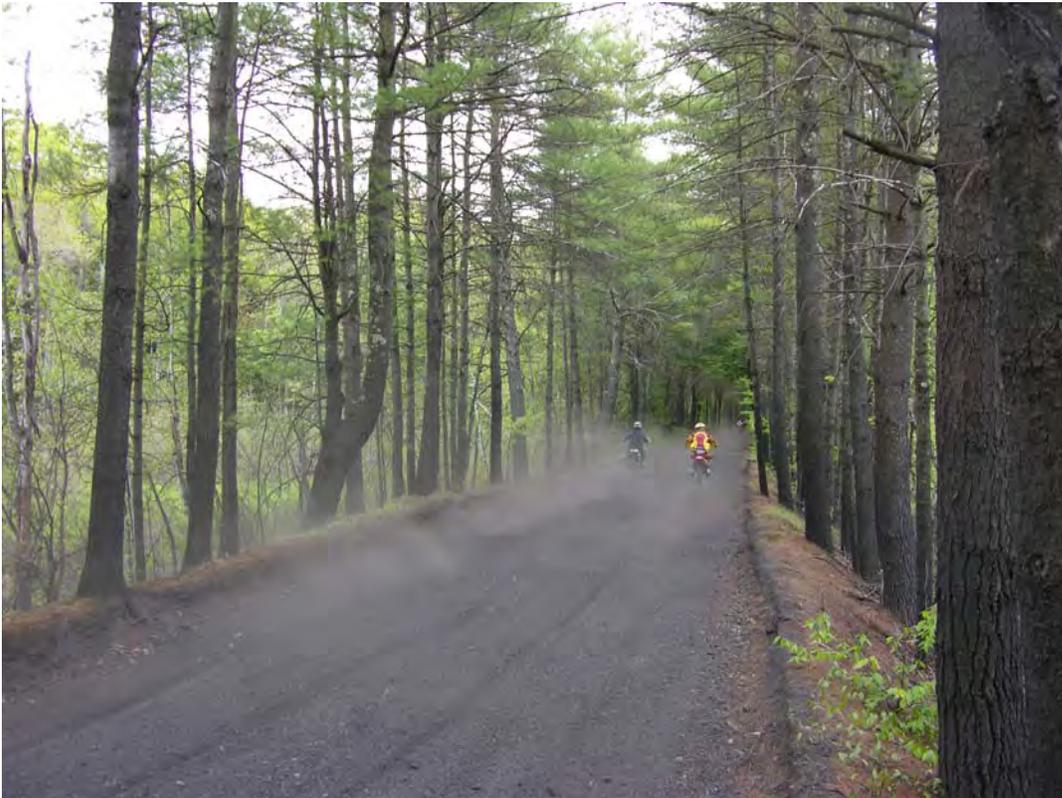
5. A state ATV trail bisects this wetland.

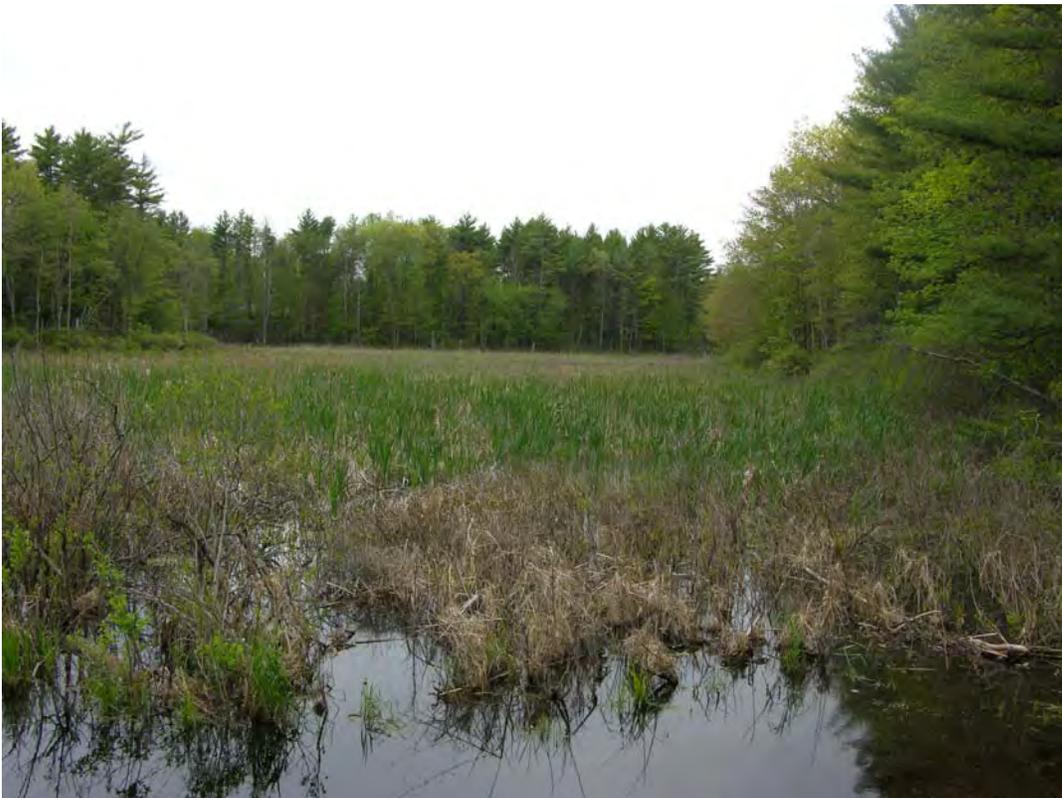
6. The southern portion of the wetland is dominated by a cattail marsh.

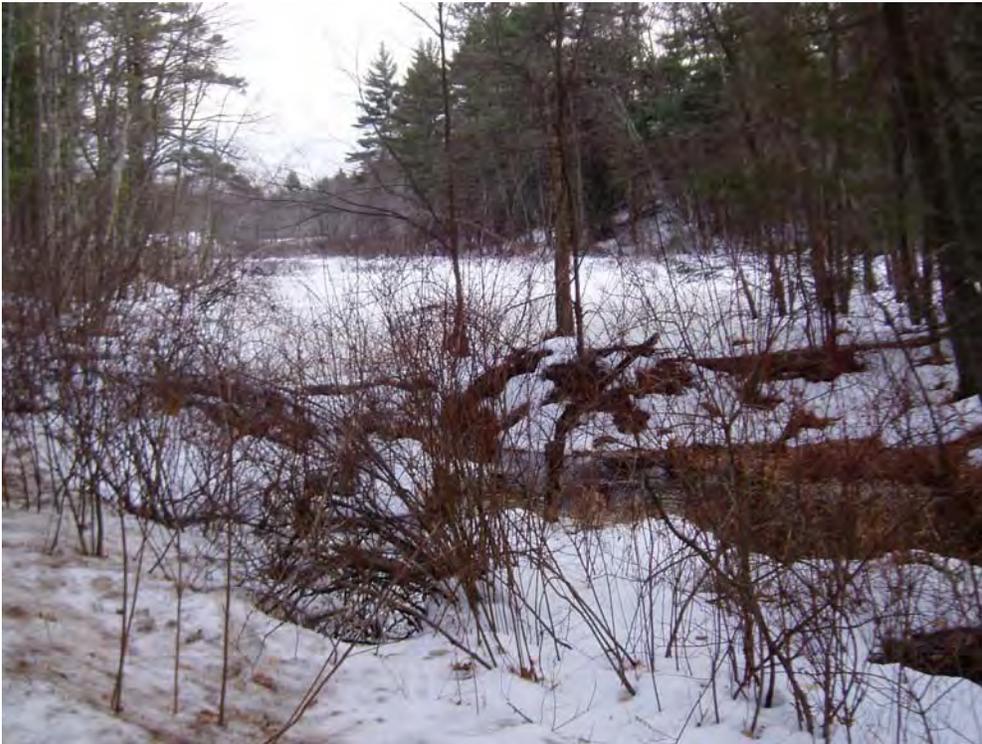
1. This photo shows Wetland #15 during mid-winter. A section of a prior beaver dam (center) has been removed and has lowered earlier water levels. It is unclear at this time whether beaver still occupy this wetland.

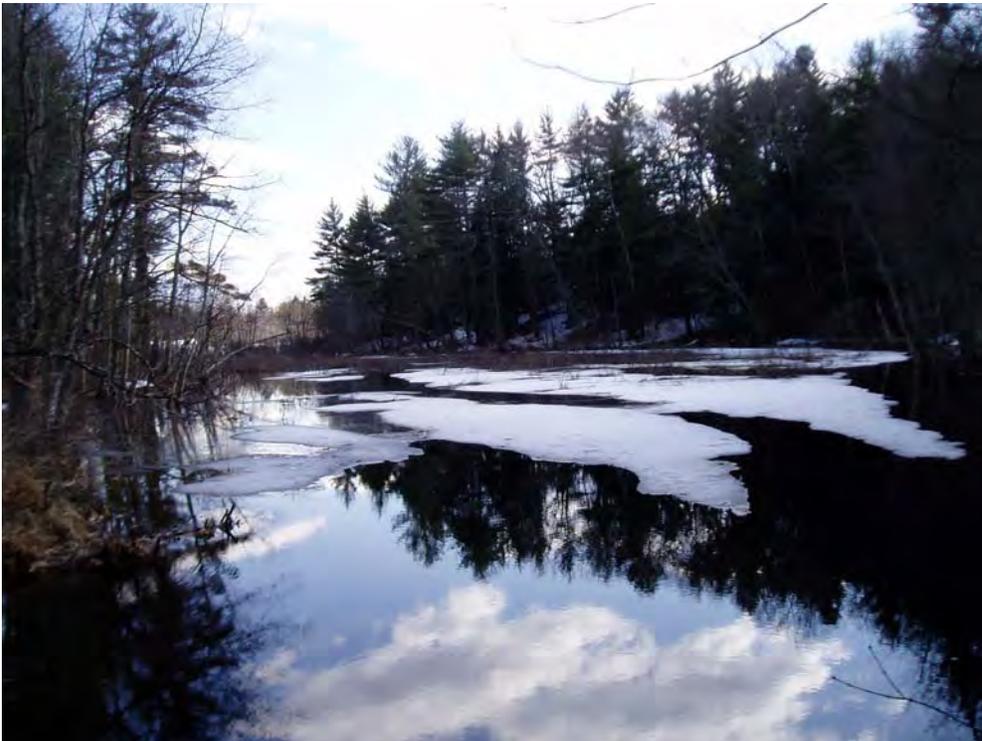
2. This photo shows Wetland #15 during spring runoff. Flood storage remains a chief function of this wetland.

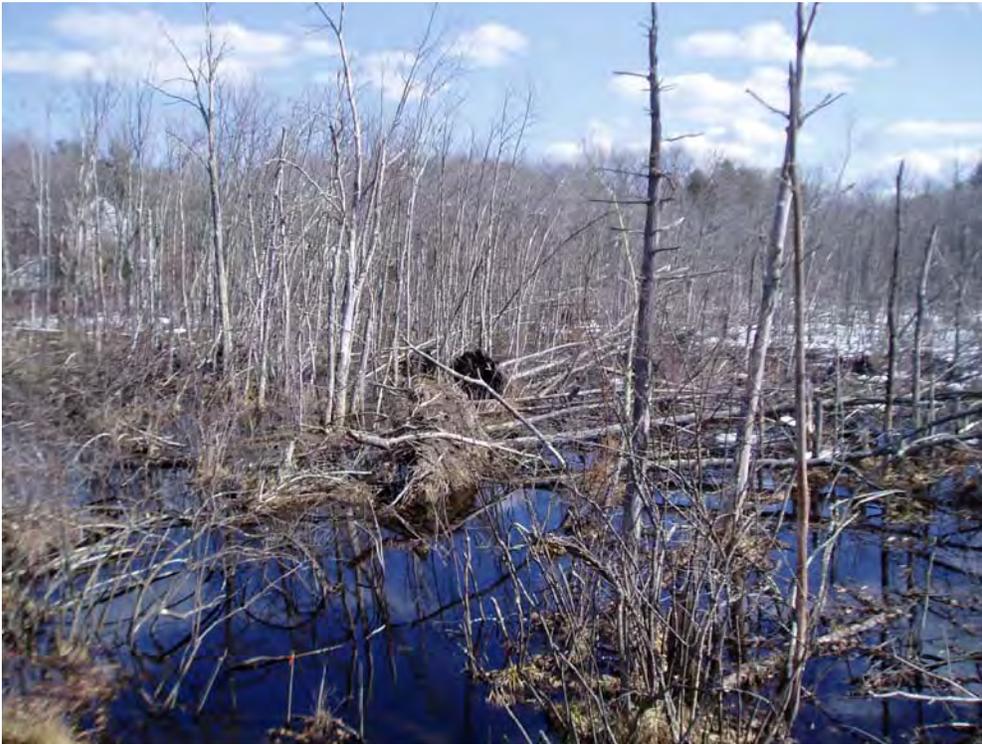
3. This photo shows the most southern end of Wetland #15. This section of wetland is forested in character.

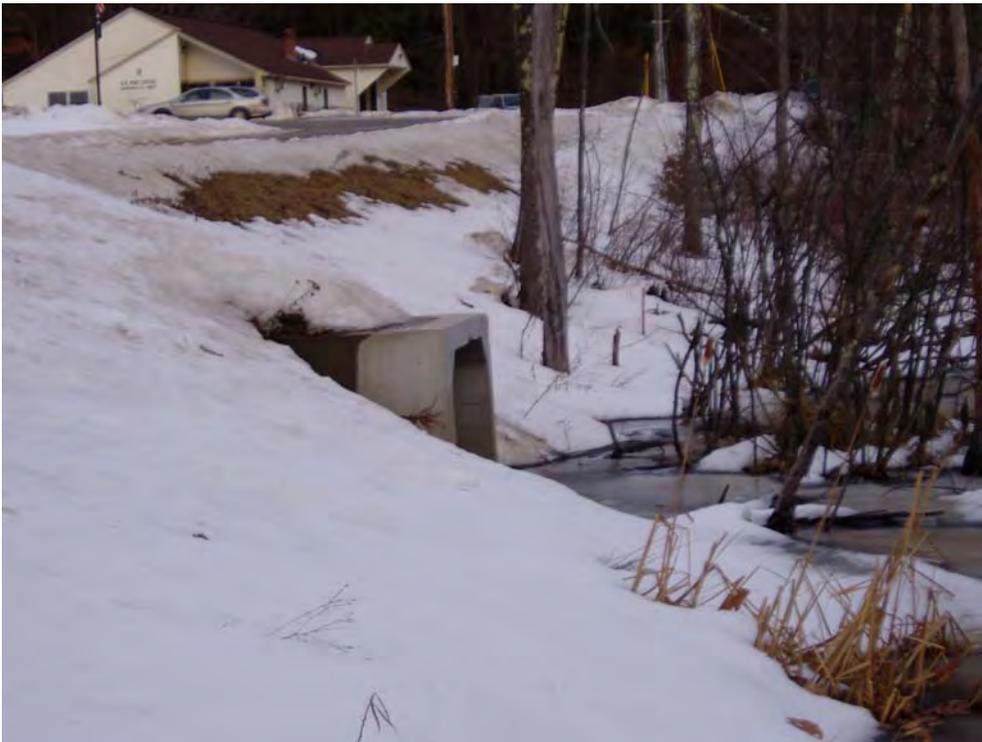
The crossing structure on Glastonbury Drive is a 4'x4' concrete box culvert. Appropriate headers were not noted.

4. This photo shows the large 4' x 4' concrete culvert that connects the upper and lower reaches of Wetland #15. This existing culvert passes beneath Glastonbury Drive, the road that provides access to Avalon Estates.

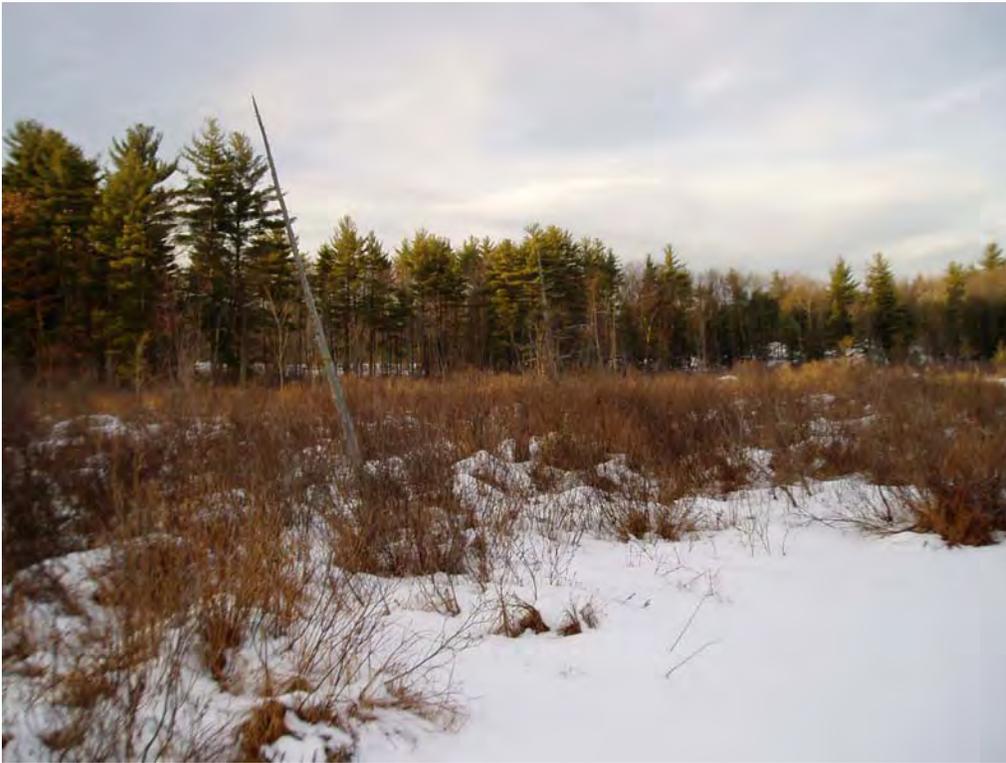
1. This photo shows a section of Wetland #16 situated along the southwestern perimeter of Philips Pond. This component of scrub-shrub wetland is semi-permanently flooded.
