Town of Sandown Wetland Evaluation Report

Town of Sandown, NH
Conservation Commission

August 2008

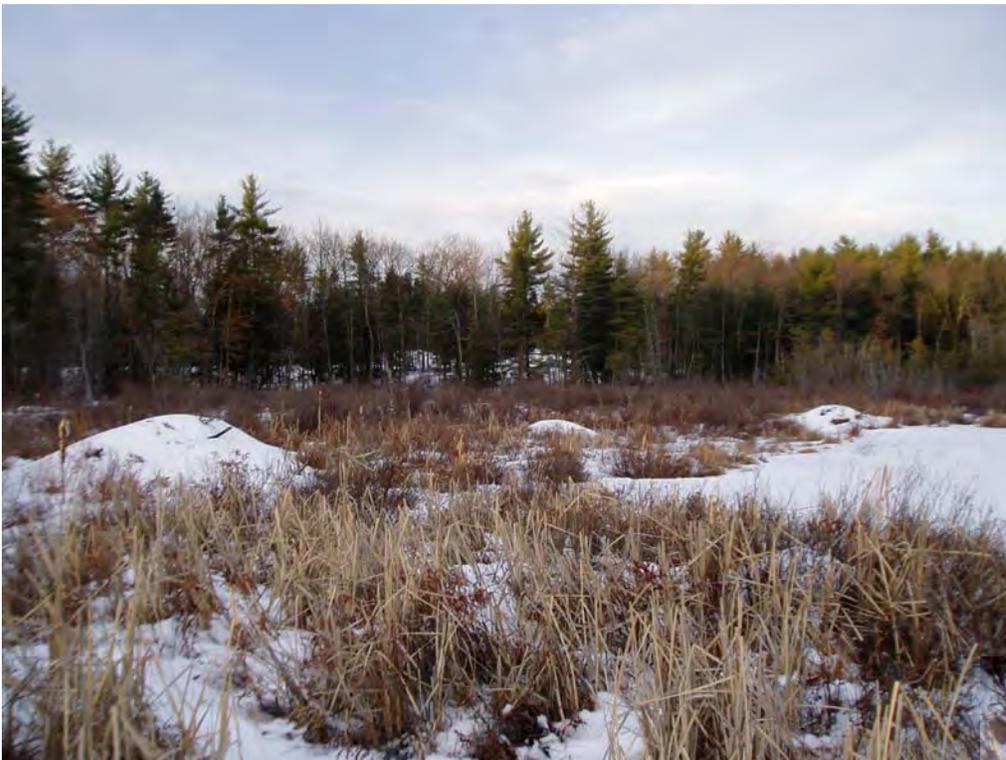
2. Beaver and muskrat are actively utilizing an emergent marsh component along the pond's edge (center of photo). When comparing the three lodges, the muskrat's is the smallest.

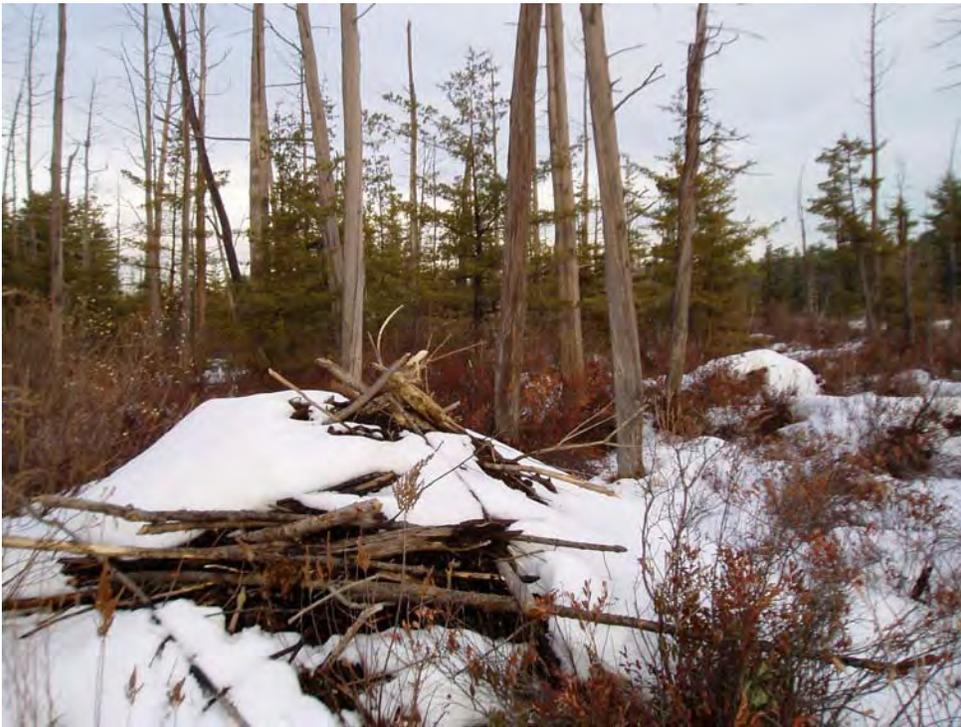
3. A third beaver lodge (left, center) was observed in the northeastern PFO5/4Fb wetland component. Atlantic white cedar (sapling layer) and leatherleaf (shrub layer) are the two dominant plant species here.

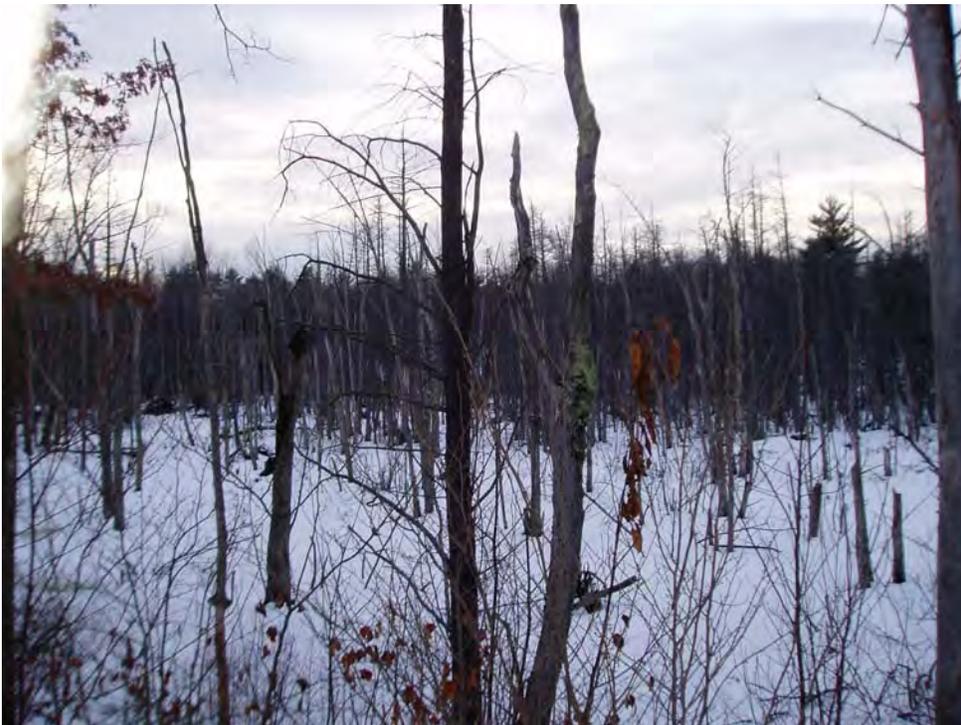
4. Beaver activity was also observed further west in the PFO5Eb wetland component. Water impoundment over several years has killed a large percentage of the tree canopy. The remaining dead standing trees now provide potential nesting to several species of songbird.

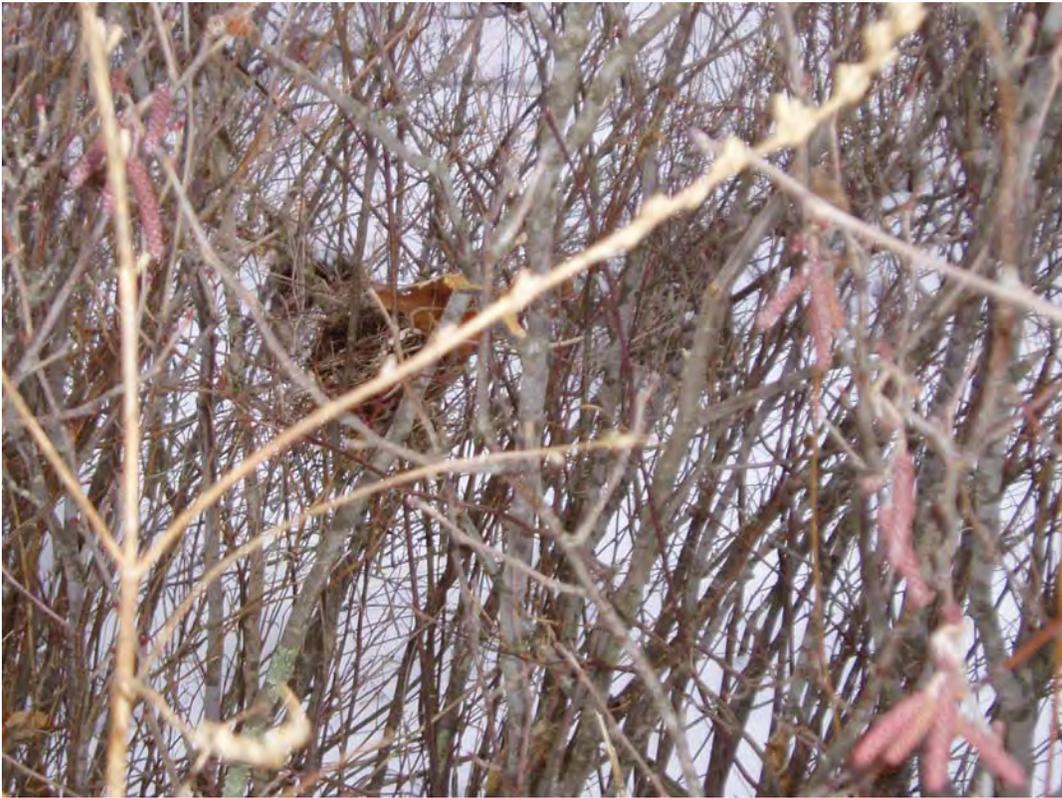
5. Another indication of songbird usage within the wetland components adjacent Phillips Pond was this bird nest (left, center).

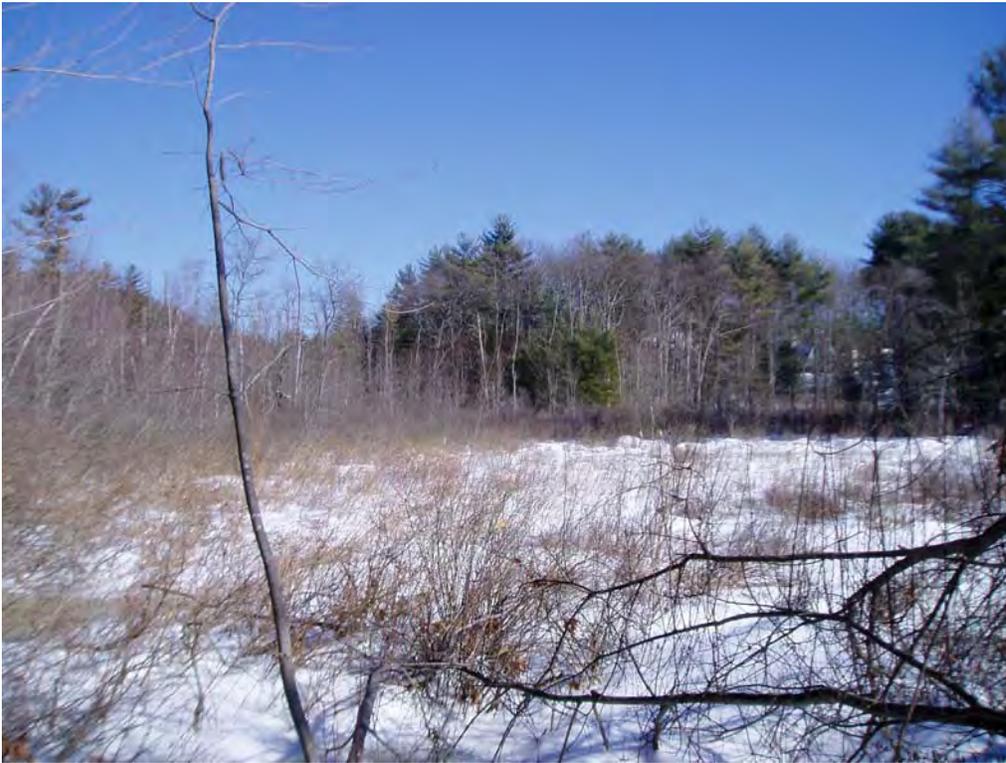
1. This photo shows the permanently flooded component of Wetland #17 adjacent Phillips Pond. Wetland shrubs are the dominant species.

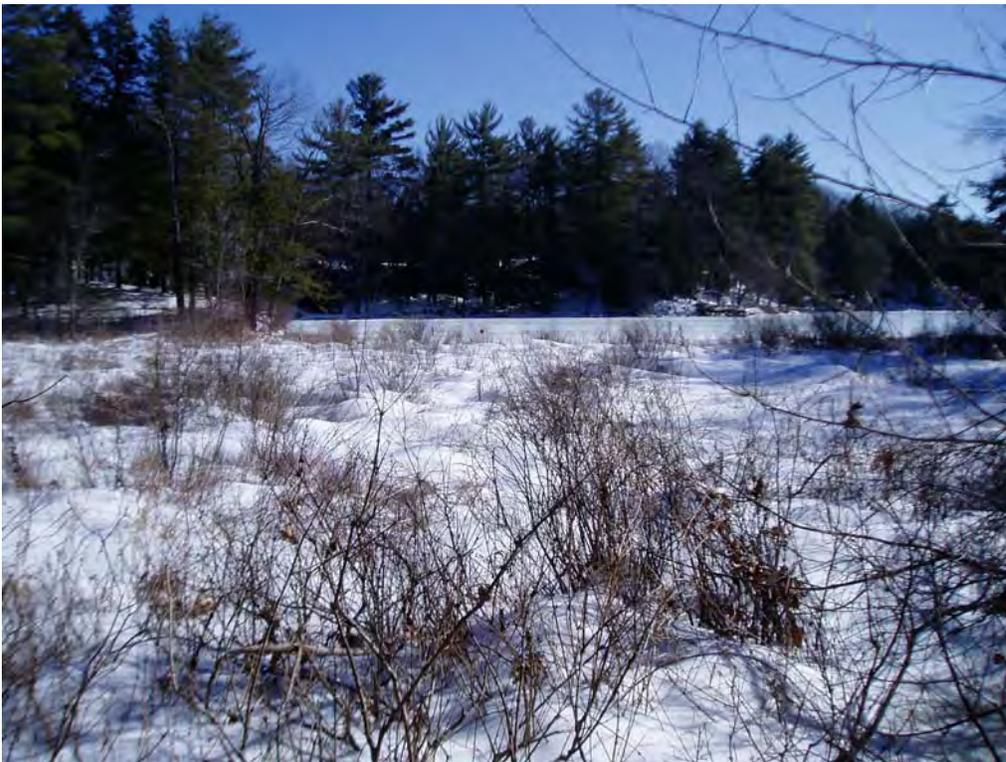
2. This photo is of the same wetland component as above but directed back towards Phillips Pond. Lake/pond-associated wetlands are generally ranked higher in function and value.

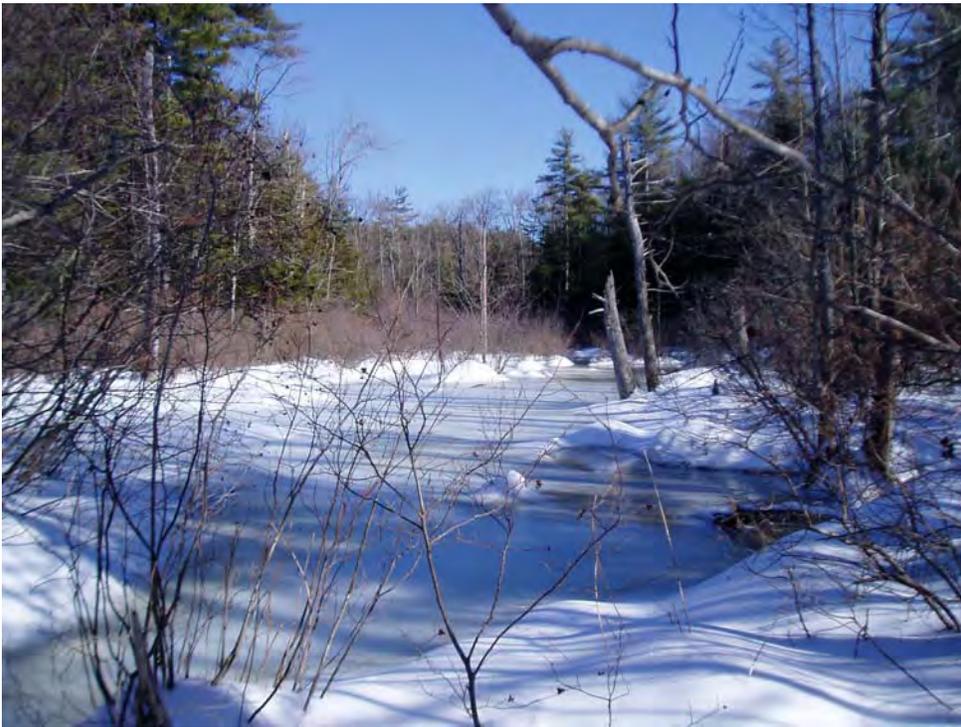
3. This photo shows the small open water component (PUB3E) situated at the center of Wetland #17. From this juncture, it appears flowage moves both northwesterly via an intermittent stream and southerly through the connecting wetland system.

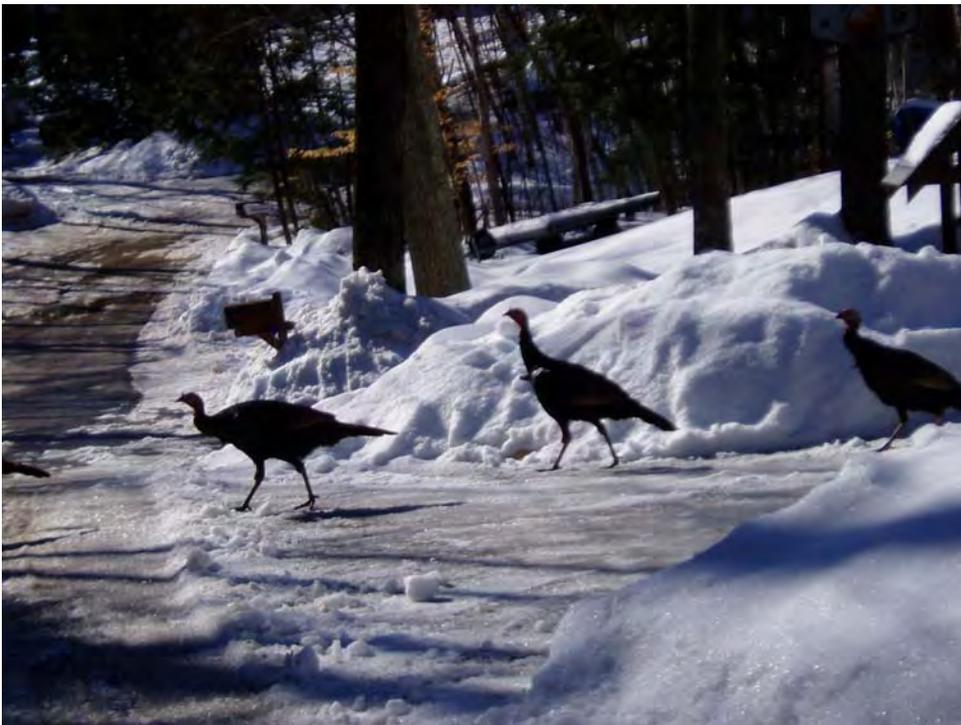
4. These wild turkeys were observed moving from a forested component within Wetland #17 to the adjacent uplands. This emphasizes the importance of wetlands even in the winter months to various wildlife species.

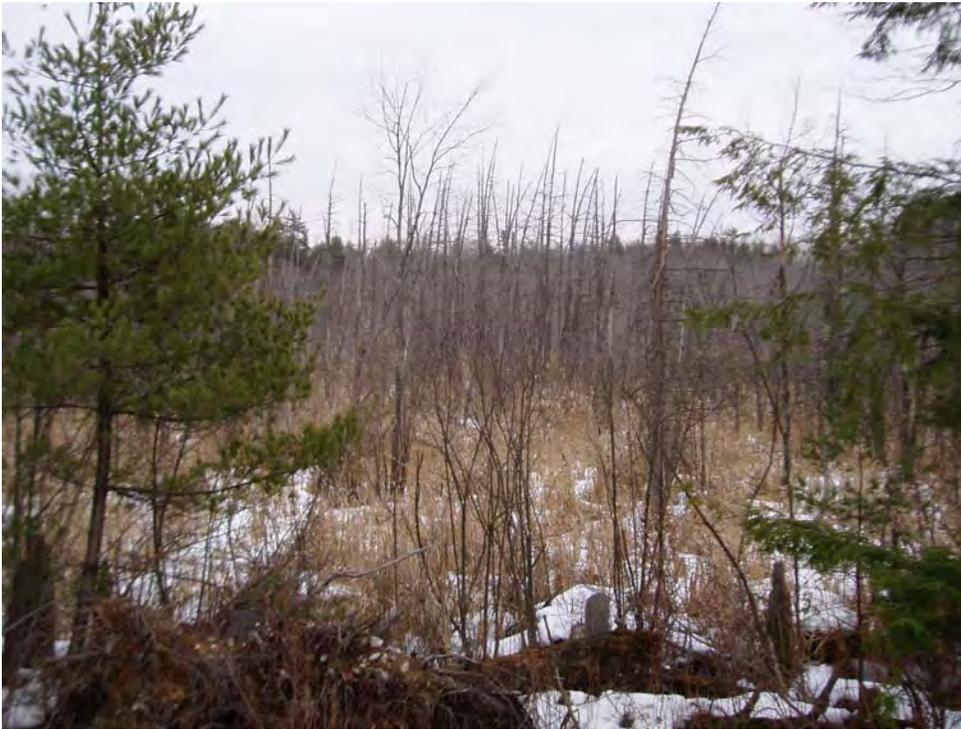
1. Wetland #18 is bisected by a large perennial stream that exits Phillips Pond and flows northwards. The photo shows the southwestern end of this wetland. In this section of wetland, an emergent marsh/scrub-shrub wetland (PEM1E/PSS1E) was observed. The dense vegetation and wintertime conditions obscure the existing stream channel.

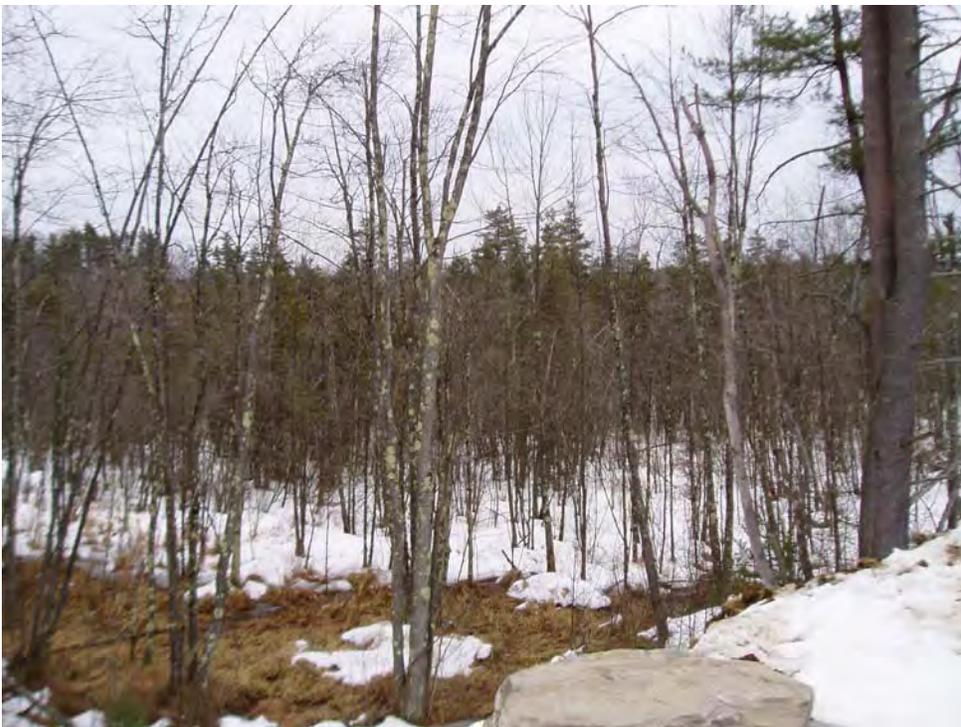
2. This photo is directed northwards from Shore Drive at the northeastern section of Wetland #18.

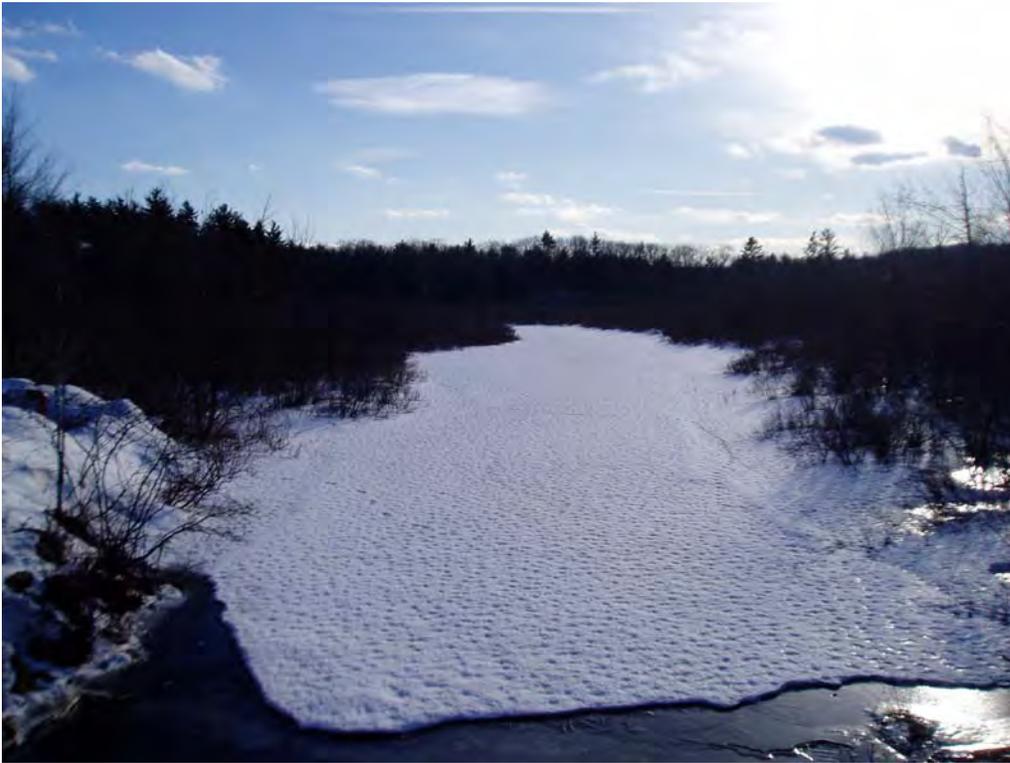
1. This photo is directed southwards from Route 121A at Wetland #19. Coyote (possibly fox) tracks are evident (left, center) on the frozen Exeter River channel.

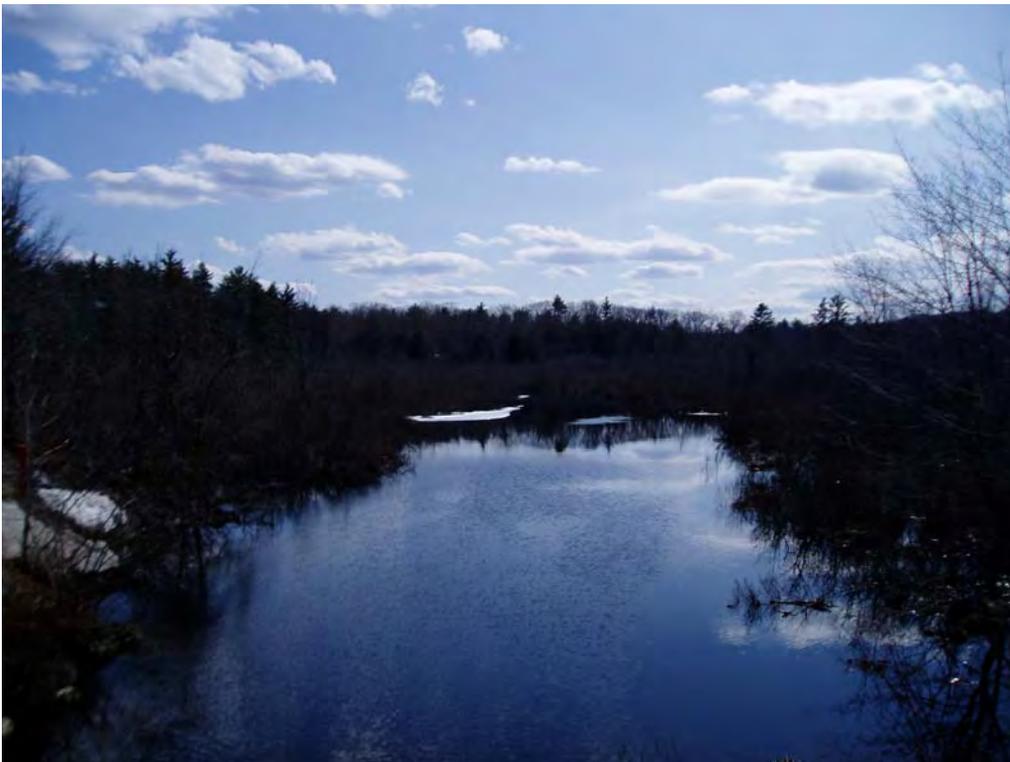
2. This photo provides the same view from Route 121A of the Exeter River, but during the spring months. Wetland #19's association with this river amplifies its function and value.

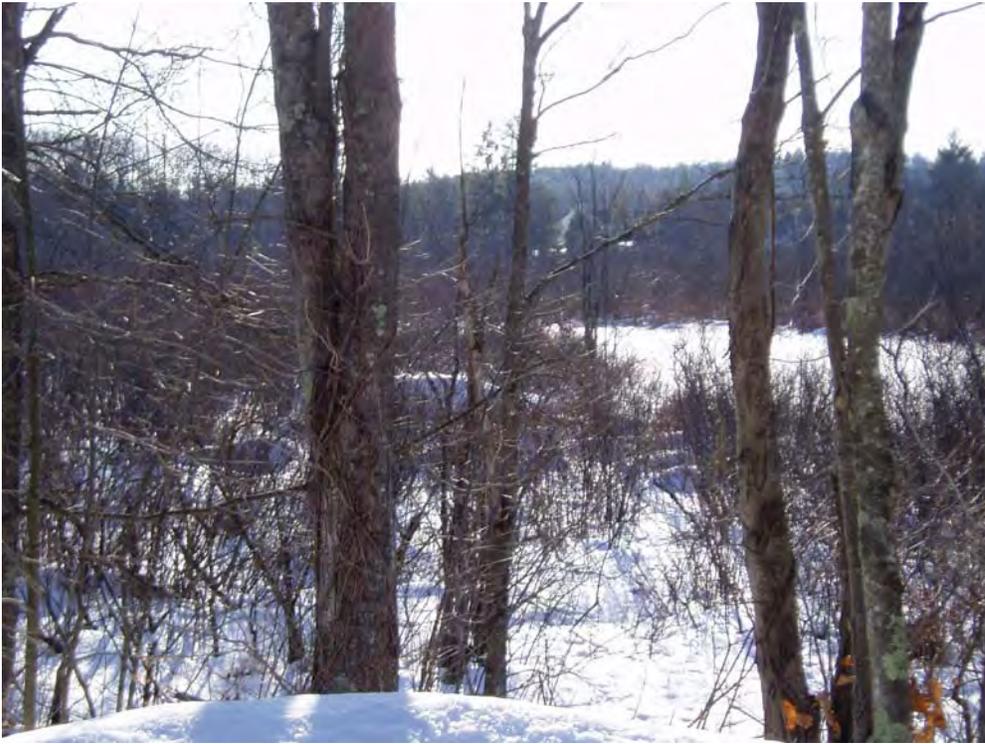
3. This section of Wetland #19 is occupied by a colony of beaver (the beaver lodge is situated at the center of the photo). Beaver, although troublesome at times, attract a diverse range of wildlife species who utilize the associated valuable habitat.

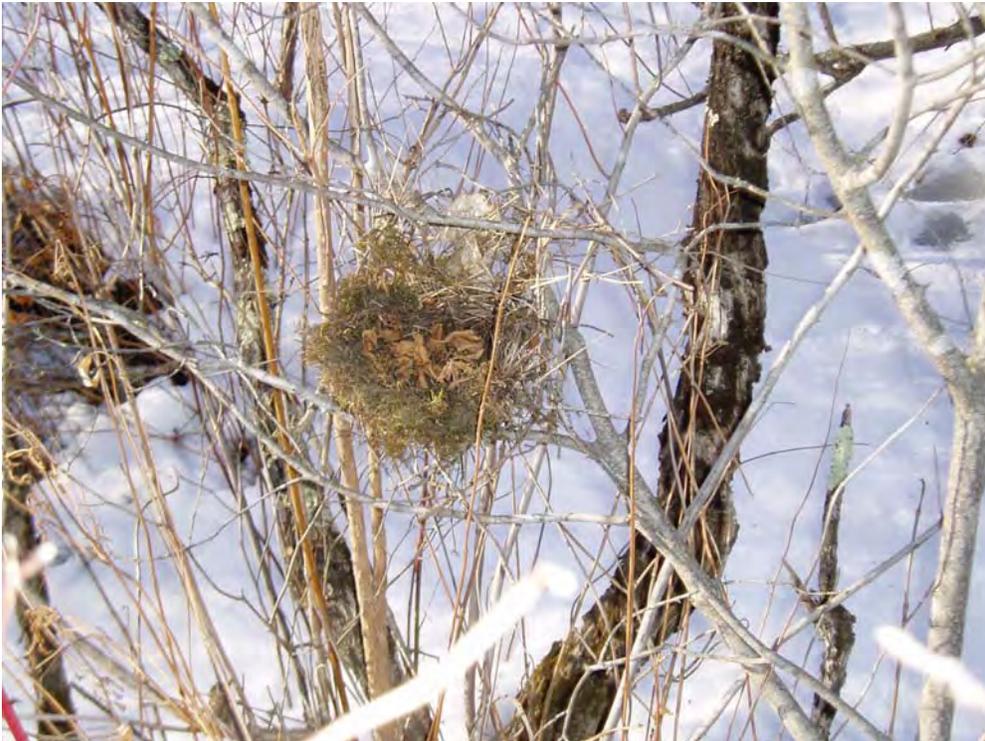
4. Frequently, songbirds are one of those species utilizing beaver flowage or riparian habitats. Here, a bird's nest was observed in the river's adjacent scrub-shrub plant community.

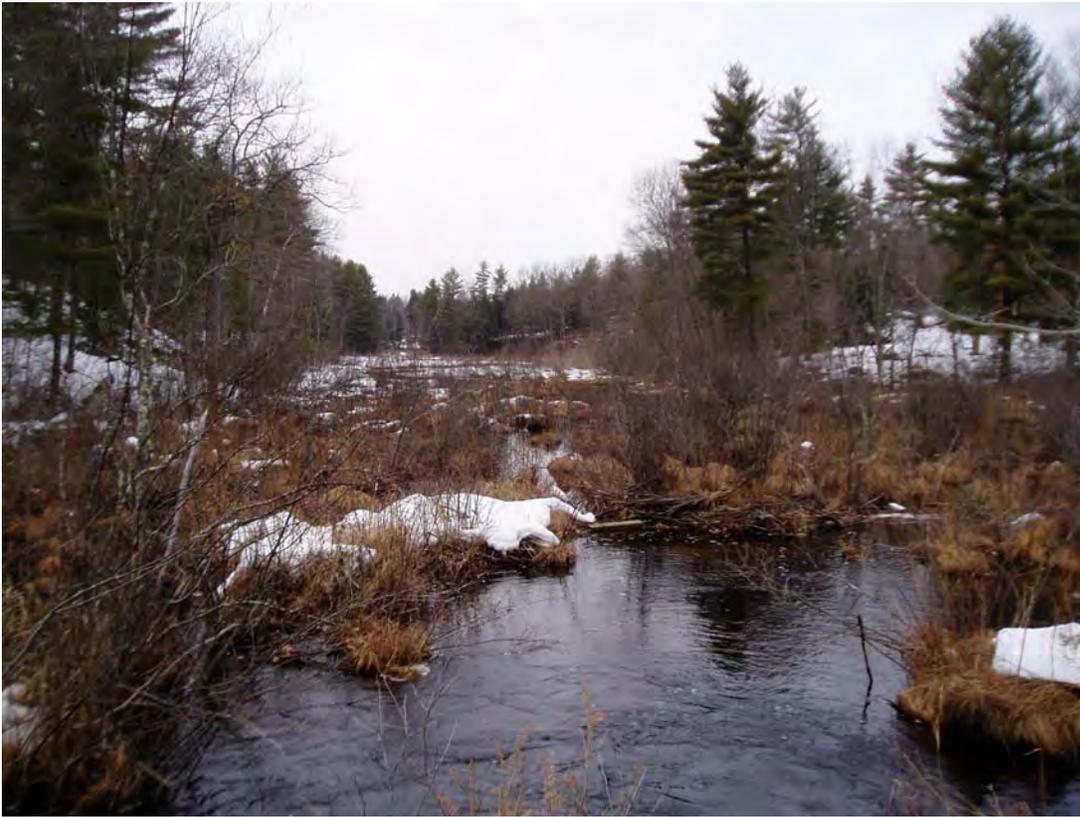
5. This is a view of the most southern end of Wetland #19 looking north. Here a perennial flows north from Phillips Pond. In a short distance upstream, this perennial merges with the Exeter River.

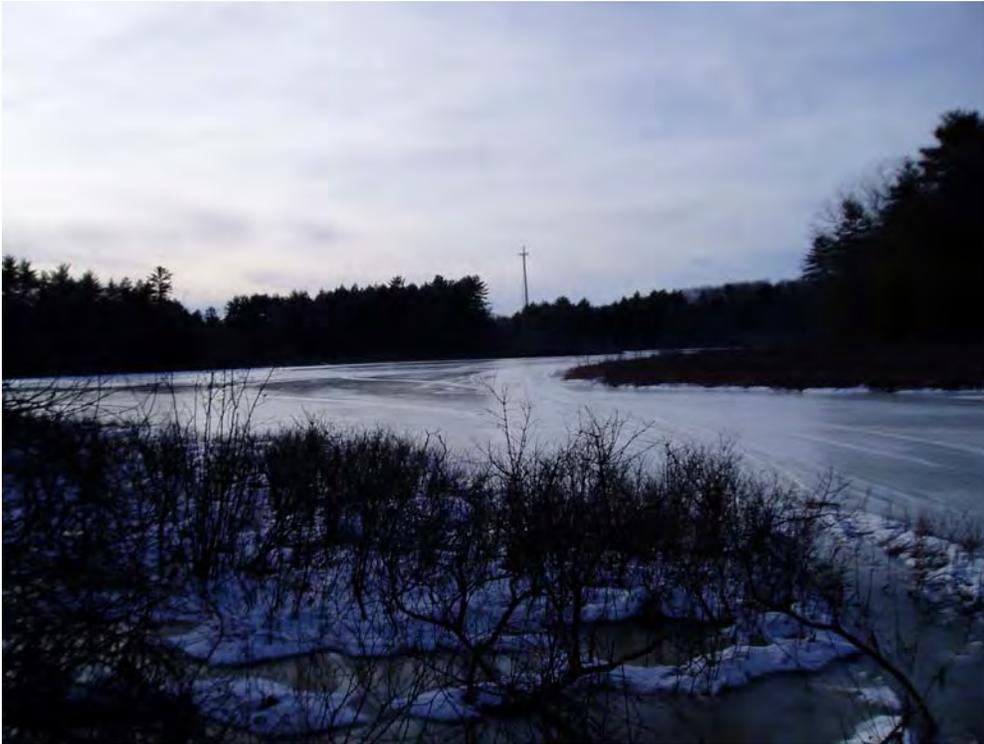
1. This photo shows the large open water component (Lily Pond) situated within Wetland #20 during the late winter months.

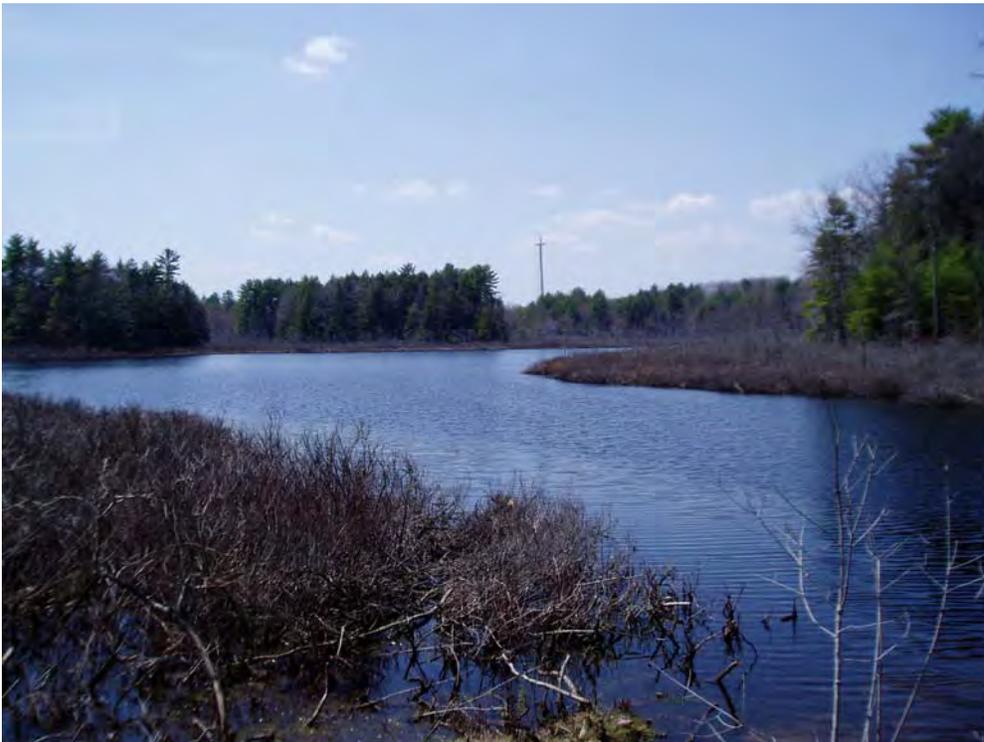
2. This photo (taken about 3 months later from the same camera angle) shows Lily Pond just after ice-out. The pond's associated scrub-shrub plant community (chiefly buttonbush) is evident.

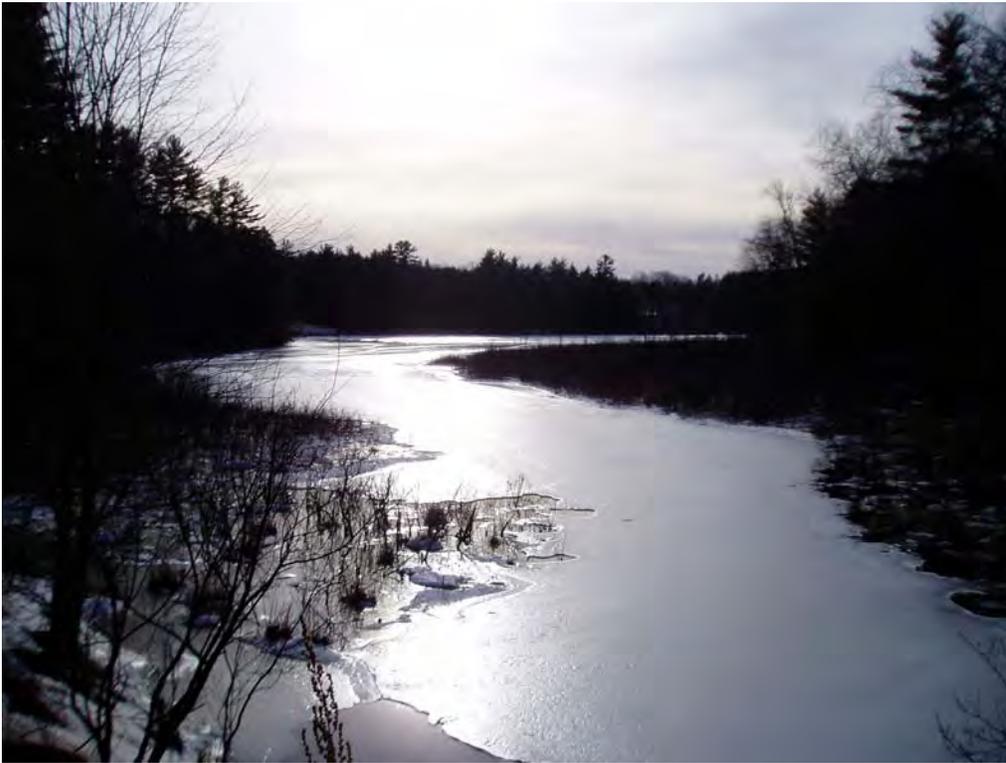
3. This is a view of Wetland #20 looking southwesterly from Phillips Road. The adjacent scrub-shrub plant communities potentially provide turtle species with critical habitat.

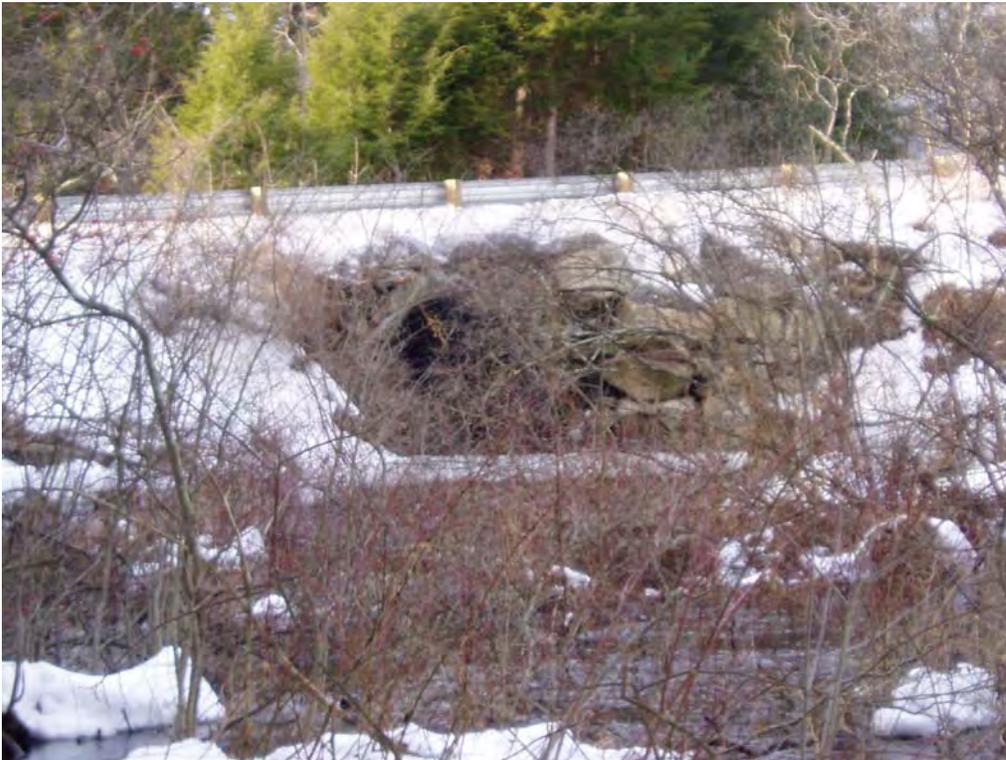
4. This is a photo of the crossing structure (center) passing beneath Phillips Road which connects Lily Pond with the Exeter River.

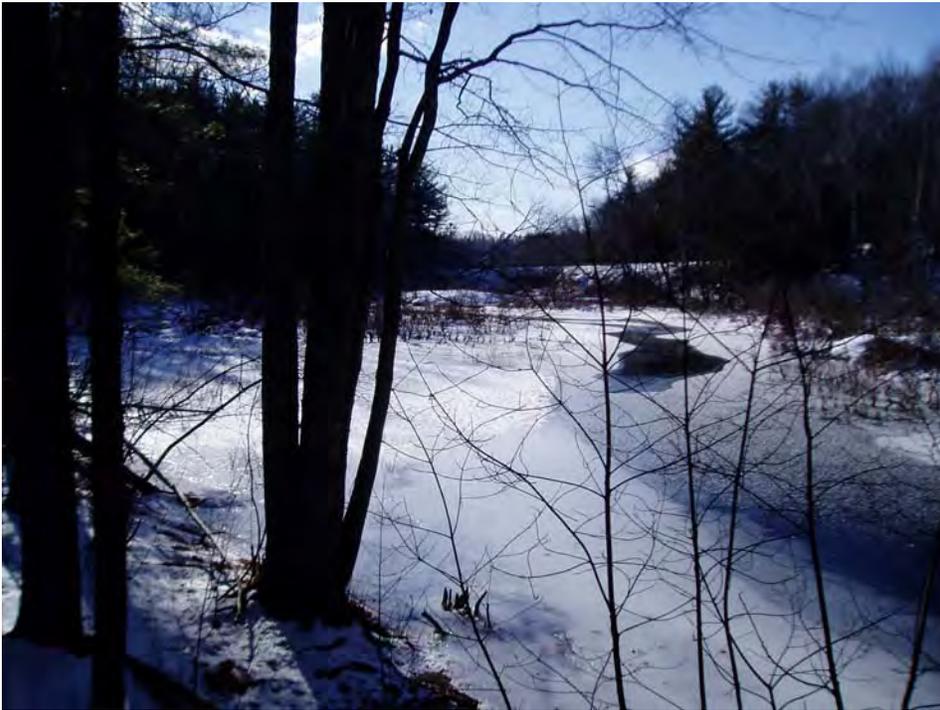
5. This is a photo of the emergent scrub-shrub / open water wetland component situated just east of Phillips Road. This section of wetland is being occupied by beaver (see the beaver lodge in the right center of the photo)

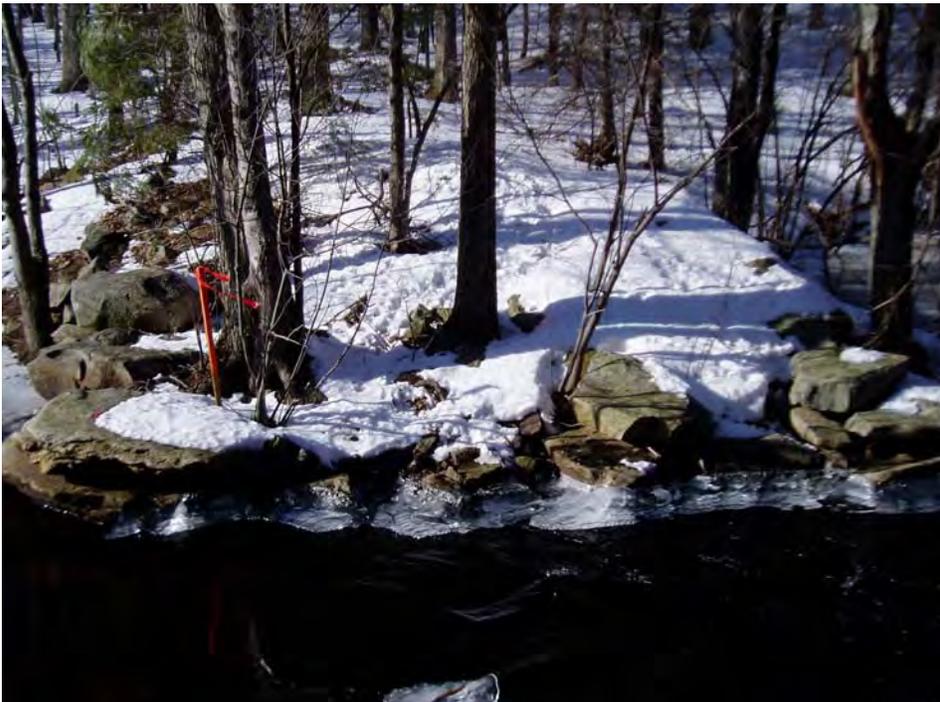
6. This photo shows the earlier historical crossing of the Exeter River. Close observation of the photo's background reveals white-tailed deer tracks. It appears that deer are accessing the open water (created by the strong current) for drinking during the winter months as it exits the wetland.

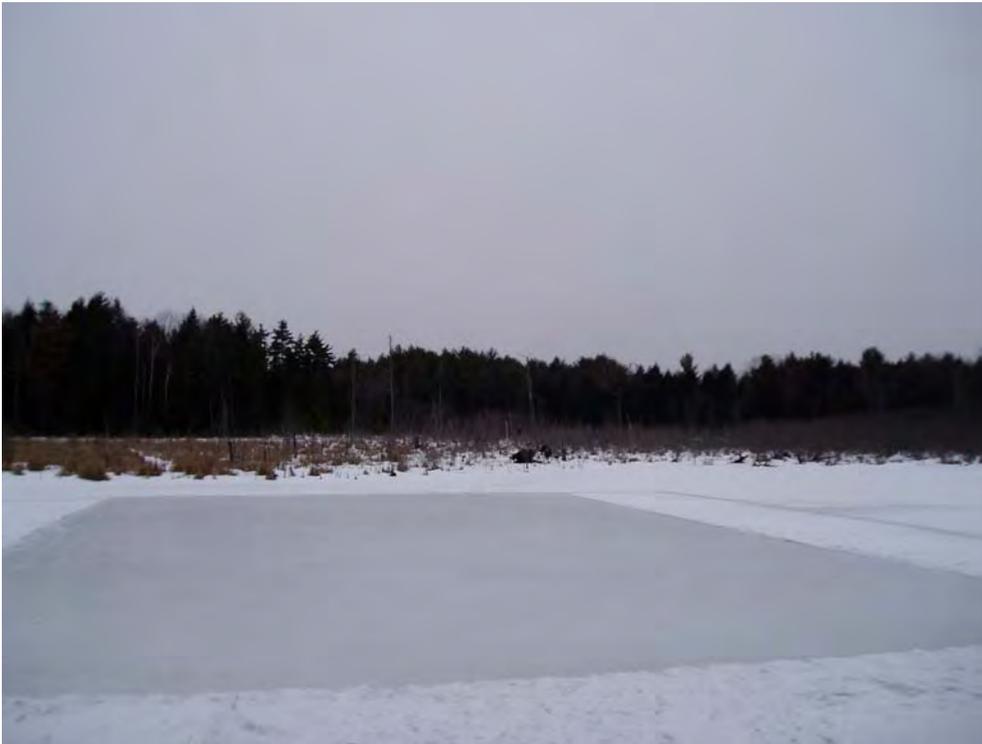
1. This photo is directed westwards from an adjacent parking area at Wetland #21. This wetland is comprised of three main components: open water, scrub-shrub, and emergent marsh. As indicated on the photo, the local residents are using the open water component at this wetland for skating.

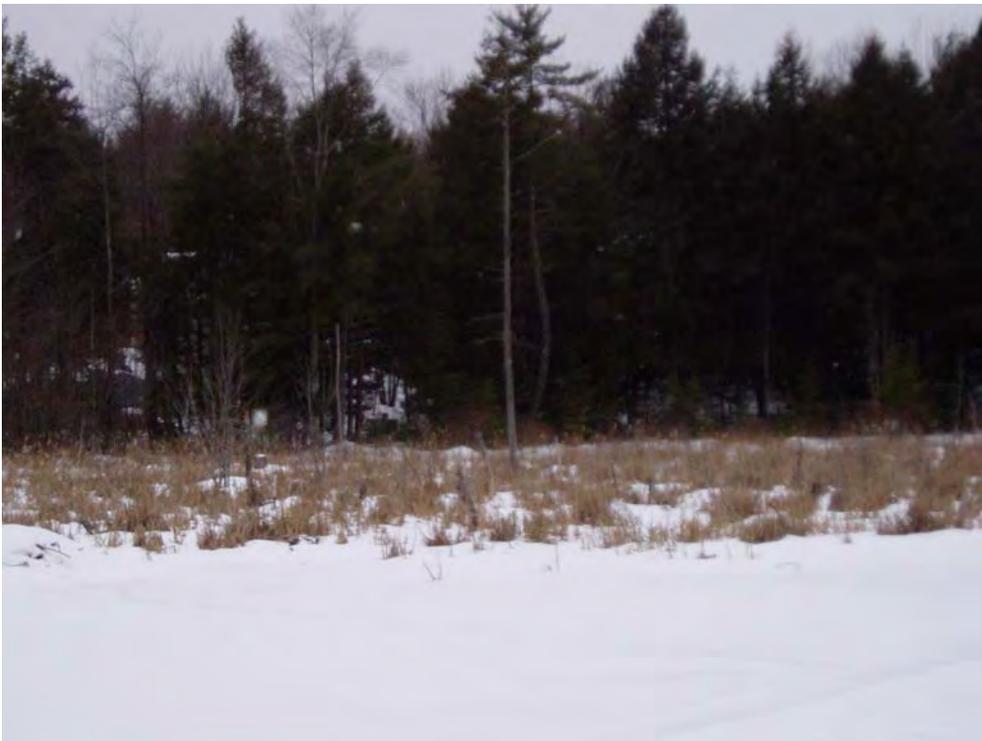
2. This photo shows the emergent marsh component within this wetland.

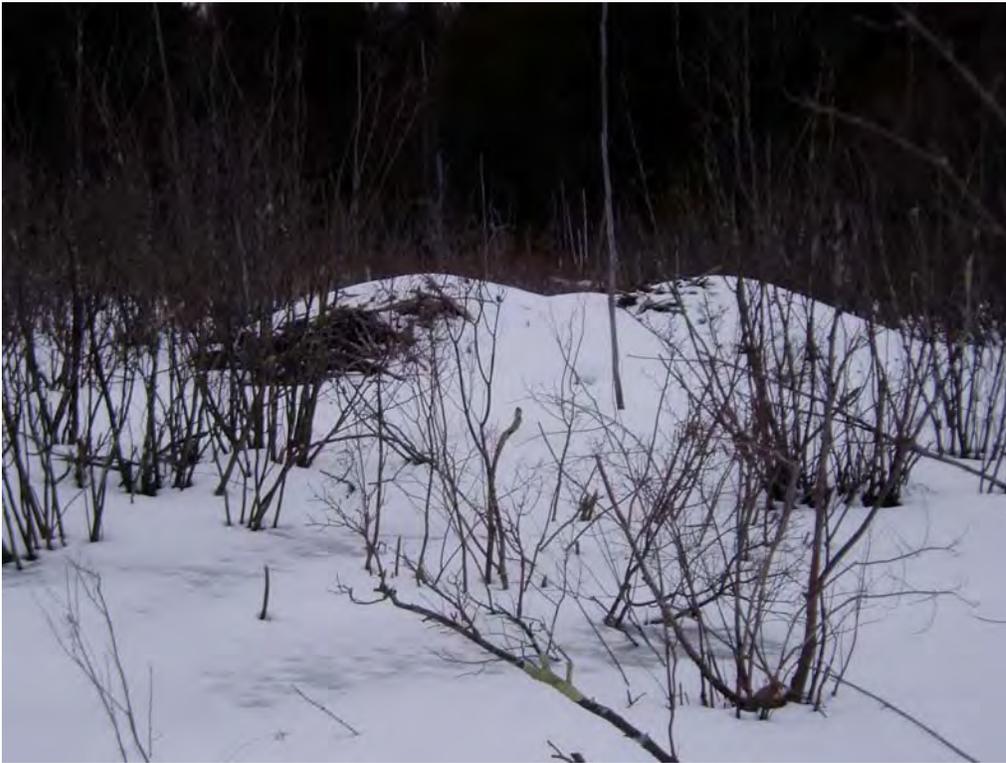
3. A colony of beaver has constructed two lodges within the scrub-shrub component (chiefly buttonbush and speckled alder).

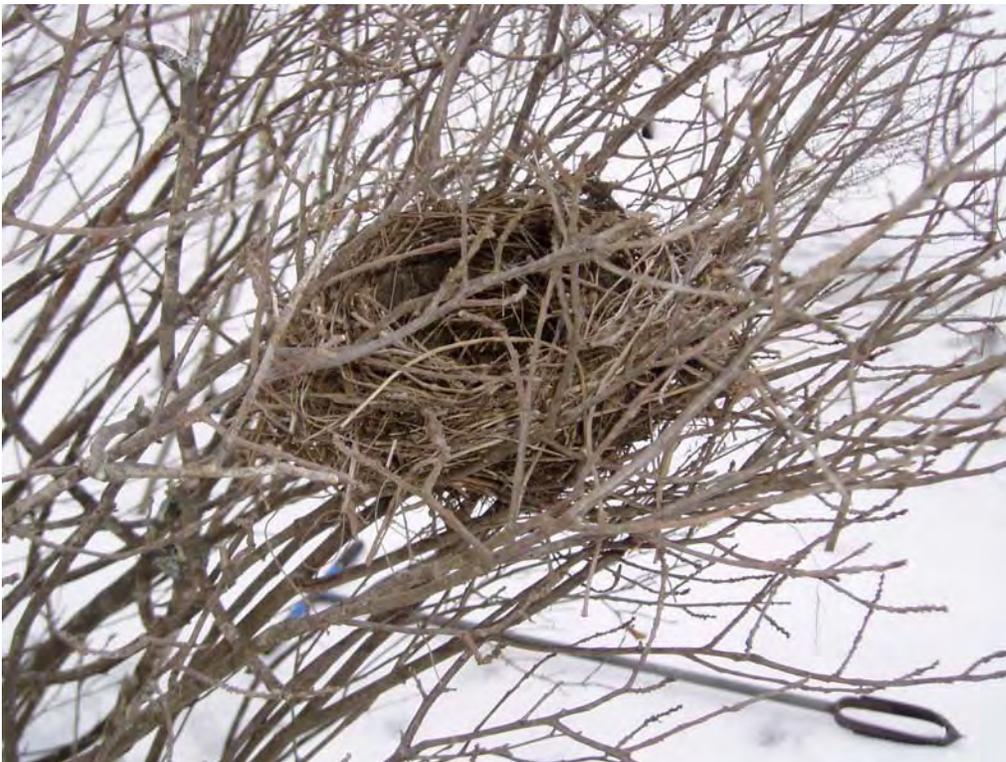
4. A songbird's nest was also noted in the scrub-shrub component utilizing the thick cover provided by buttonbush.

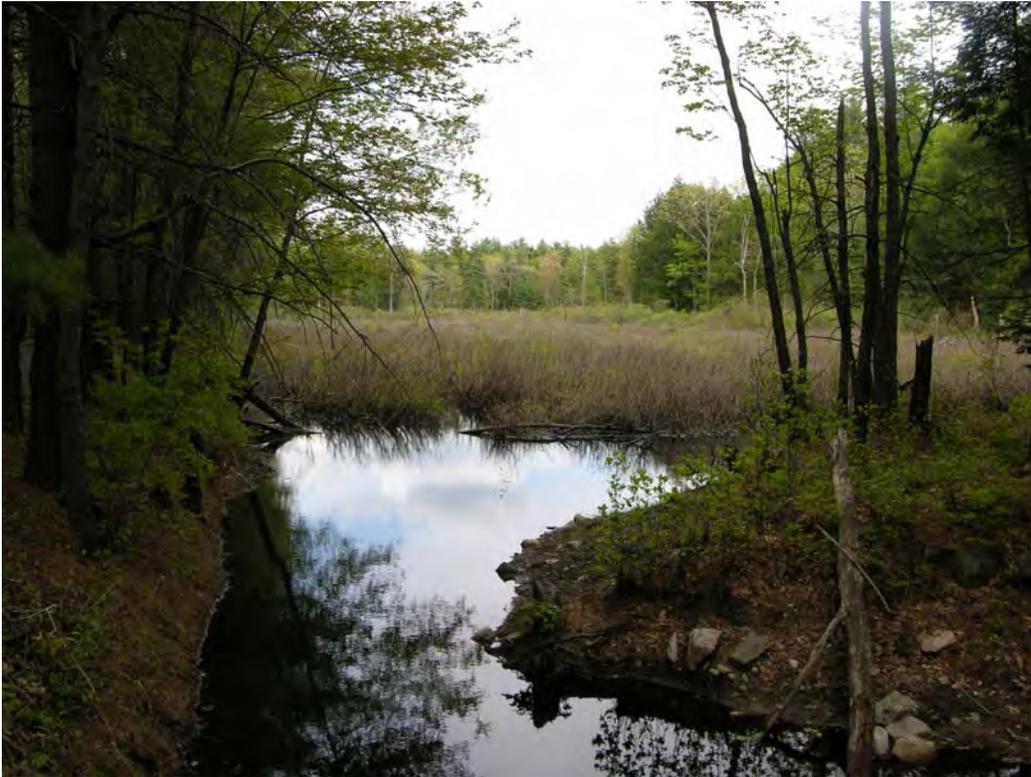
1. This is a view of the wetland from its southwestern end looking northeast. This is a classic scrub-shrub buttonbush swamp.

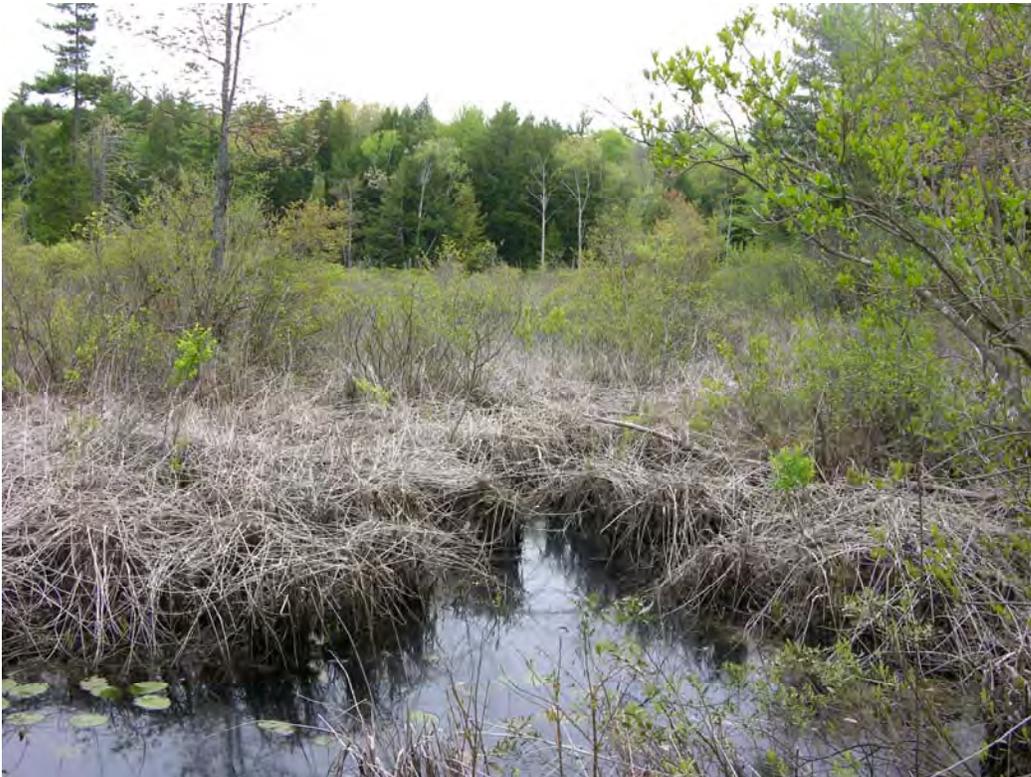
2. There are pockets of deep marsh with water lilies and water willow present.

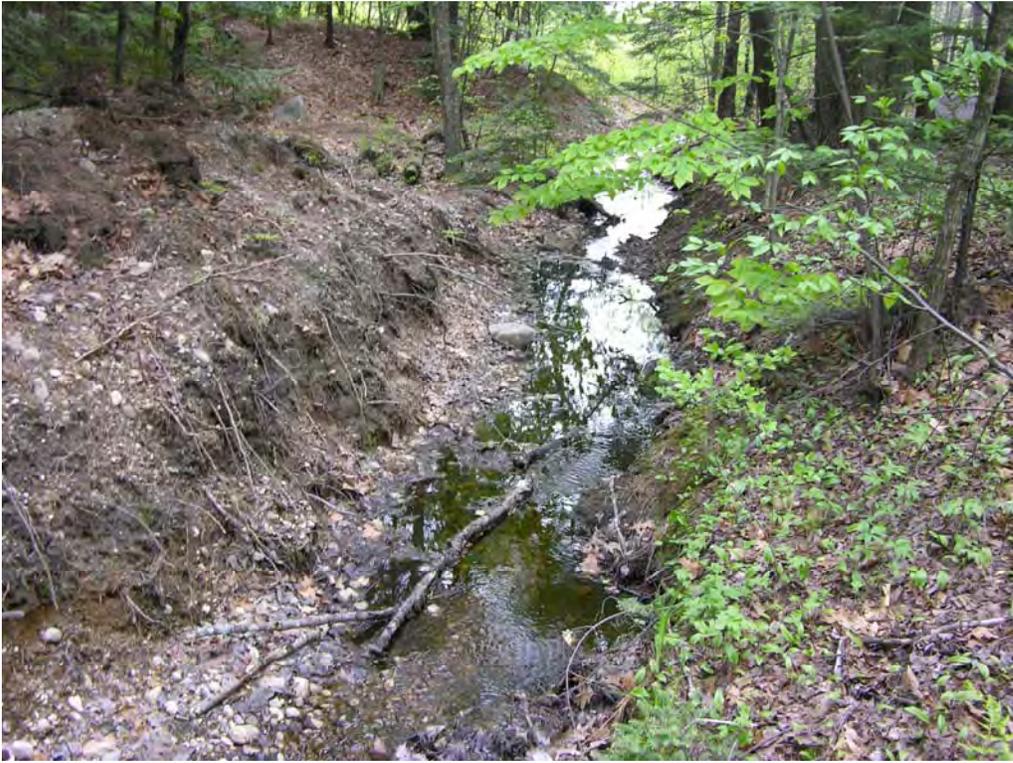
3. This is a view of the outlet of Wetland #22 which drains along the railroad bed to Wetland #14. This area has been recently dredged and a beaver dam may have been removed.

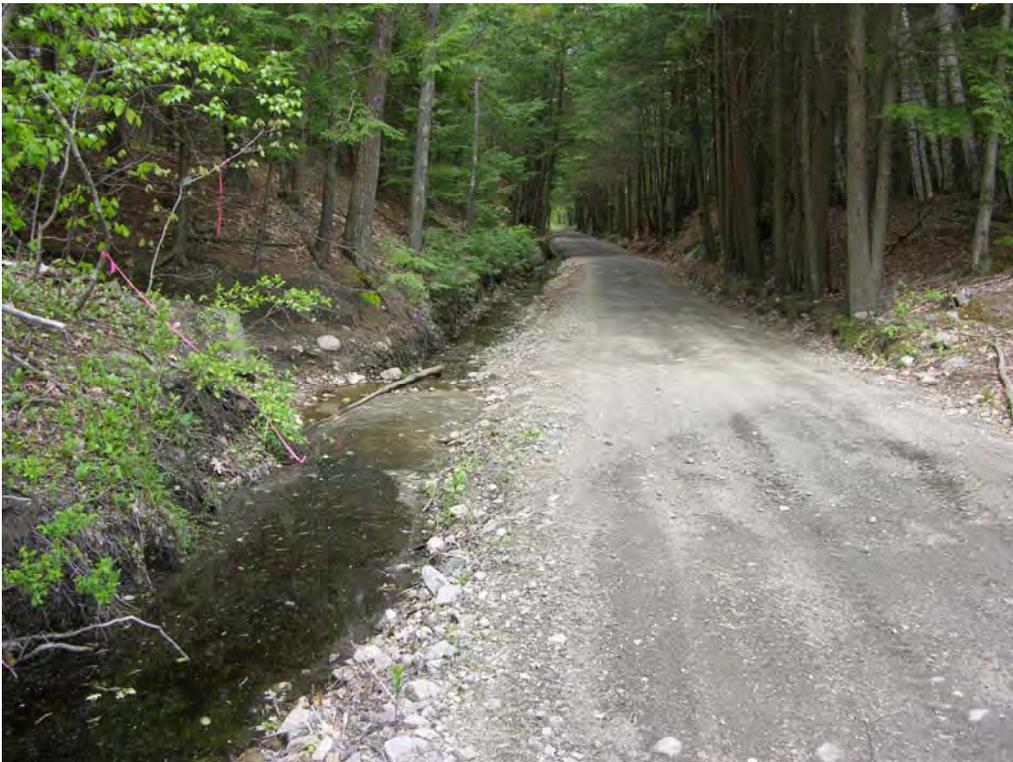
4. It appears that water levels have been lowered in this wetland by maintenance dredging in the ditches along the railroad bed.
