Town of Sandown Wetland Evaluation Report

Town of Sandown, NH
Conservation Commission

August 2008

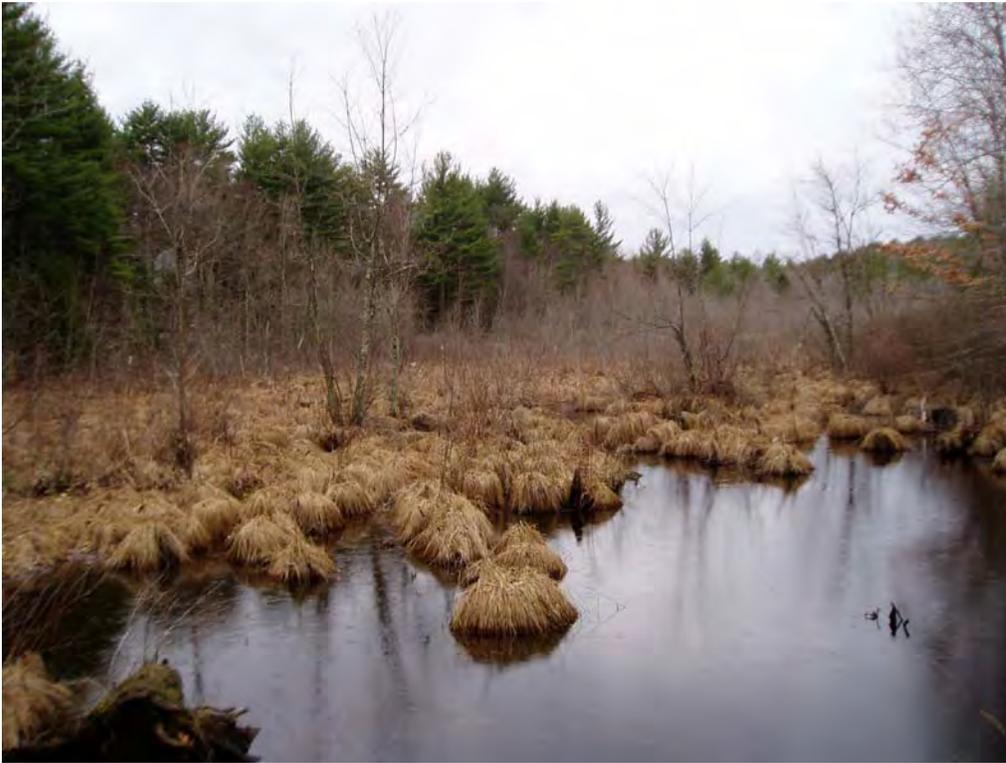
1. Wetland #23 is approximately two-thirds emergent marsh and one-third scrub-shrub. Tussock sedge is a dominant wetland plant species.

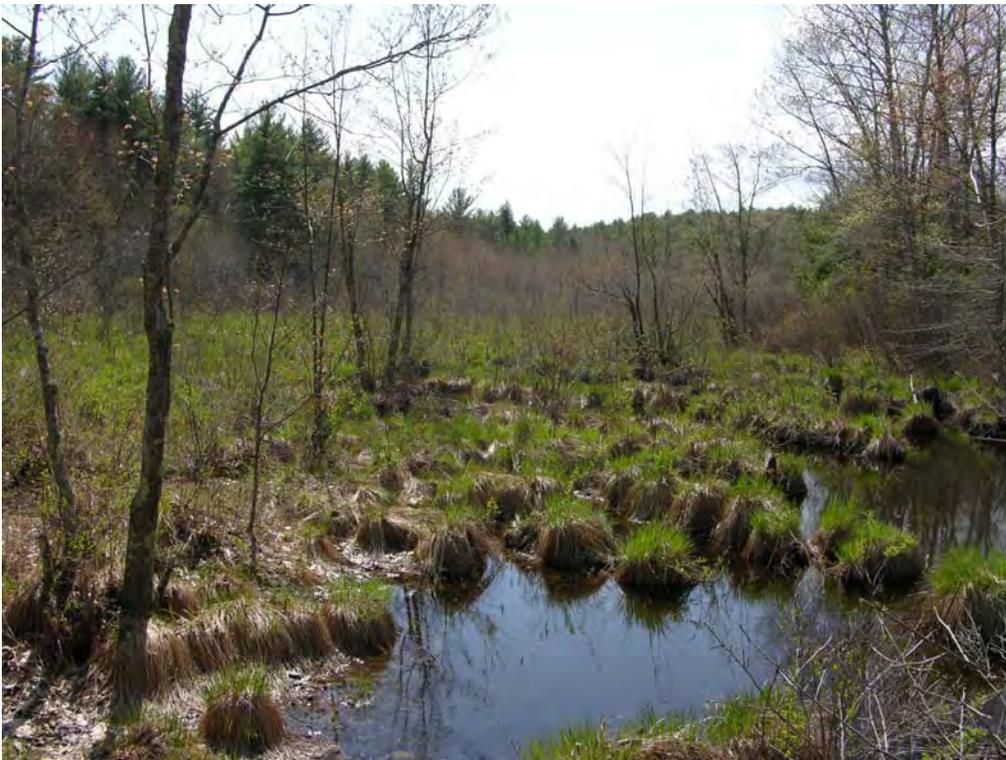
2. This photo provides another view of the same wetland in early spring 2008. A perennial stream exits this wetland flowing in a northerly direction.

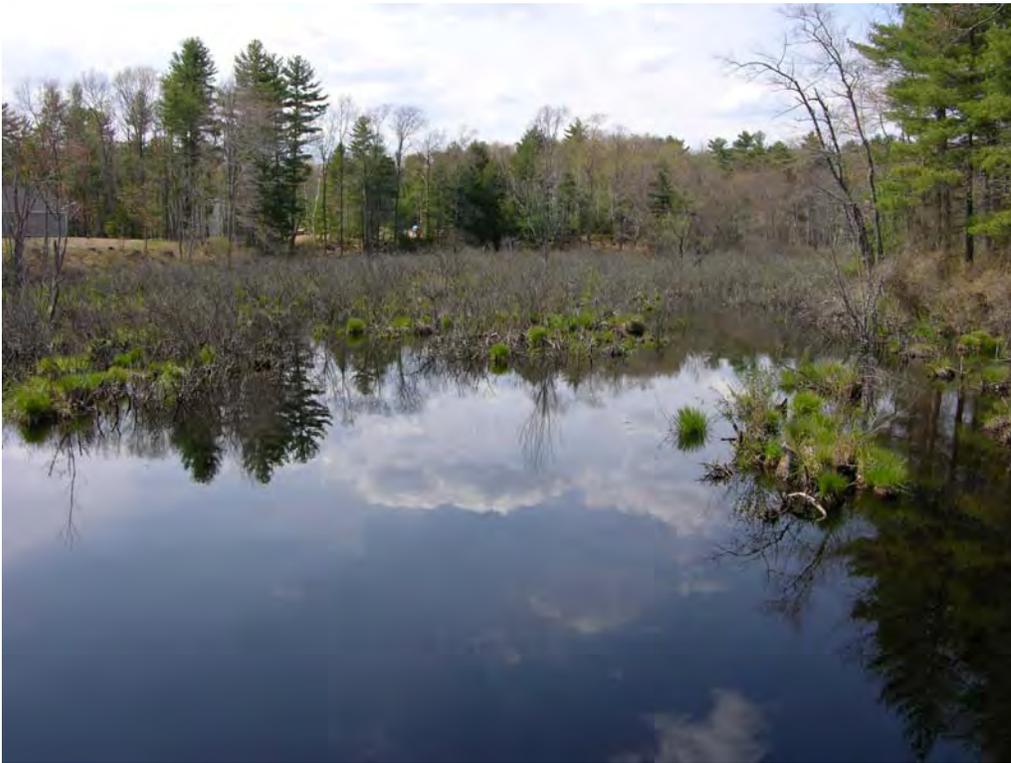
1. This photo was taken from the railroad trail looking north into the northwest portion of this wetland. A subdivision borders the western boundary of this buttonbush swamp.

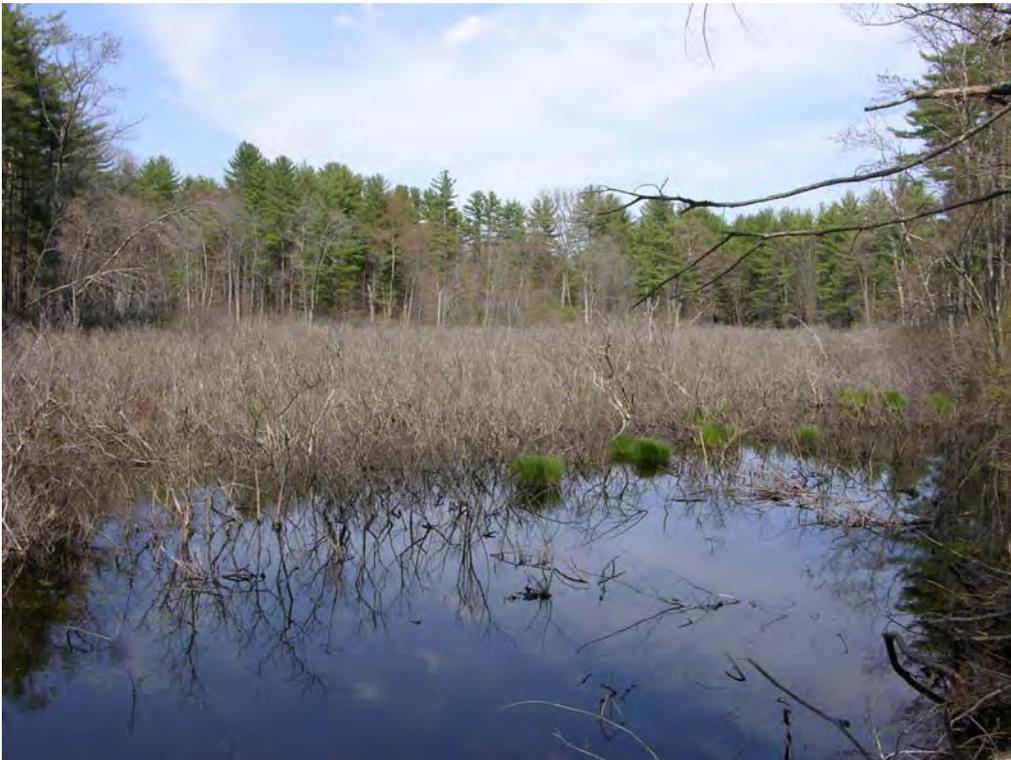
2. This is a closer view of this portion of Wetland #24. These swamps provide important habitat to waterfowl, especially wood duck.

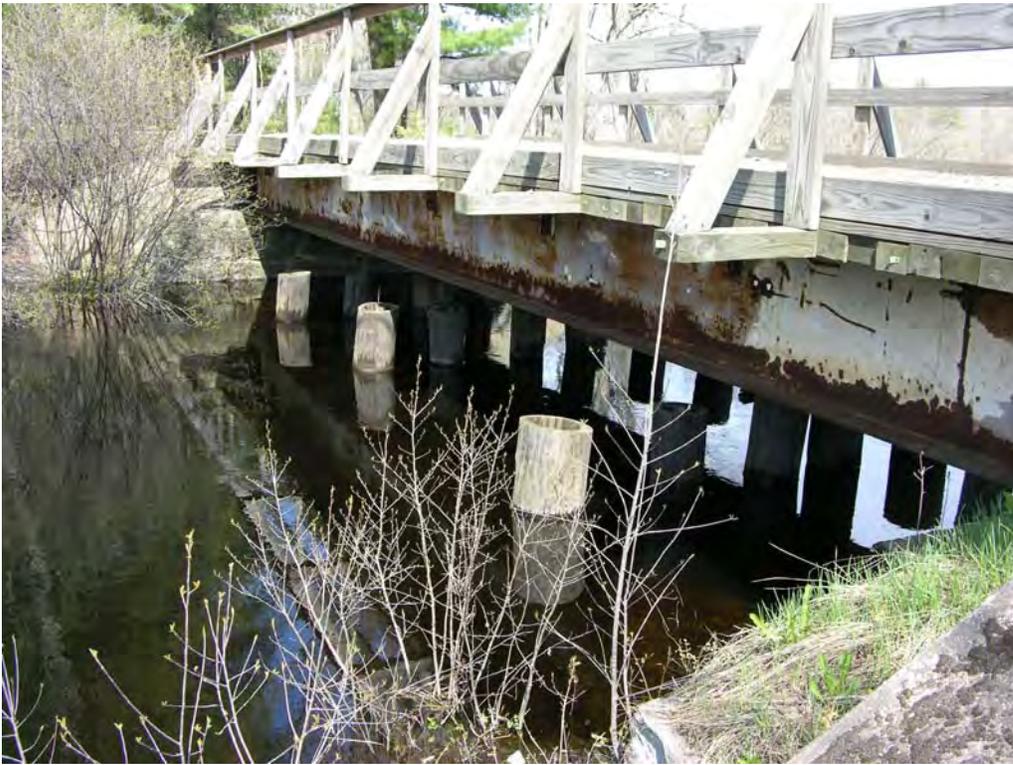
3. This is a view of the railroad bridge where the Exeter River flows south into the main portion of this wetland.

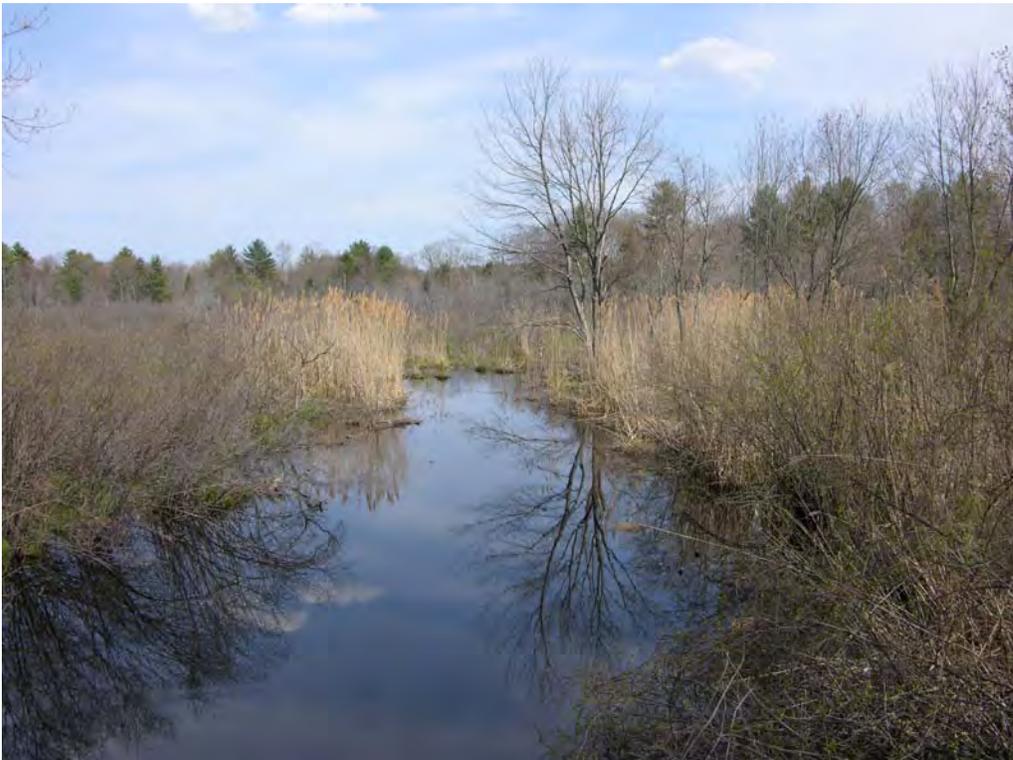
4. This photo is looking east (downstream) at the Exeter River from the railroad bed. Phragmites (the tall tan reed) has invaded a few small areas of this wetland.

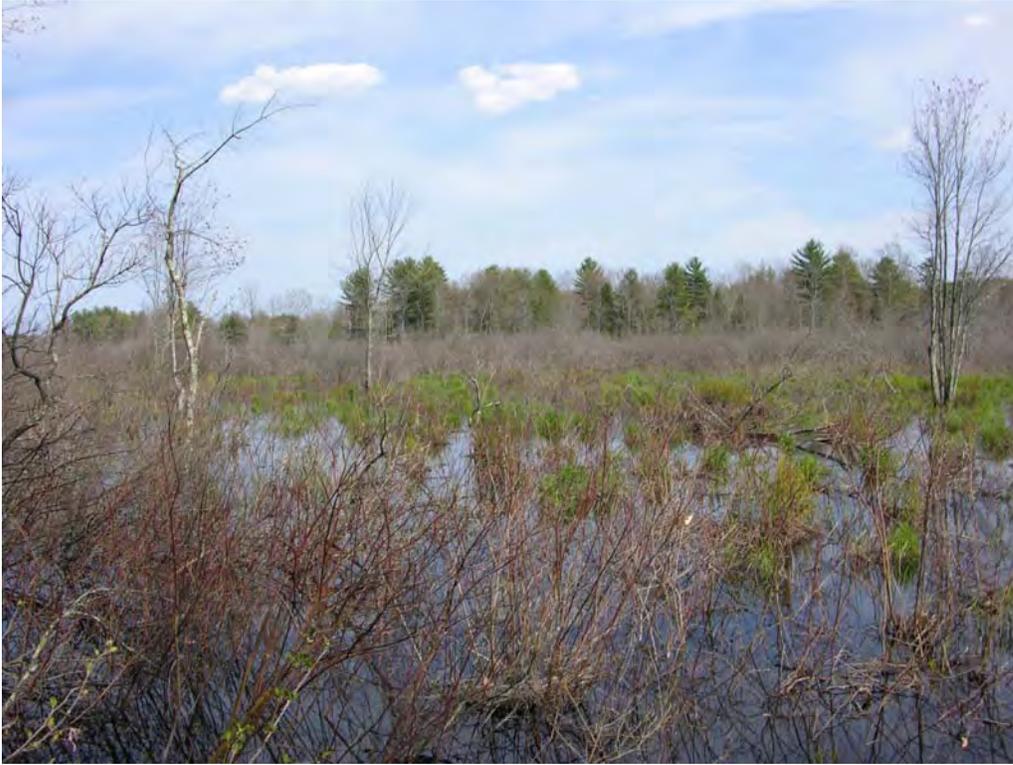
5. The central portion of this wetland is a large scrub-shrub, floodplain swamp. Both deep and shallow marsh are also present.

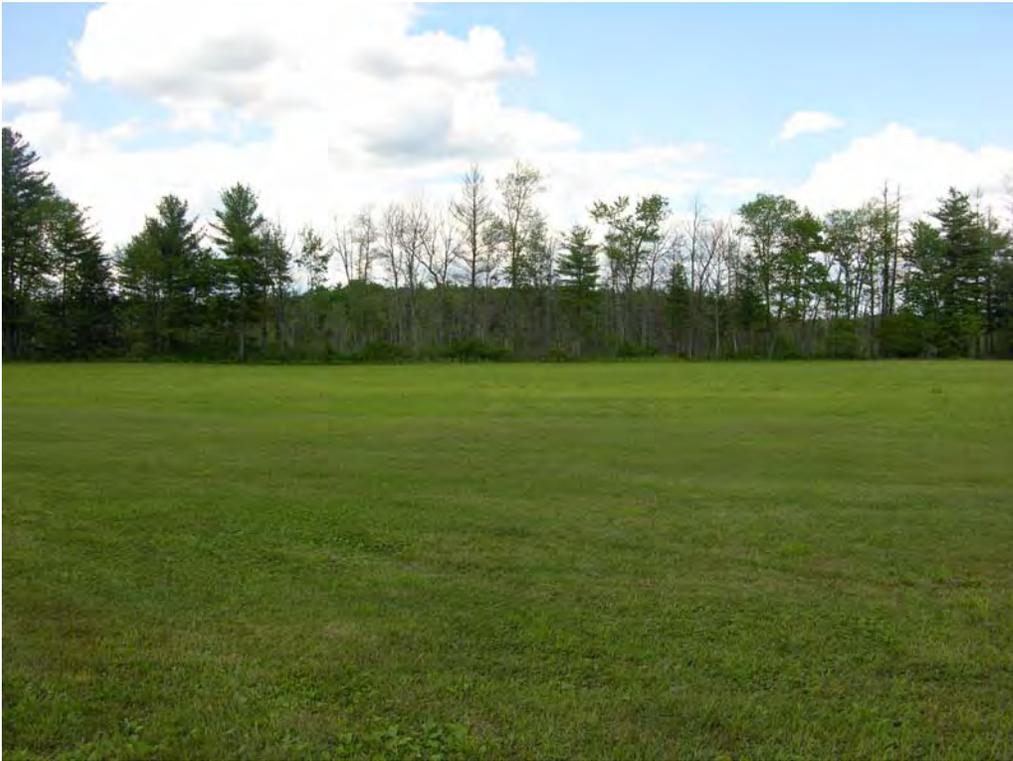
6. Large hayfields border the southern boundary of the eastern end of this wetland along the Danville town line.

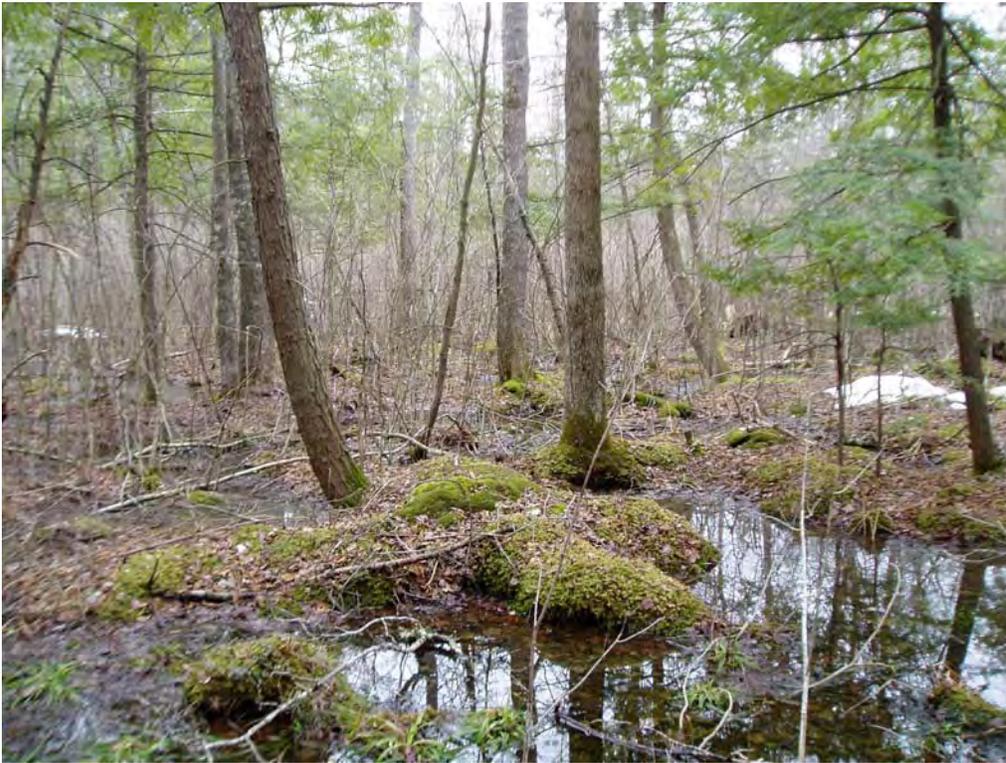
1. Wetland #25 is forested in character with a scrub-shrub understory. Pit and mound topography was evident.

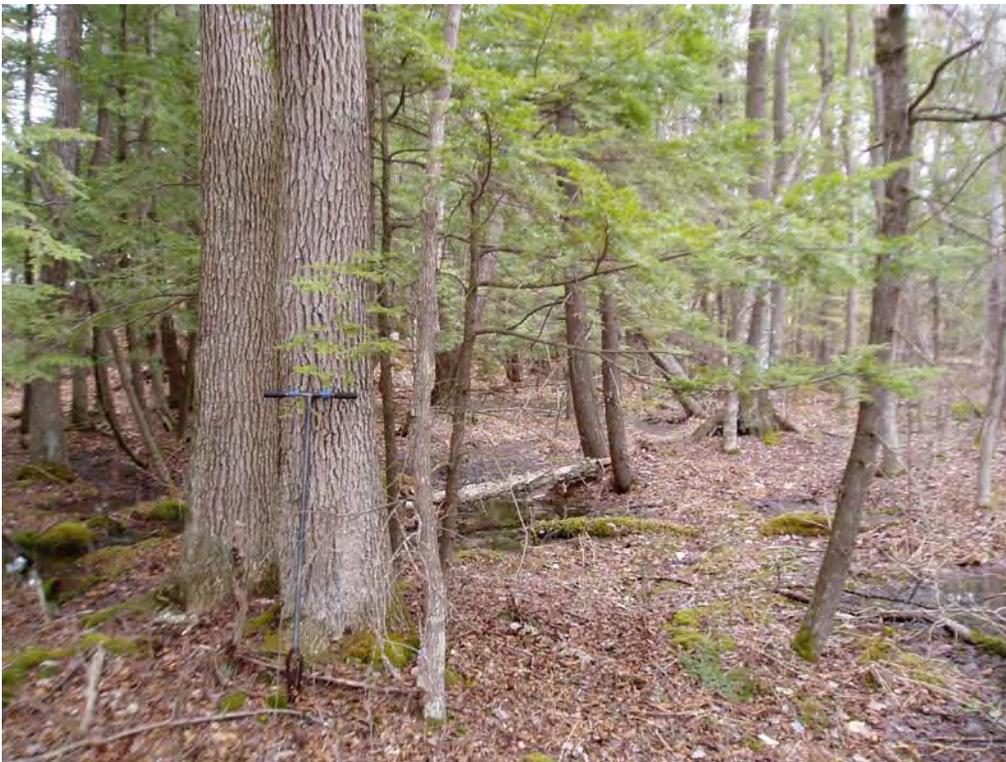
2. Black gum, a wetland tree species (left) was observed within this wetland. A new 40-lot subdivision is located just north of this wetland.

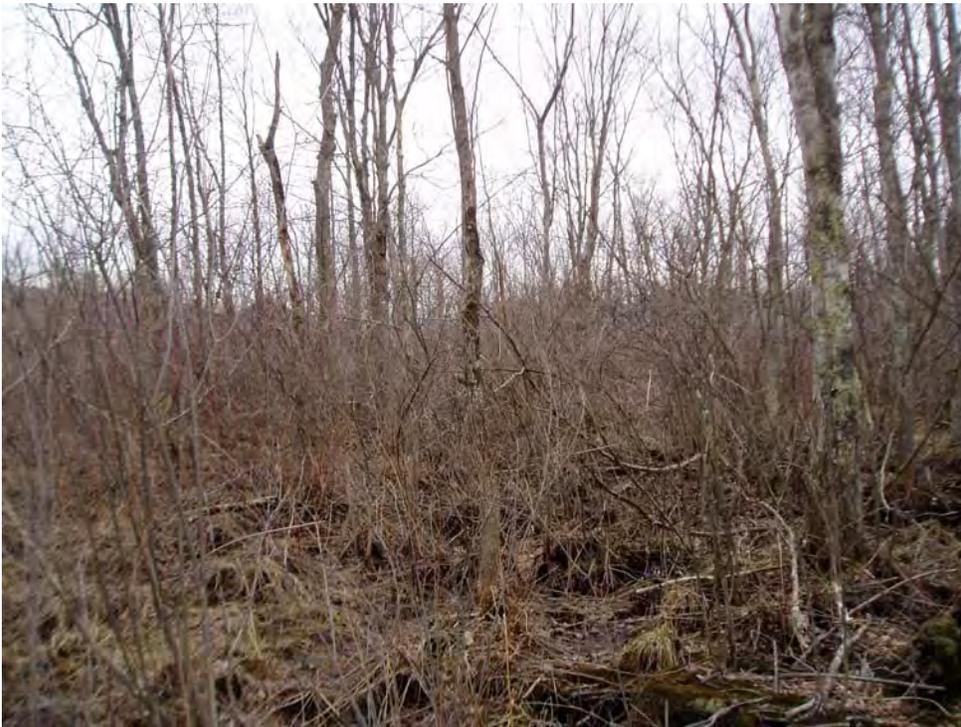
1. Wetland #26 is situated just south of the Chester town line. The larger wetland system extends northward to the Exeter River. Historical ditching was evident throughout this wetland.

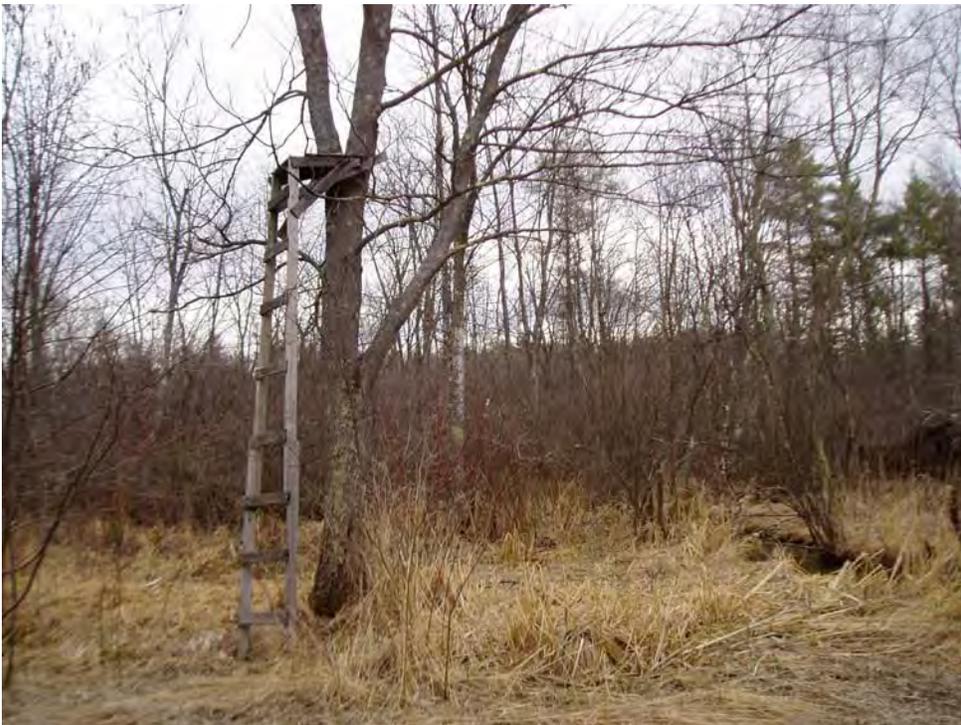
2. This photo shows a deer stand at the perimeter of the forested / scrub-shrub component. White-tailed deer often utilize these forested areas to bed-down in as the vegetative cover is thick and difficult to traverse.

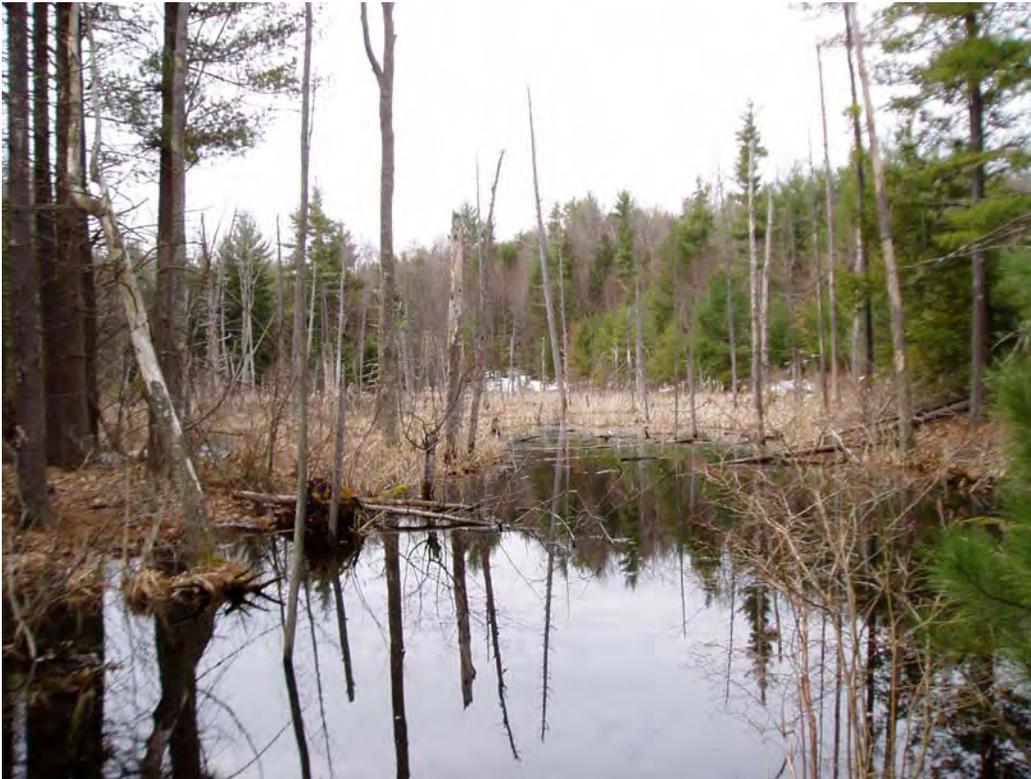
1. Wetland #27 was previously occupied by beaver. Its adjacent topography appeared to restrain the further expansion of this beaver flowage.

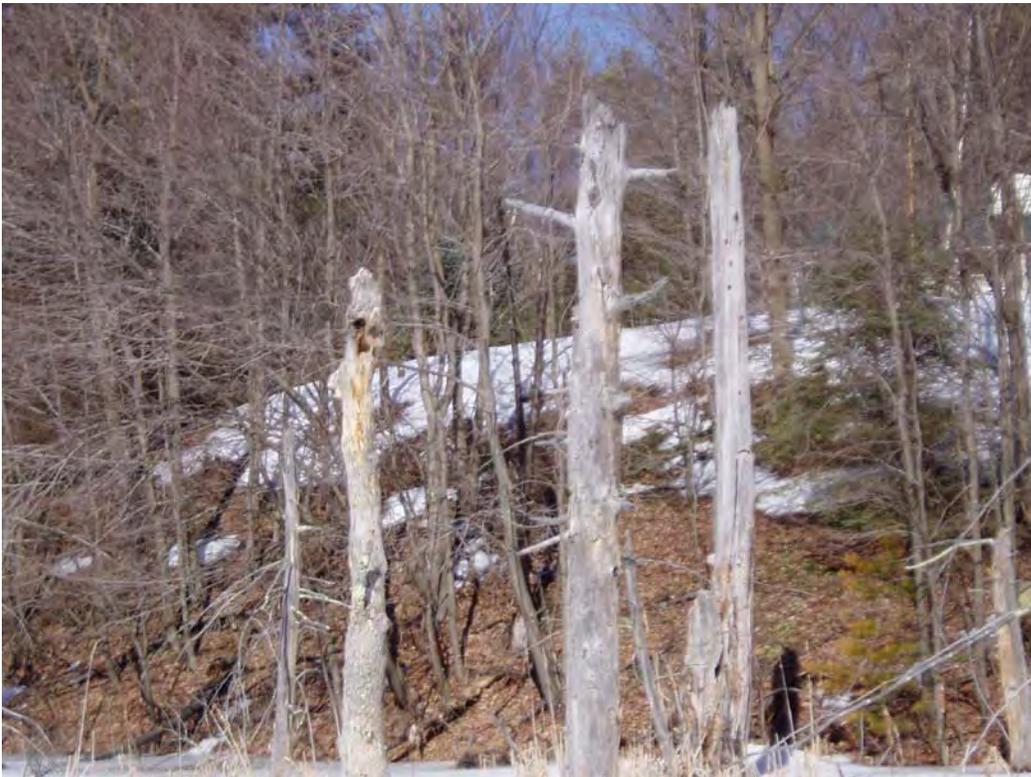
2. Snags within the wetland still provide a critical habitat feature for nesting songbirds.

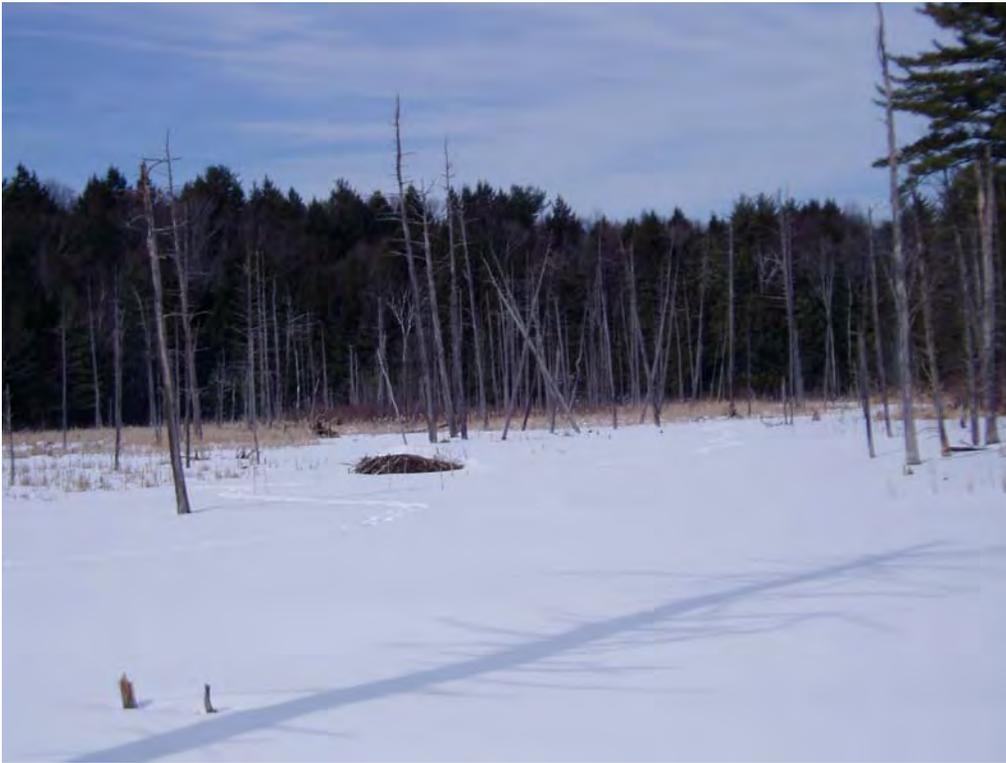
1. Wetland #28 is a series of interconnected beaver flowages. This photo shows one of the beaver lodges observed (right center) in the more central portion of the wetland.

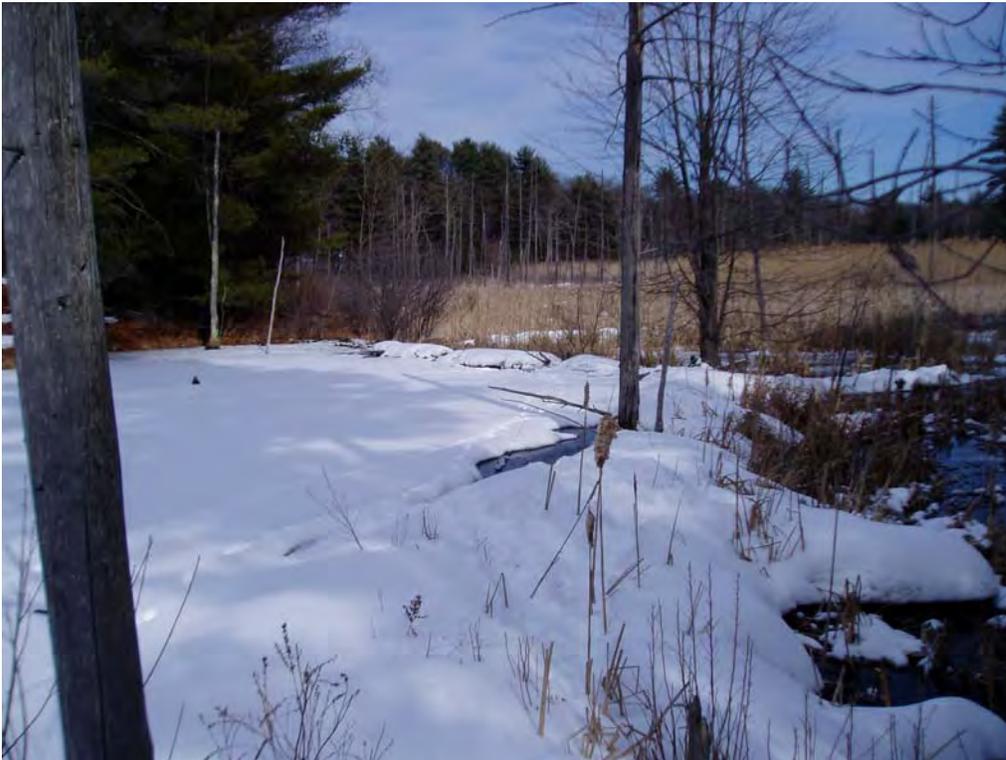
2. This photo shows one of the several beaver dams that separated the individual beaver flowages.

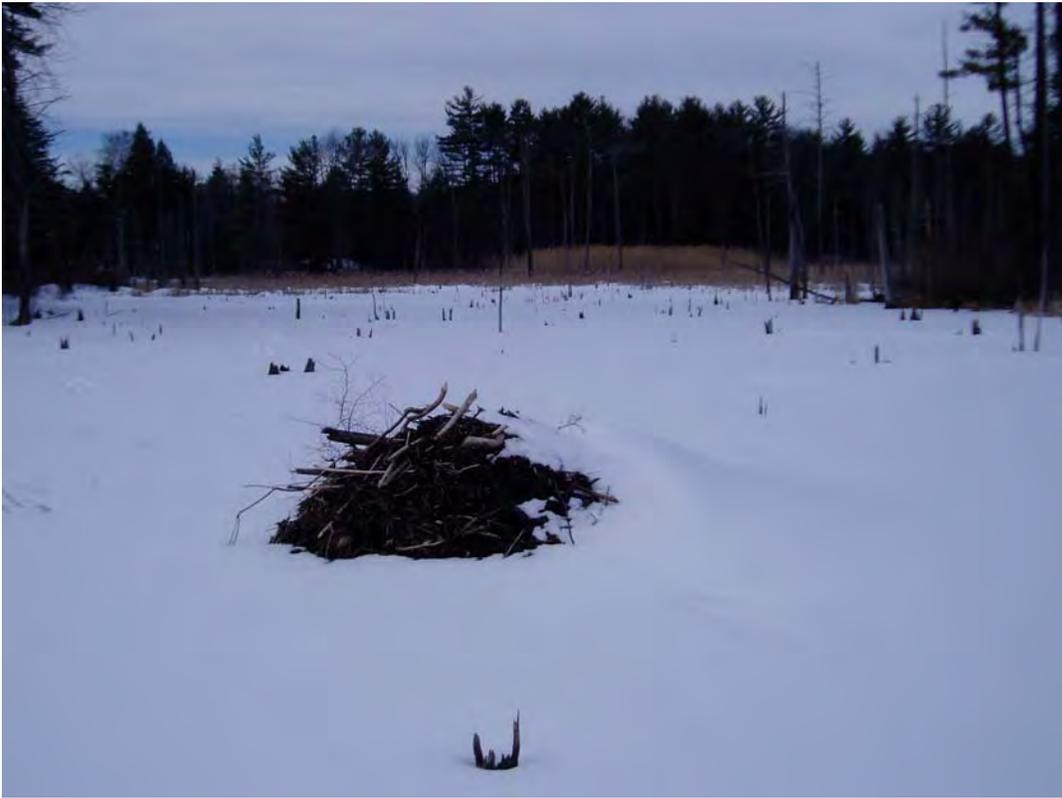
3. This photo shows another beaver lodge situated in the southeast section of Wetland #28.

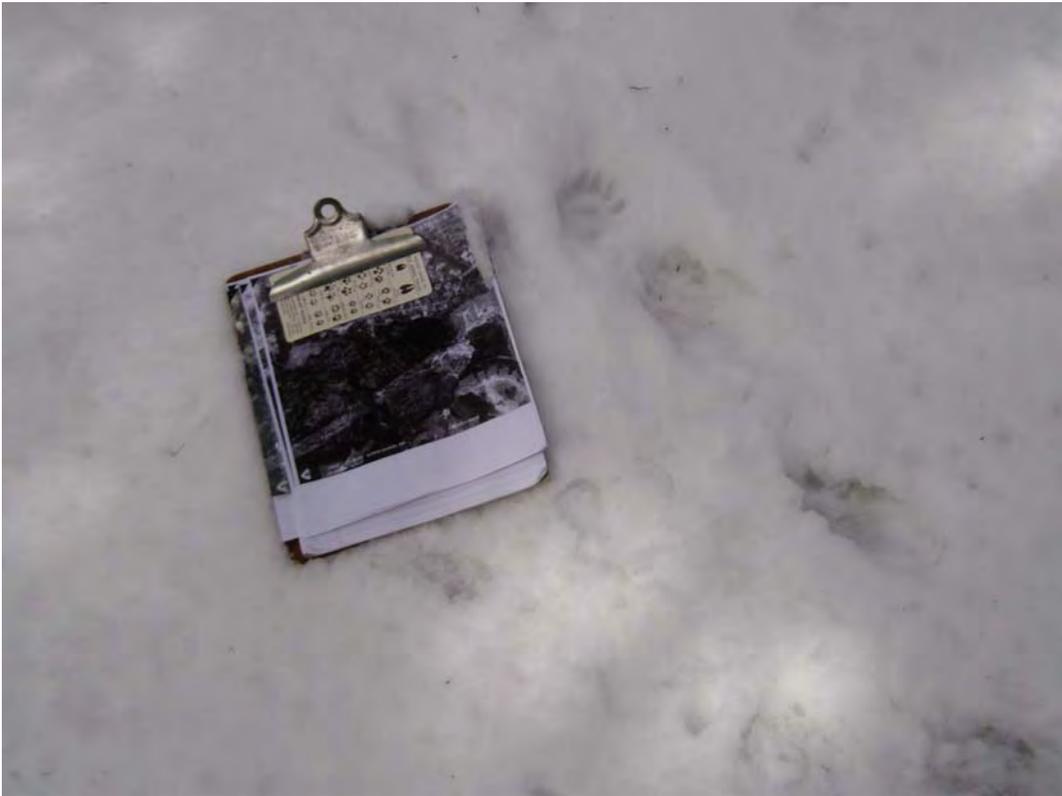
4. Fisher tracks (shown right of clipboard) were observed in the adjacent uplands.

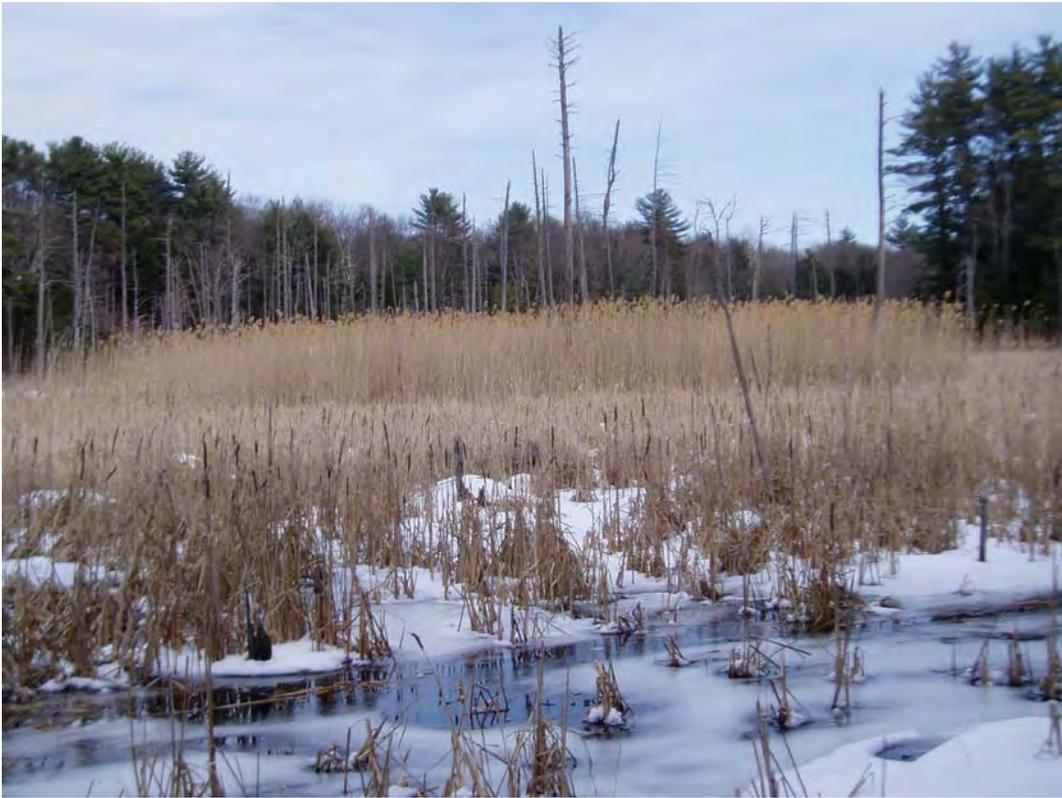
5. Common reed (phragmites), an invasive species, was noted in one of the beaver flowages (the taller vegetation in photo). This invasive often displaces other naturally occurring wetland plants and over time reduces plant diversity.

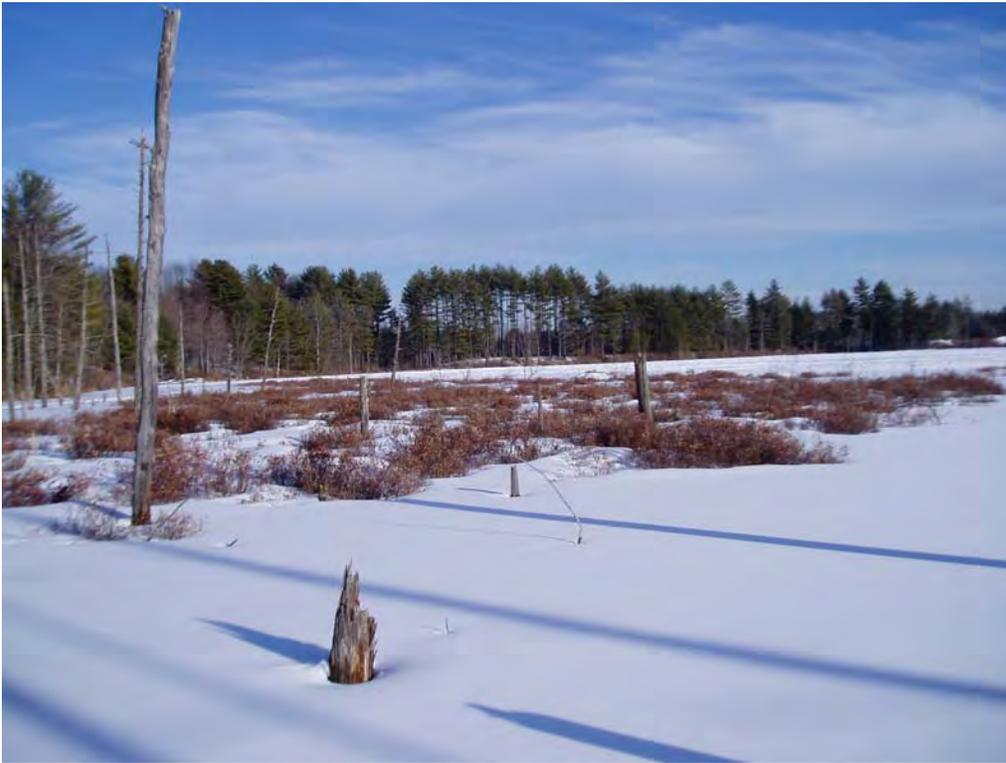
1. Wetland #29 contains a large open water component with an internal scrub-shrub leatherleaf plant community (PSS3Fb).

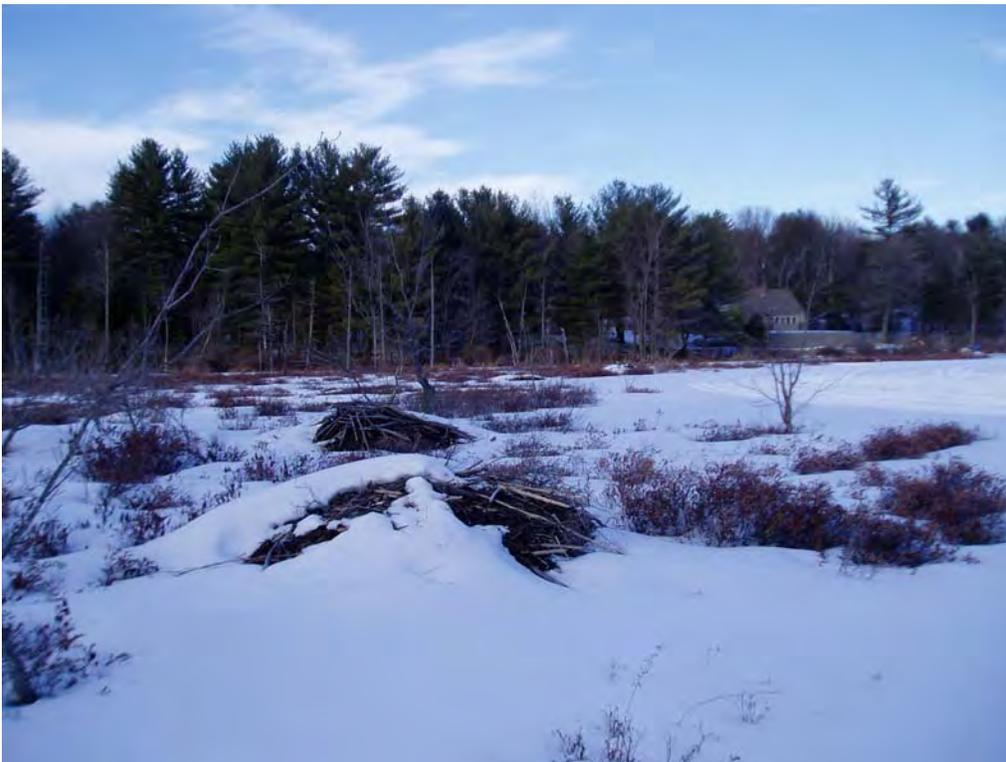
2. The wetland is occupied by a large colony of beaver. Six individual beaver lodges were noted. It appears (not confirmed) that a large percentage of their diet is aquatic plants.

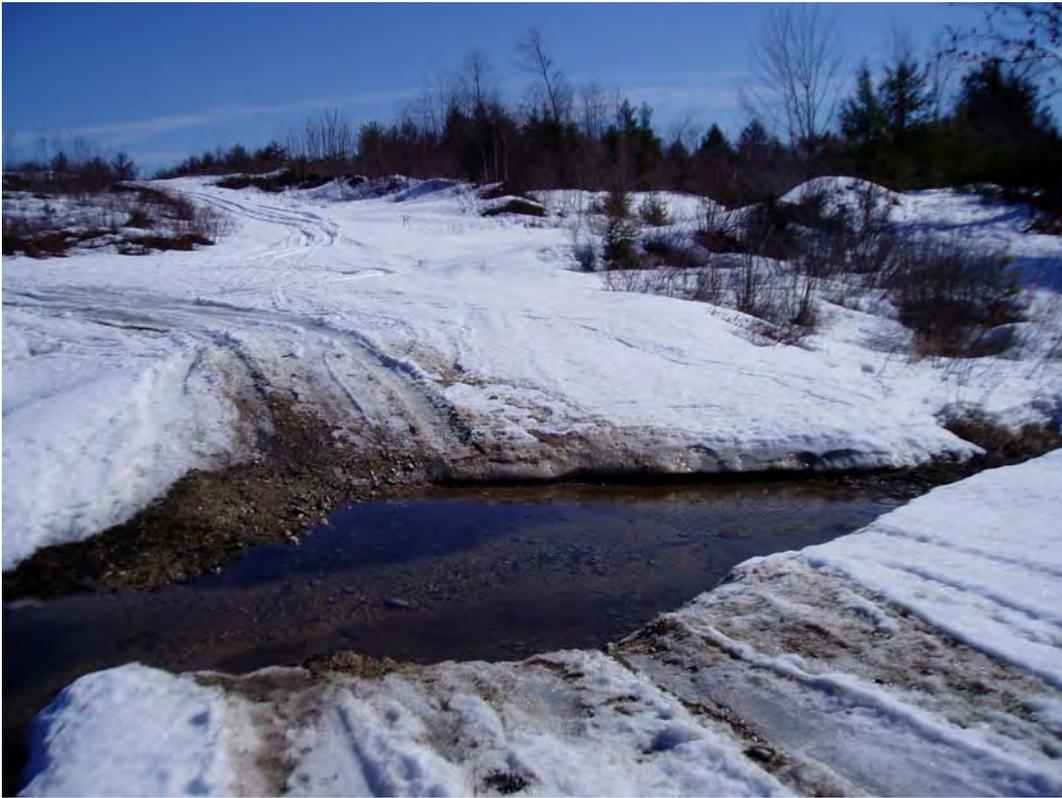
3. This photo shows a heavily used snowmobile/ATV crossing at the most southern end of Wetland #29. Efforts should be made to employ an appropriate crossing structure on this power line road to protect surface waters entering Wetland #31.

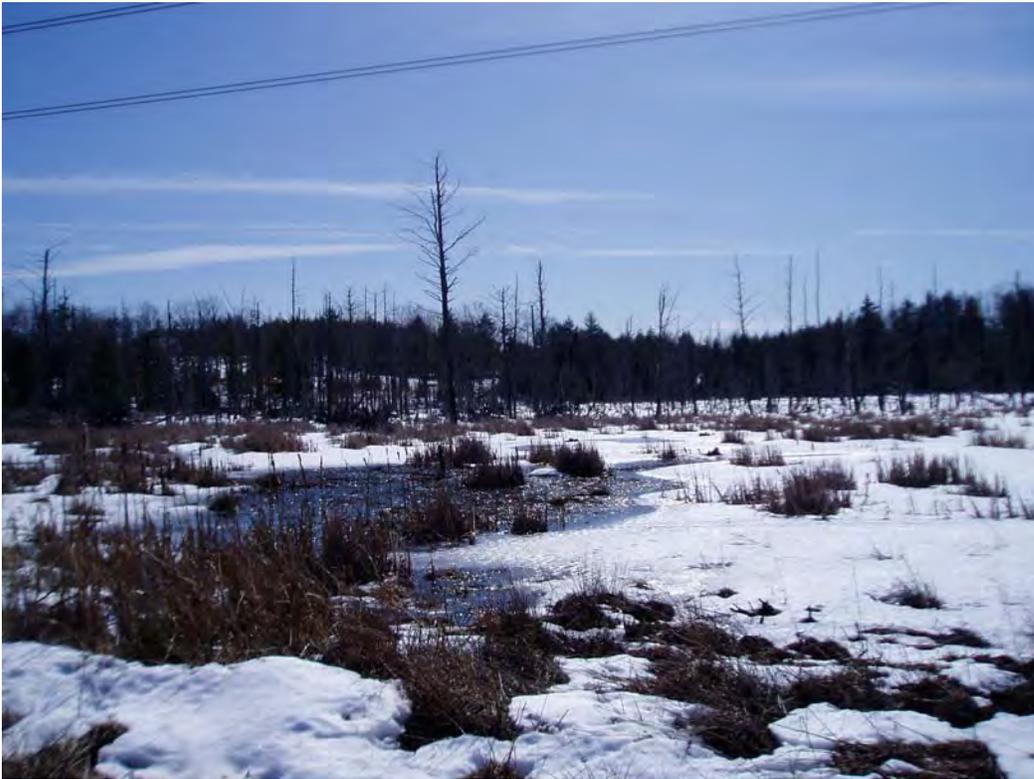
1. Wetland #30 is largely emergent marsh with a component of overtopping snags.

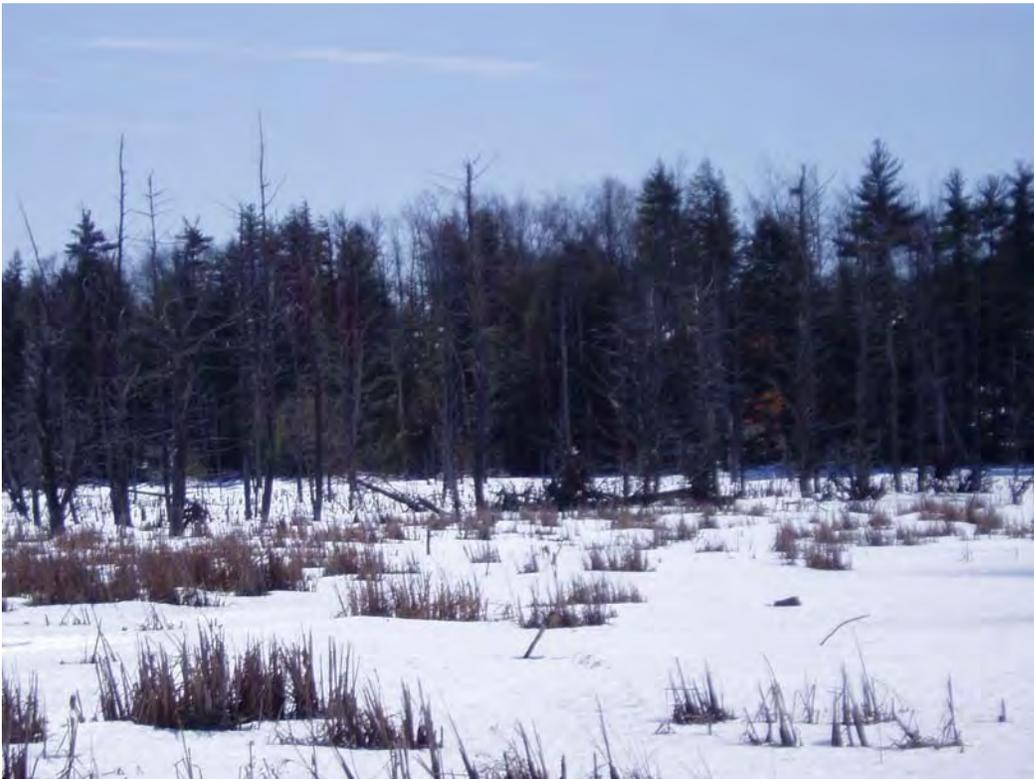
2. A single great blue heron nest was noted (top, right) in one of the existing snags. Wetlands that are utilized by this particular bird are usually considered very important.

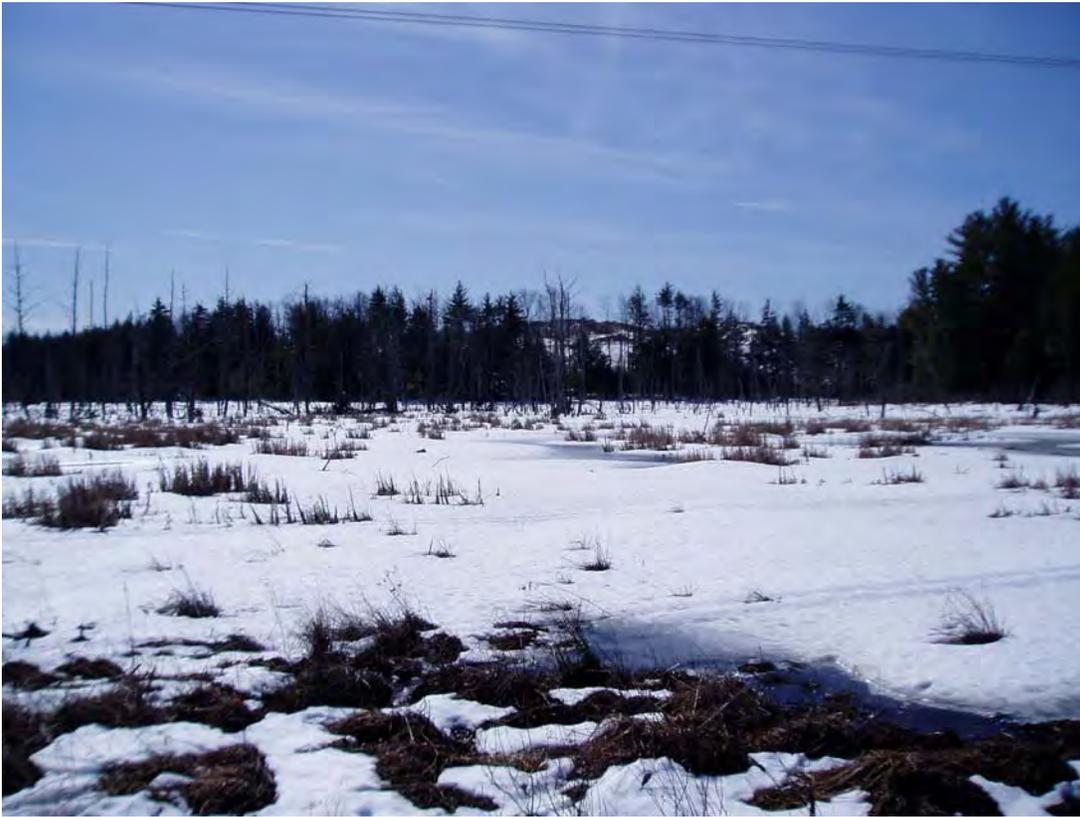
3. Wetland #30's position between a development and active gravel operations may limit its overall protection over time.

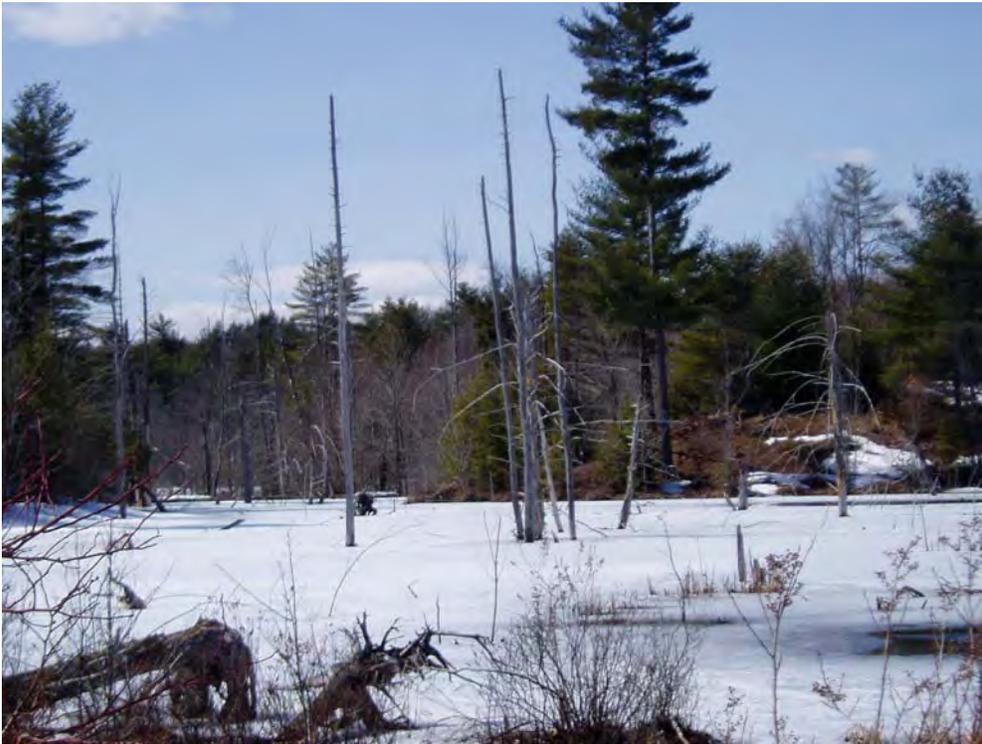
1. This photo, directed eastward, shows one of the open water components contained within Wetland #31. In two locations, beaver have constructed dams that have impounded water.

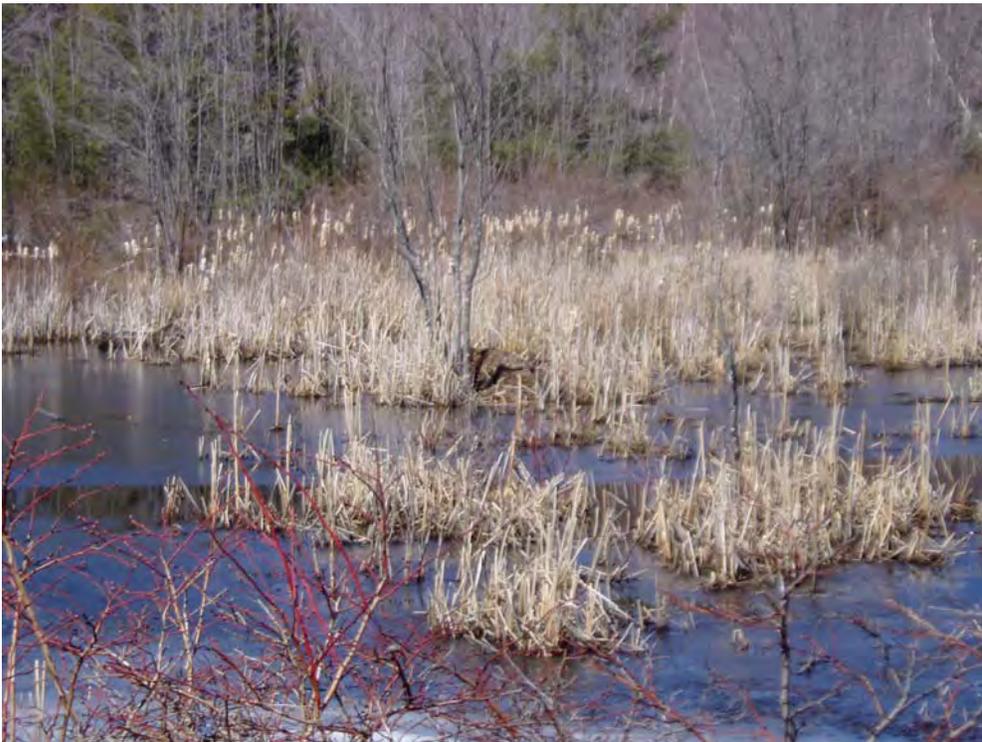
2. Oftentimes, beaver attract other wildlife species that utilize these valuable habitats. This photo reveals a muskrat lodge (center). Muskrat migrate to wetlands with broad-leaved cattail plant communities.

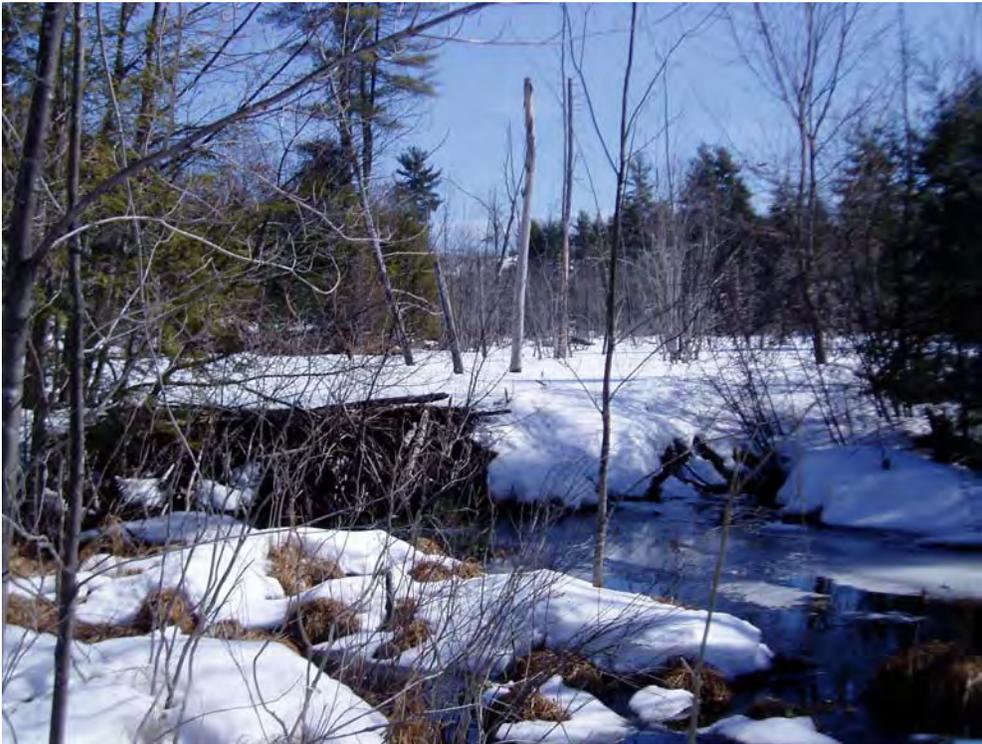
3. This photo provides a view of Wetland #31 looking east from its most western end. Here, a second dam structure was noted.
