Town of Sandown Wetland Evaluation Report

Town of Sandown, NH
Conservation Commission

August 2008

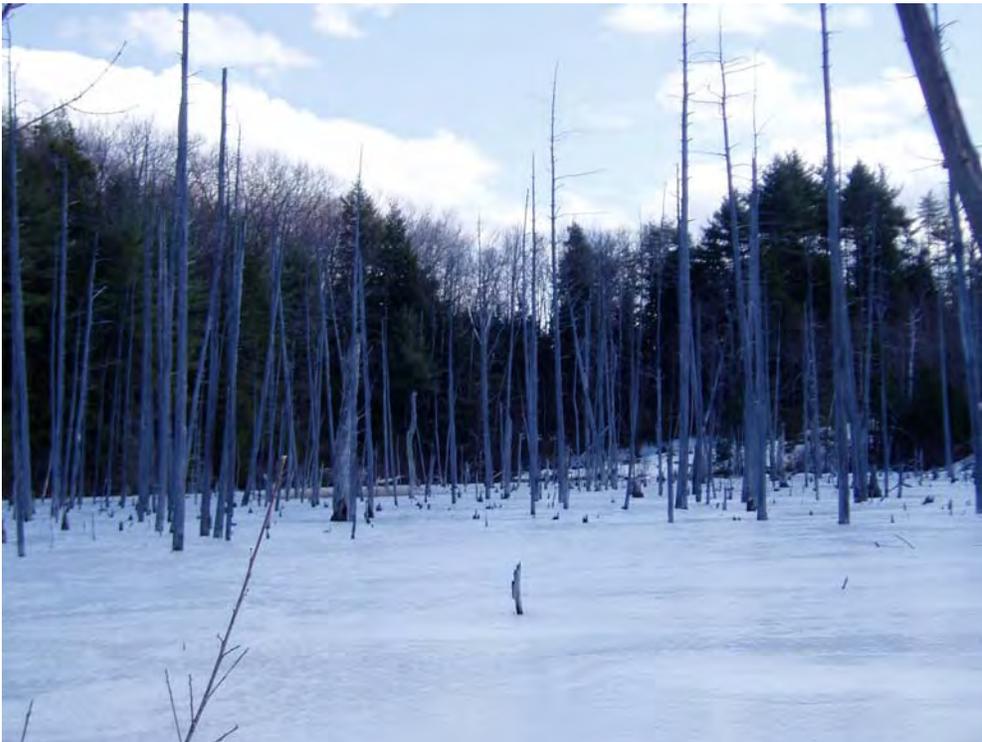
4. The impoundment of water by beaver often surrounds trees which eventually kill them. This photo shows a component within Wetland #31 where this has happened. These trees later provide surfaces in which birds glean for insects.

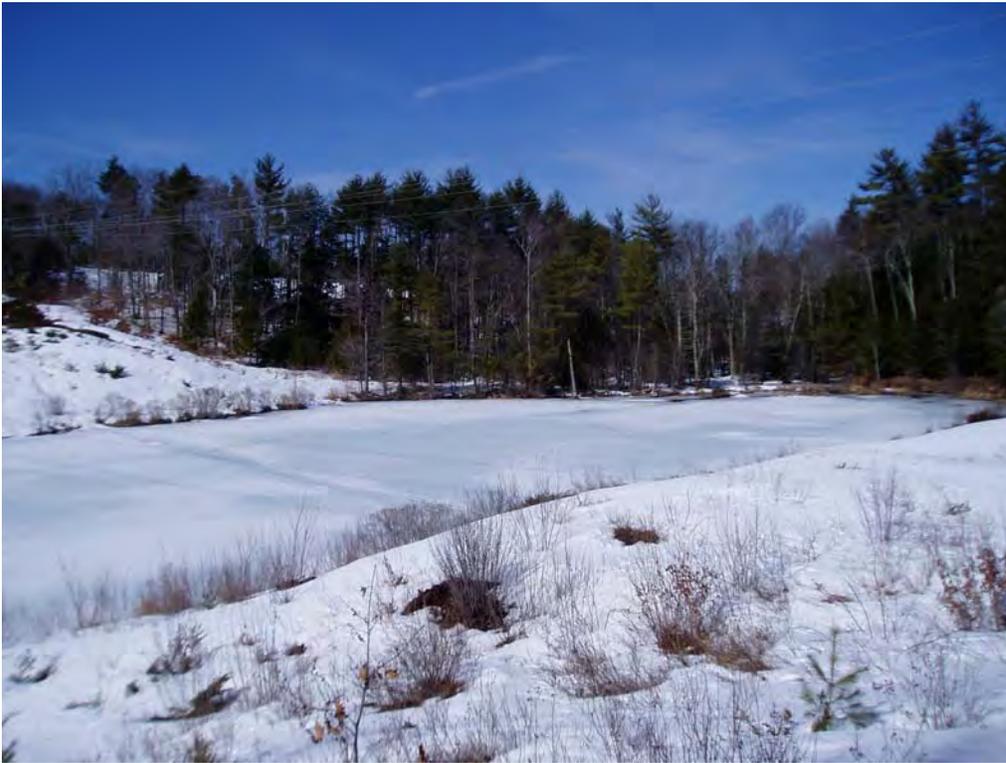
1. Wetland #32 is another beaver flowage being actively occupied by beaver. The wetland is situated underneath a large power line.

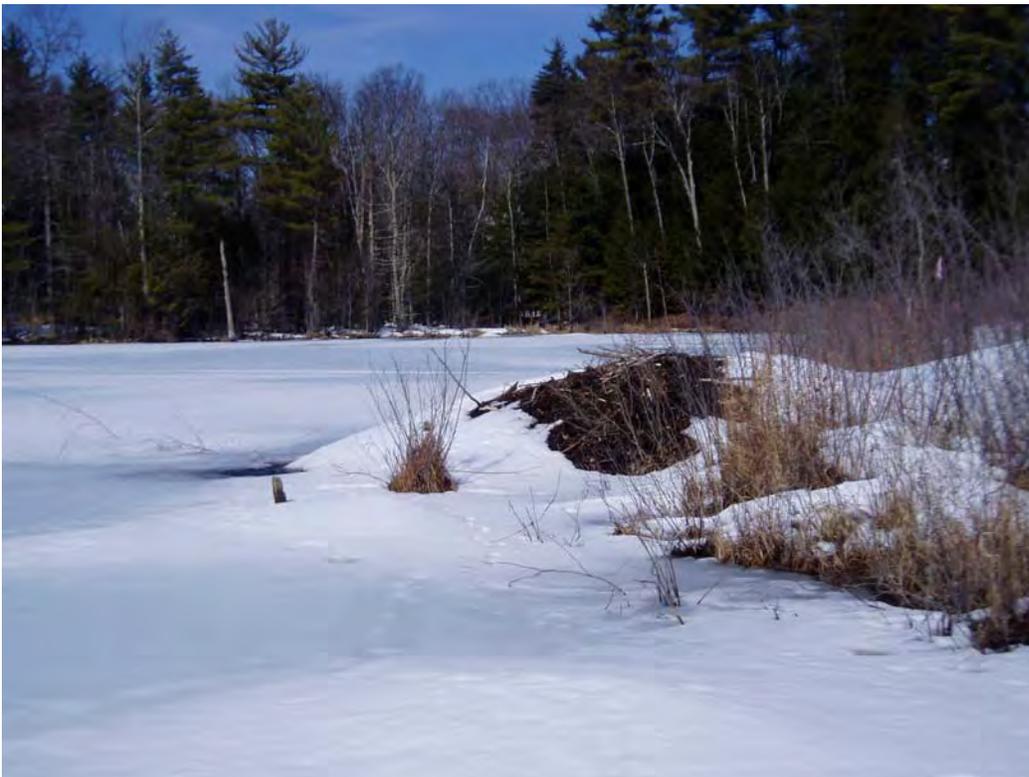
2. A beaver lodge was noted along this wetland's eastern embankment.

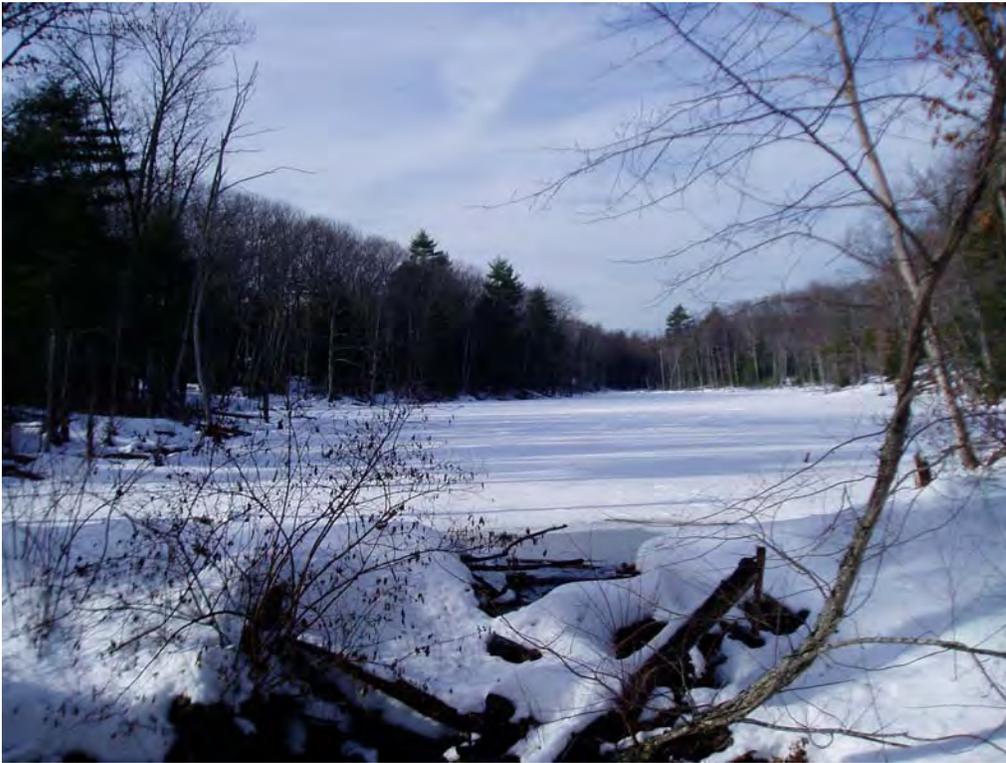
1. Wetland #33 contains a small surface water that has been historically impounded. A perennial stream exits this wetland on the southeast.

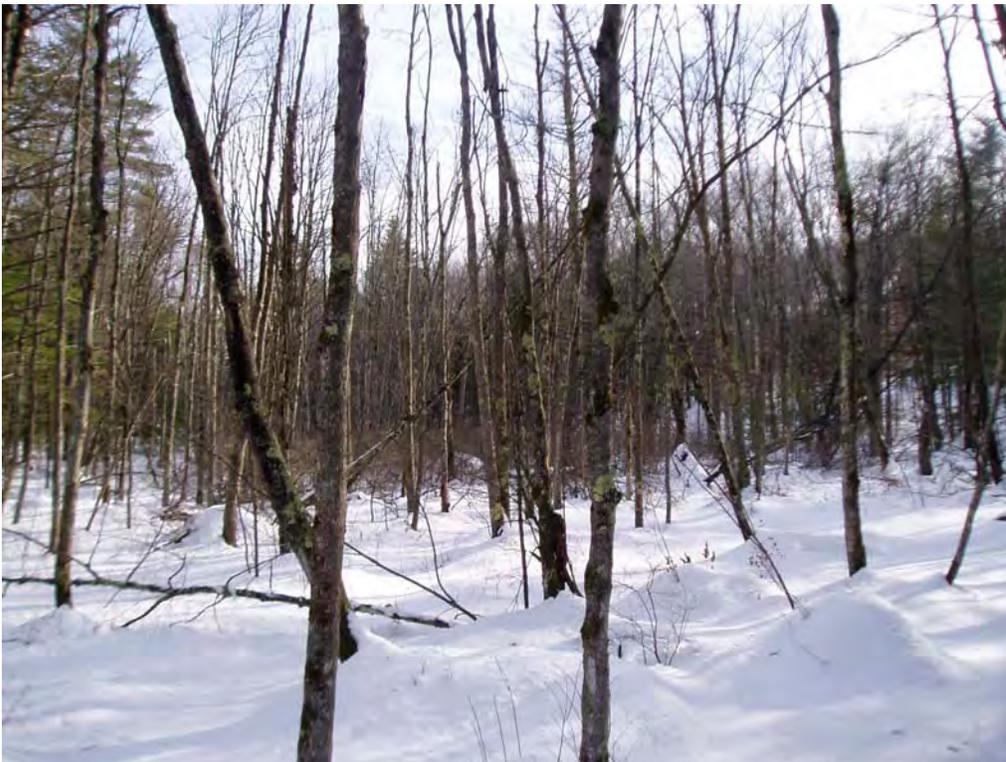
2. This photo shows the forested wetland component situated just north of Wetland #33. Flowage here drains northerly to the Exeter River.

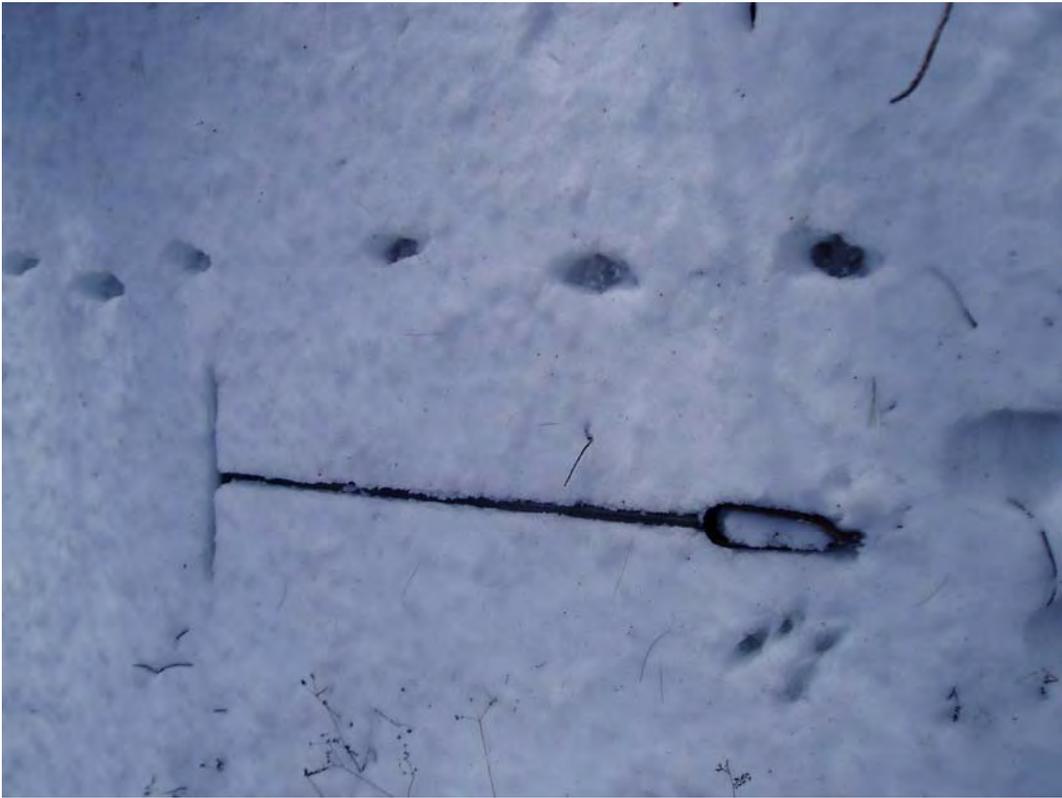
3. Coyote trails were observed within the forested wetland component, substantiating usage by a predator species.
